# ***Vesta Home Inspections, LLC*** **Home Inspection Report**

**1234 Fifth Street**

**Report Prepared By:**

Tom Breslawski  
NYS Licensed Home Inspector #1600047670  
(585) 615-8696  
[www.vestainspector.com](http://www.vestainspector.com)

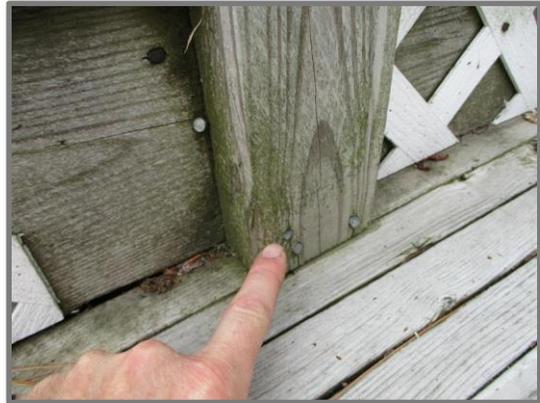
2. We discussed the deck during the inspection. It needs work. I'll start with the lack of safety railings. Railings are required on decks above 30 inches in height. The location that we measured was 40 inches, and it was even higher on the north side of the deck. Appropriate hand rails should need to be in place on both sides of the stairs as well. The current stair hand rails are nailed to the rim joist (see where I'm pointing) instead of bolted, as they should be, and wobble very easily. They are likely to break right off in a slip and fall situation.

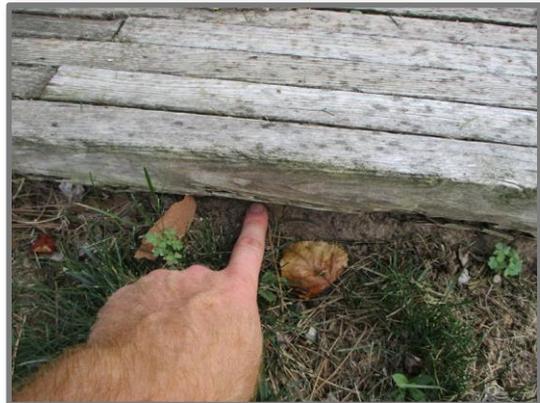
Portions of the deck, including the steps, are in direct contact with the ground (see where I'm pointing). Wood should never be in direct contact with the ground since it retains and even wicks up moisture, causing it to decay and fail. I didn't check the steps to see if they are still level, but typically over time steps built like this will decay at the wood/ground area and begin to lean away from the deck. If it hasn't happened yet, it will.

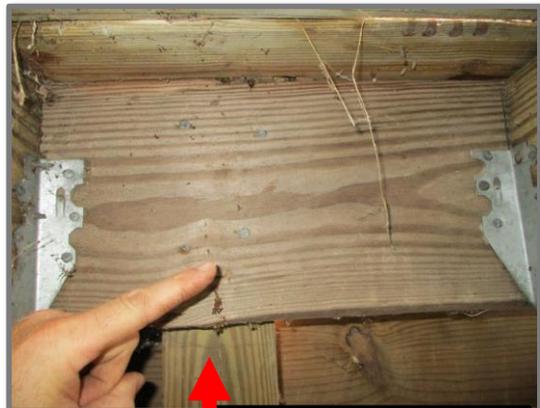
The deck beams are 2x8 construction, and only some of them are vertically supported on 4x4 posts. The beams are simply nailed to the posts. All beams and butt joints should be vertically supported and bolted to the posts or attached with an approved connector. This is a serious construction defect and could result in deck collapse and injury or death.

There should be vertical support here

I recommend that you contact at least one qualified carpenter/contractor to discuss repair or replacement options for these deck issues before closing on the home.

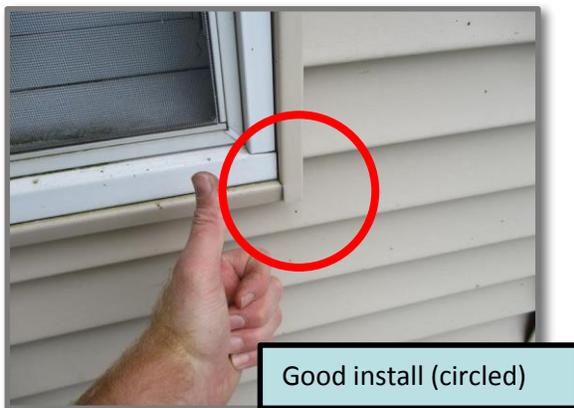
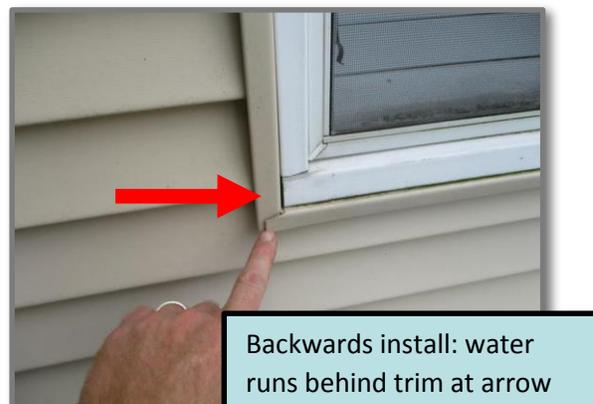
4. The window on the front (lake side) east corner of the house has a piece of trim installed backwards at

one corner. The trim should be installed so that water cannot run behind it and get walls and framing damp. In this case, a couple pictures are worth a thousand words. A qualified window/siding contractor or handyman can fix this quickly and easily.

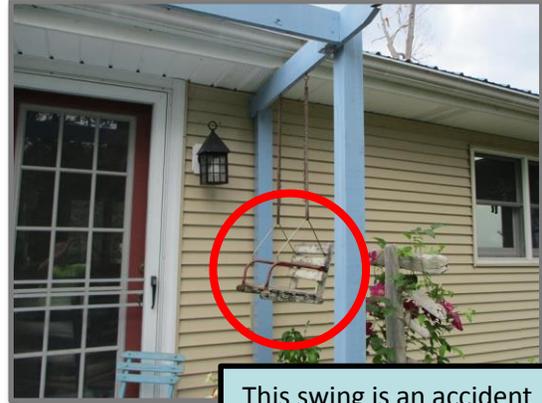
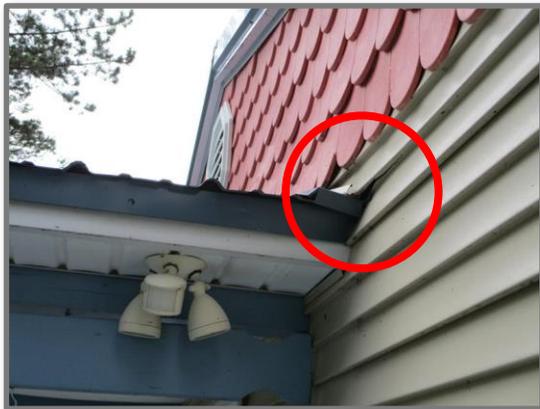
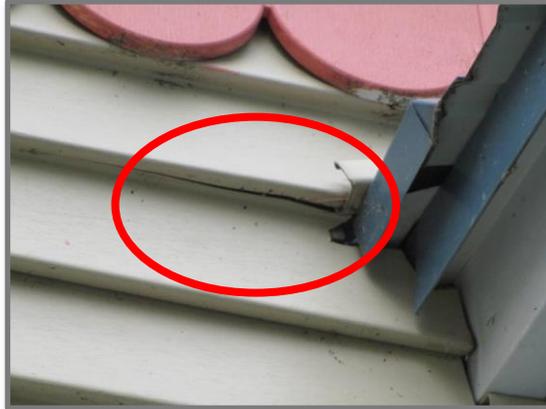
12. The vinyl siding on either side of the entry door overhang has been damaged (see pictures below). It's an invitation to bees and insects, and could let moisture into the house too. I recommend having this repaired or at least sealed up by a qualified siding contractor.

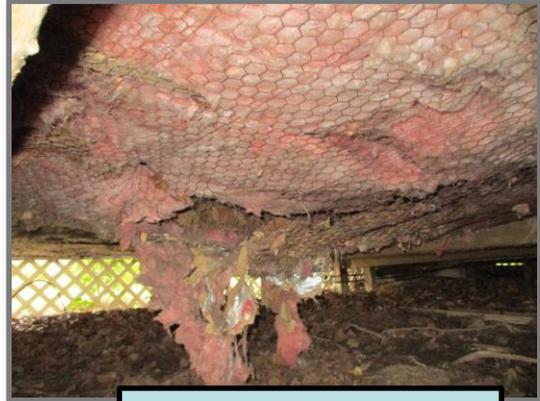
2. Some of the floor insulation underneath the addition (north room) and in other areas has fallen down. Insulation must be continuous to do its job. I recommend having the insulation repaired/replaced as necessary and considering an insulation upgrade to the crawlspace (I'll talk about this more in the plumbing section). A qualified insulation contractor should be used for all repairs/upgrades.

Floor insulation coming out

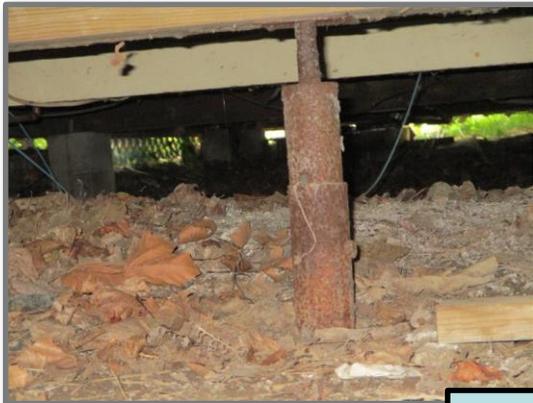
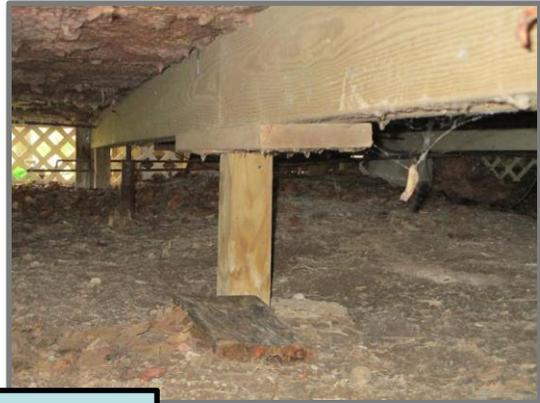
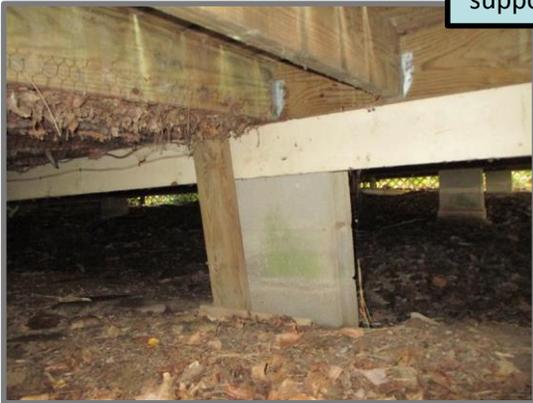
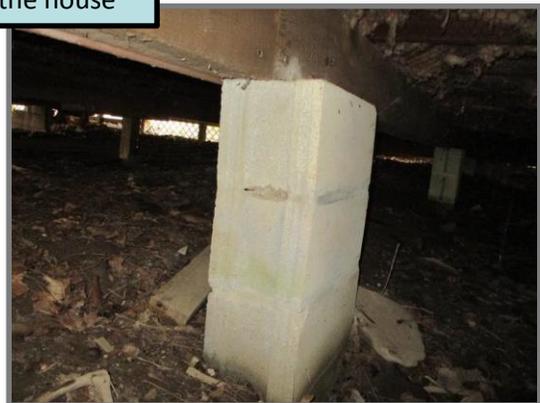
3. This is an older house, and has had a lot of framing modifications over the years. There are some questionable/non-standard supports beneath the house. Some of the supports may be effective, others may not. It's impossible for me to know for sure. The floors throughout the house were not overly squeaky or spongy. I do not recommend removing any of these supports at this time. If one or more of these supports fail in the future, repairs will be necessary and should be carried out by a qualified structural contractor.

Various unconventional supports under the house

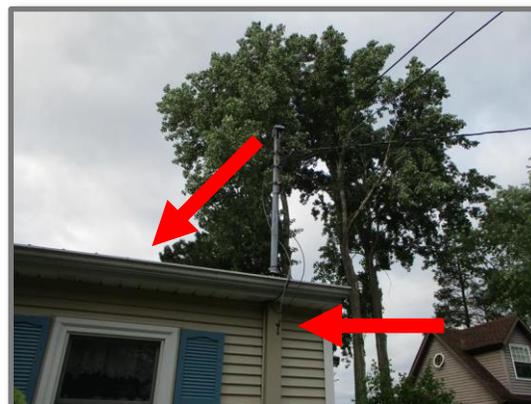
2. The weather head mast of this electrical system extends more than 3 feet above the surface of the roof. Generally-speaking, electricians will brace these masts when they are taller than 3 feet, in order to prevent the strain on the mast exerted by the weight of the service drop from bending the mast. There is no specific requirement for bracing in the electrical code, but most utility providers specify where and how they want these masts braced. I recommend consulting with the local utility provider to determine whether there are any local bracing requirements. If so, the mast should be appropriately reinforced by a qualified electrician. In the photo, the lower arrow points to the detached cable, the upper arrow is where the cable should be connected to the roof.

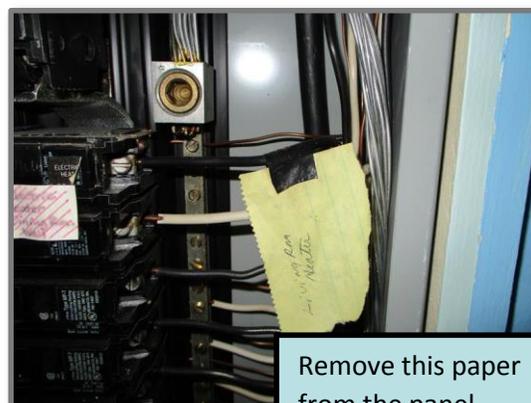
3. There is a paper note taped inside the main service panel. Paper is flammable, of course, and should not be inside the panel where a fire could start. I recommend having the qualified electrician remove this while he is working on the other repairs in the panel.

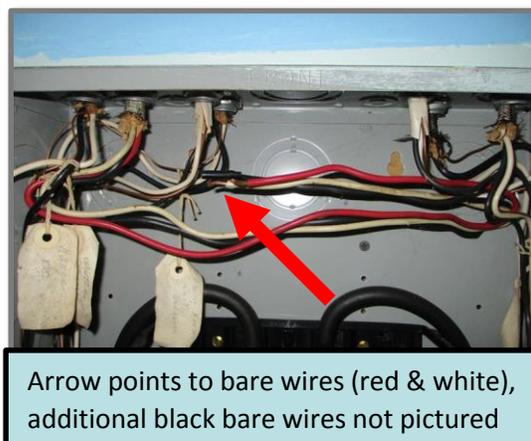
4. There are four wires with bare ends that do not terminate inside the main panel box. This is an electric shock and/or fire hazard. I recommend having a qualified electrician find the source of these wires and either remove or properly terminate them.

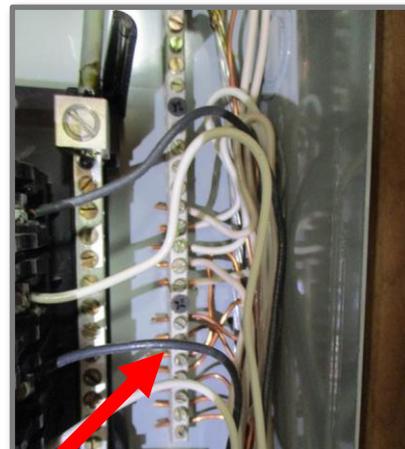
8. There are ground (copper color) and neutral (white) wires on the same bus bar in the sub panel (located in the family room closet, see picture). This is an improper wiring and can allow the ground wire to regularly carry voltage, which can be a shock hazard. Any qualified electrician can quickly and easily repair this. I recommend that you have it done.

White and copper colored wires should not terminate together in sub panel

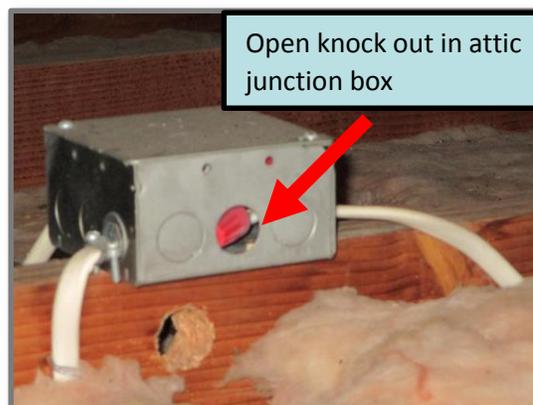
10. There are open knock outs in the junction box in the attic where fixtures have been removed. Junction boxes are designed to prevent electrical fires by keeping wire connections enclosed. I recommend repairing or replacing this junction box, with work to be done by a qualified electrician.

Open knock out in attic junction box

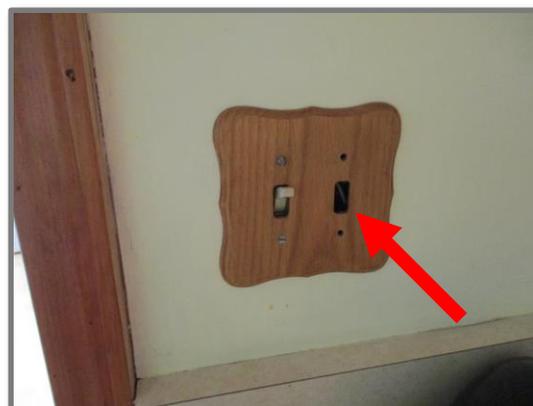
13. There is a double light switch in the kitchen that is damaged/missing one of the switches (see picture/arrow). The opening could expose energized wires to contact with a person reaching for the switch, causing injury or death. I recommend having this repaired/replaced by a qualified electrician.

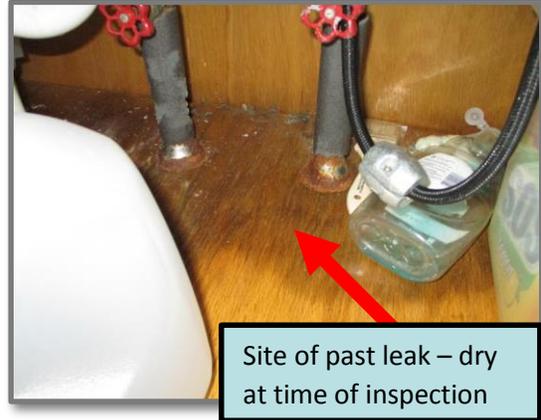
6. There is evidence of a past leak underneath the kitchen sink. There is discolored wood and rust on exposed metal, however there are no signs of current moisture.

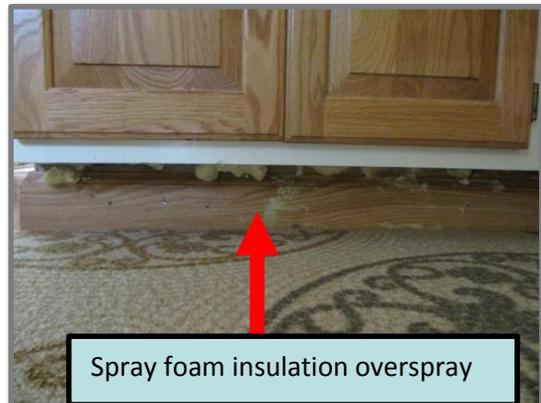
9. There is a piece of trim (kick plate) missing underneath the cabinets directly to the right of the stove. It's really a cosmetic item as well, but you may want to have it added.

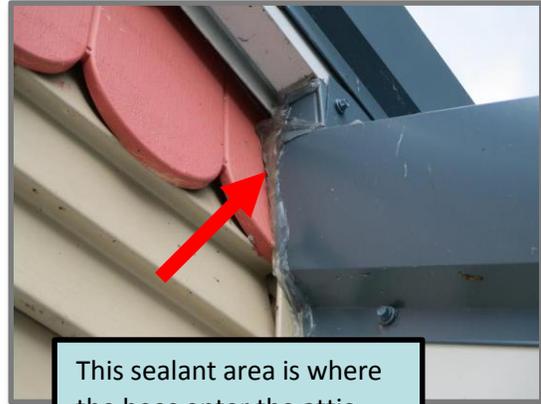
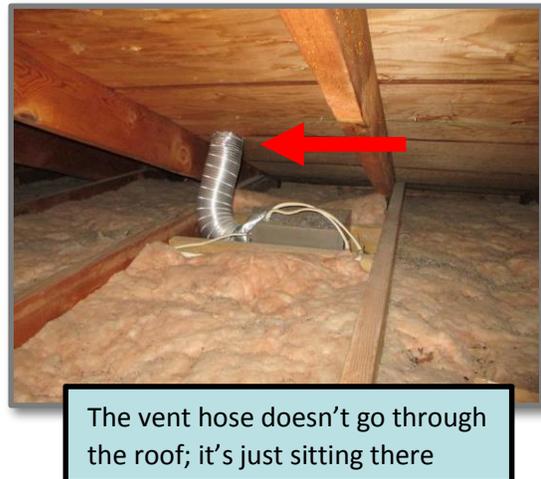
5. The bathroom fan exhausts directly into the attic. This is an improper termination. It sends warm, humid air from the bathroom into the attic resulting in moisture damage to the underside of the roof and other attic surfaces and mold and mildew growth. I recommend correctly venting the bathroom fan through the wall or soffit directly to outside. In the picture, it looks like the vent goes into the roof sheathing, but it doesn't go through the roof. The roofer never connected it after installing the metal roof.
