# Vesta Home Inspections, LLC

## Home Inspection Report

**123 4th Avenue**

Any Month, 2016

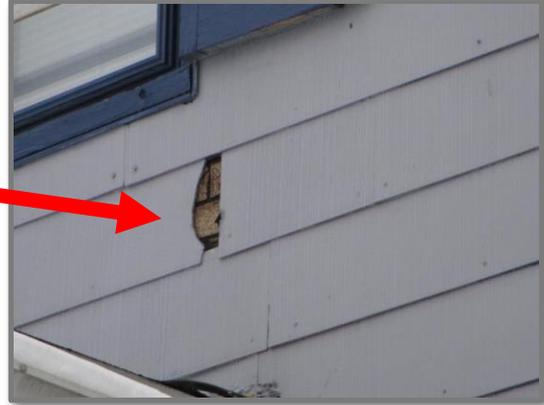
6. There are several broken/missing pieces of siding on the house. This one is on the front, above the porch roof and below the second-floor window. All the broken pieces should be replaced to keep moisture from damaging the wall and framing behind it.

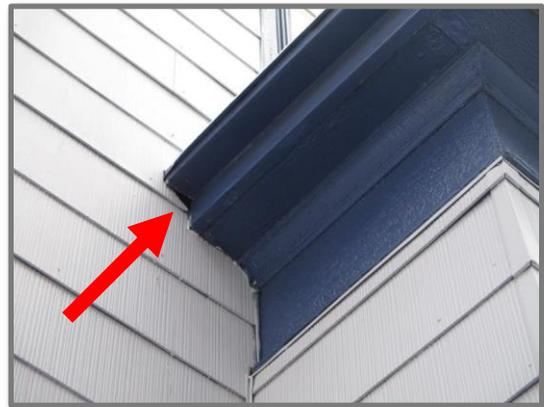
7. This hole on the east side of the house (at the bay window) needs to be sealed up or it will probably become an entrance for squirrels. It's also an entry point for moisture, so you'll want to have it sealed up. The other side of the bay window is like this and should be fixed too.

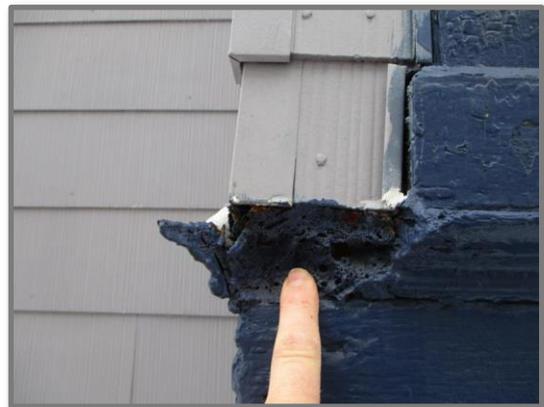
8. This area on the east side of the home has been sealed up with spray foam. Spray foam holds up surprisingly well if it's kept painted. I recommend either keeping it painted or simply repairing the small piece of trim so that you don't have to worry about it anymore.

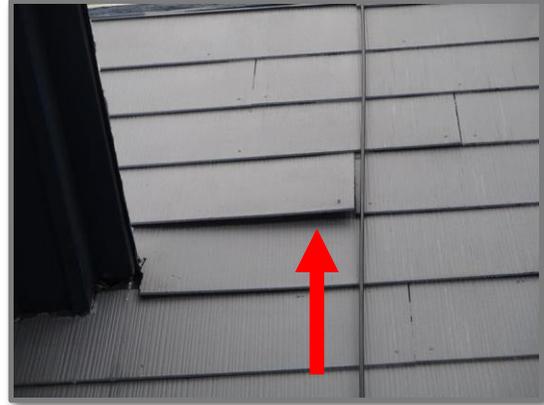
9. There are several pieces of siding that are pulled away from the house and should be re-attached before they break or get torn off by the wind. This one is on the east side of the house just north of the bay window.

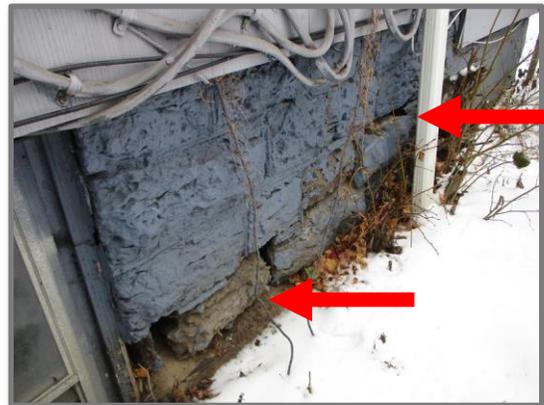
10. On the east side of the house, near the north end, there is quite a bit of mortar missing between the blocks. Some of the blocks are loose and moveable. I can't be sure what caused this, but it may have been from a badly leaking gutter/downspout that has since been repaired. I carefully checked the house for signs of structural movement and couldn't find any. You should have this area repaired by a qualified mason. If you have any additional concern about the foundation of the home, you can hire a structural engineer to give you his opinion on it.

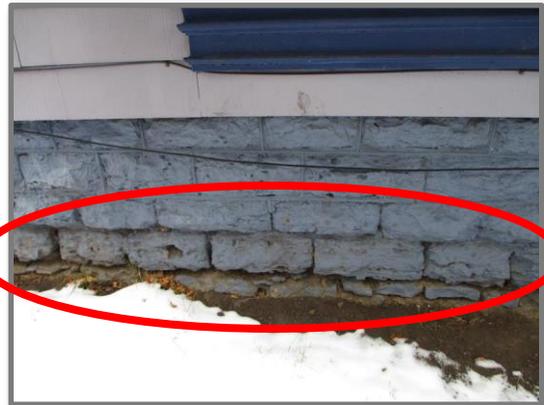
11. There are some areas that need repointing on the east side of the house. I recommend having this done by a qualified mason before it gets worse.

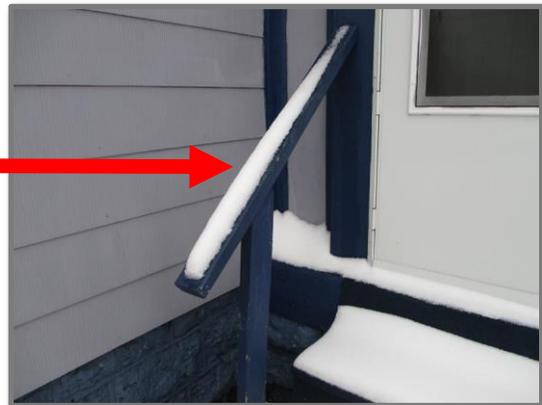
14. The porch entry railing for apartment one is made from a two by four on edge. This is not an approved type of railing because it's not graspable in the event of an emergency. The railing is too weak to hold a falling person and should be replaced.

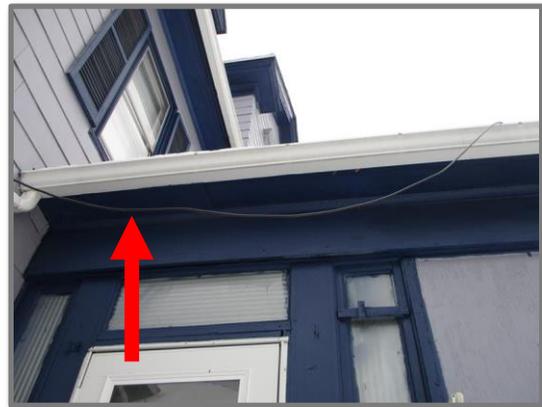
17. This board under the eave of the front porch (above the door) is made from OSB. OSB is highly susceptible to moisture. It swells, becomes soft and gets ruined by even one exposure. I recommend replacing it before this happens.

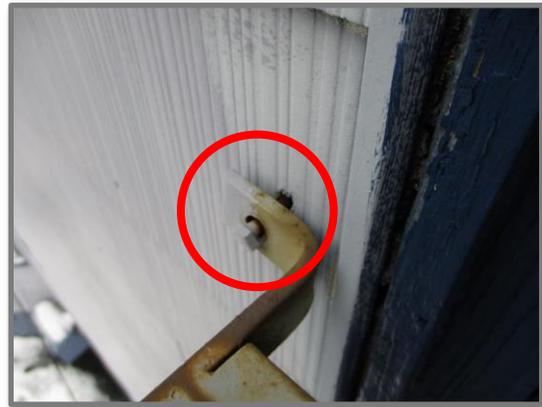
18. I climbed both fire escapes. These fire escapes should be installed to manufacturers specifications, however I found one lag screw that was partially backed out from the house. This was on the west side fire escape. I recommend tightening it down or replacing it if necessary. This is a safety issue.

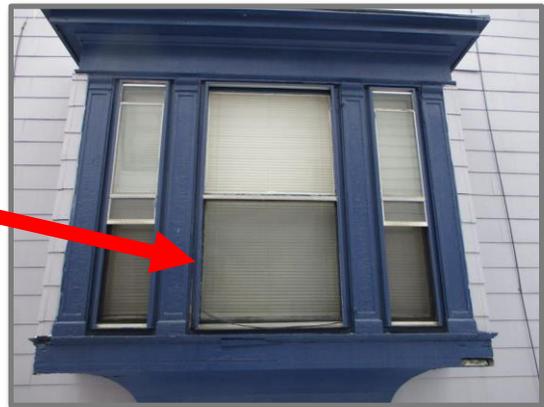
26. The storm window frame here is damaged/falling apart and should be replaced. There's a small piece of trim missing at the bottom corner of the bay that needs to be replaced to seal the area up.

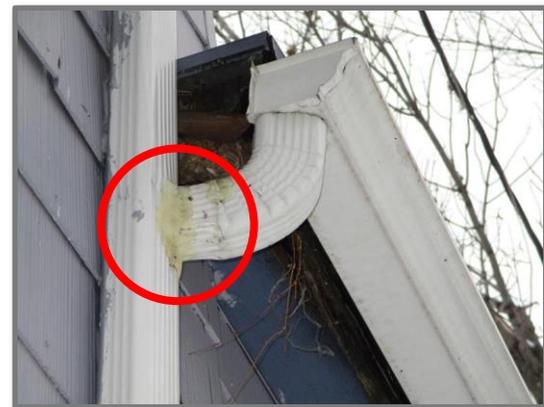
27. This downspout connection on the east side wasn't leaking, but I'm going to point it out because it's covered in some kind of caulk. In my experience, caulk never works on these. I expect it to leak soon. Be ready to replace it. There's another at the south west corner of the house.

The fascia board behind it is damaged from exposure to moisture and should be replaced too.

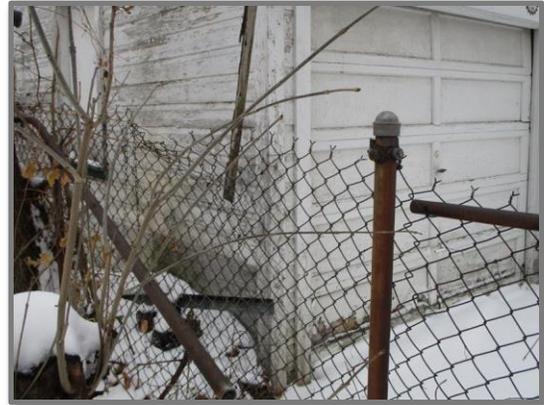
28. The fence in the back yard is pretty beat up. Fences aren't part of a home inspection, so I didn't inspect it any further than this.

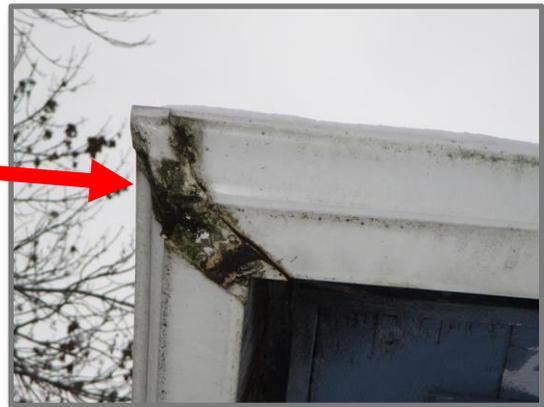
29. This gutter seam at the north side of the house (lower roof) was leaking at the time of inspection. It's not going to get better. Have it replaced before it leaks even worse.

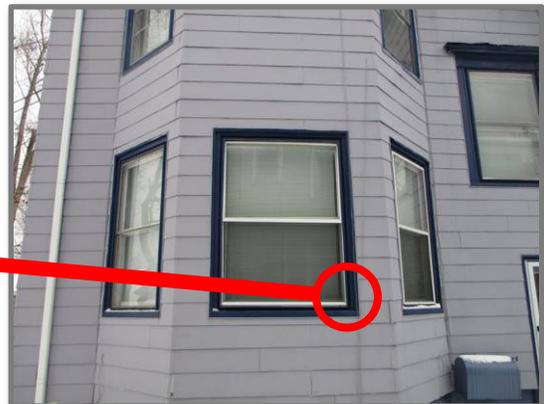
30. The storm window frame on the center window (pictured) is damaged and should be repaired or replaced.

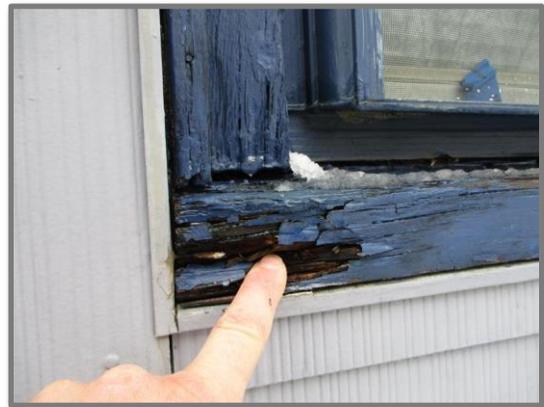
32. This window frame is rotted and should be replaced before the rot spreads to other portions of the house. It's on the west side of the house next to the fire escape.

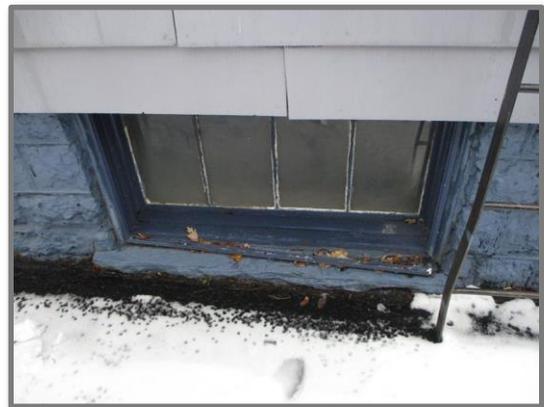
33. The storm window frame is detached at this east side basement window. There is no storm window in place. I recommend repairing this and adding a storm window.

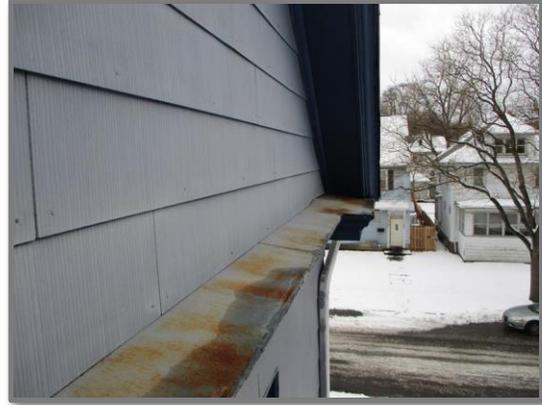
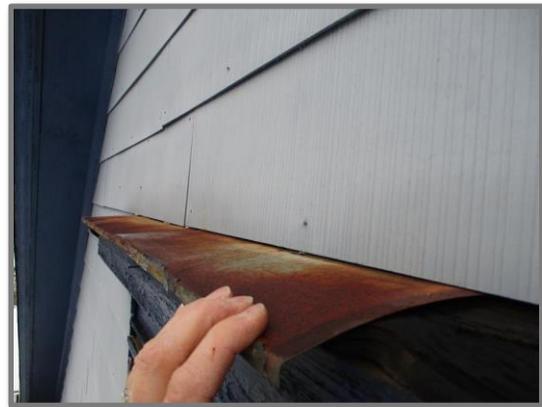
34. The flashing over the windows and ledges on the house is rusted and failing. This will allow water to enter the wall cavity of the house and can cause the sheathing and framing to rot. I recommend having this flashing replaced as soon as possible.

These pictures are from the west side of the house, but I expect all the window flashing to be in similar condition

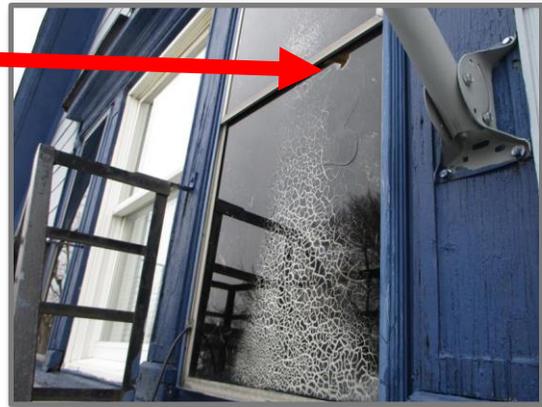
35. This storm window on the east side of the third floor is broken. Have it replaced.

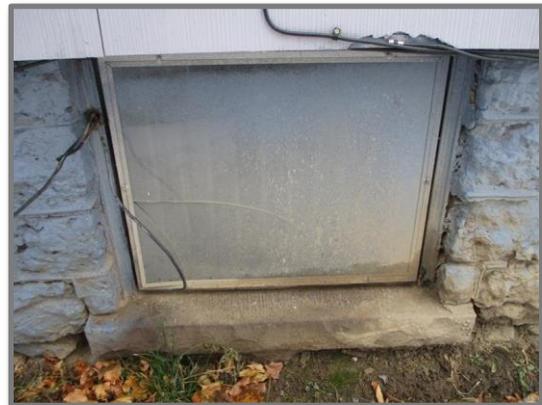
38. This basement storm window on the east side is broken. Have it replaced.

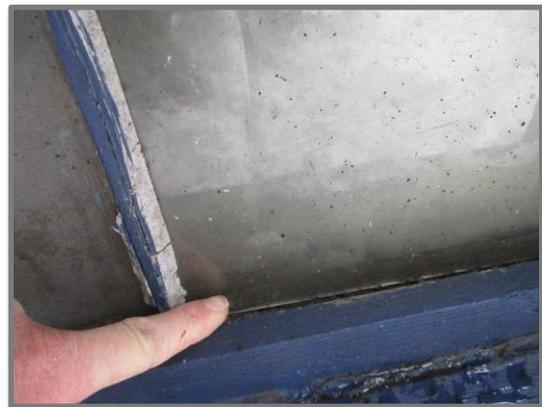
39. I'm pointing to a loose glass pane in the west side basement window. I recommend having it fixed.

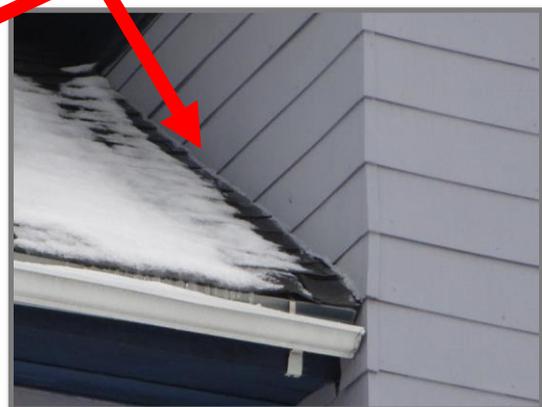
2. At the roof to wall intersections, there is siding in contact with the roof covering. This is a common problem on homes that have either been re-roofed or re-sided. It allows moisture to wick up into the siding and cause damage. There should be at least a 1 1/2 inch gap between the siding and roof covering. I recommend having this adjustment made to prevent damage to the siding.

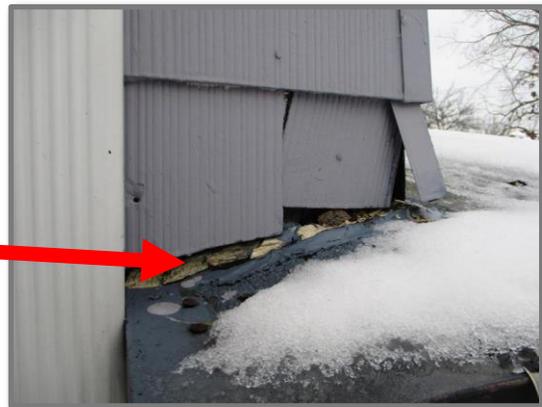
3. This is the lower roof on the north side (over apartment two's bathroom). The caulk at the roof/wall intersection isn't a long term solution for keeping out moisture. I didn't see any signs of a leak on the inside, but this area is going to take in water. Have it properly flashed.

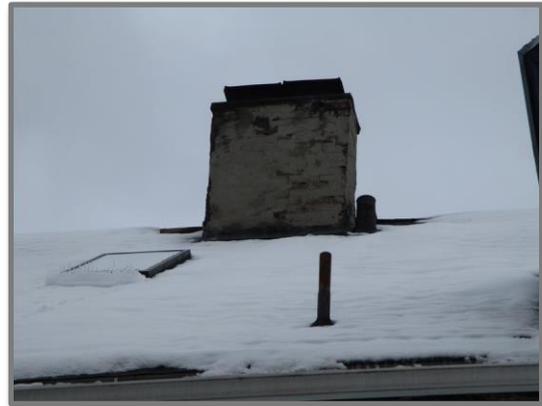
5. Here's a couple pictures of the chimney. It's obviously been repaired in the past. I didn't notice any cracks, but it's a long way up there so I couldn't see the whole thing. The roof was snow covered so I couldn't get up there.

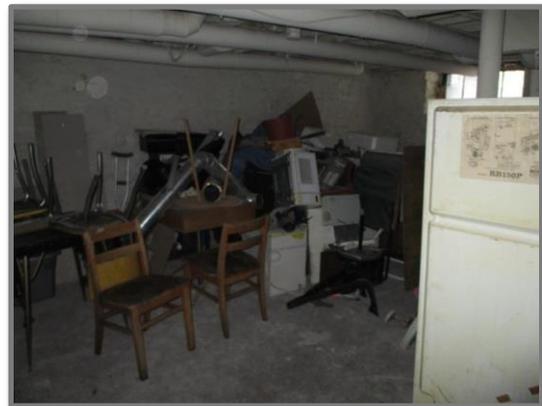
1. There is no light above the basement stairs. Lighting should be present over all steps/stairs to reduce the likelihood of tripping and falling. I recommend installing a light above the basement stairs that is switchable from both the bottom and top of the stairs.
2. The basement is full of clutter. This prevented me from conducting a full inspection, so any comments made in this report are only representative of the visible portion. I can't guarantee what I can't see. I recommend you arrange to have the clutter removed and take a look at the rest of the basement if you have any concerns.

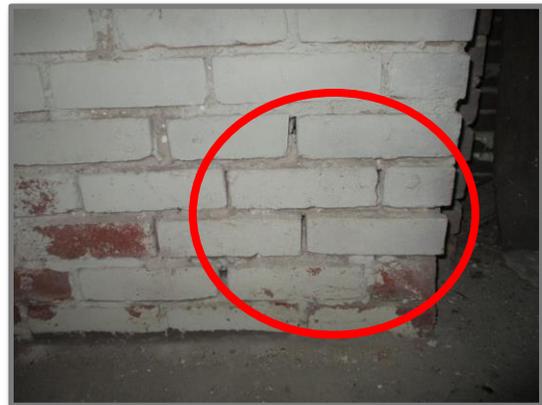
8. This is the base of the chimney in the basement. There is some mortar missing between the bricks but I didn't see any broken bricks. I recommend having the mortar replaced here.

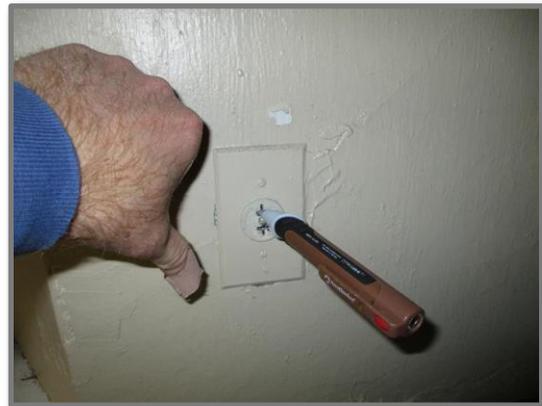
5. This old outlet behind the dryer is dead. I recommend removing it.

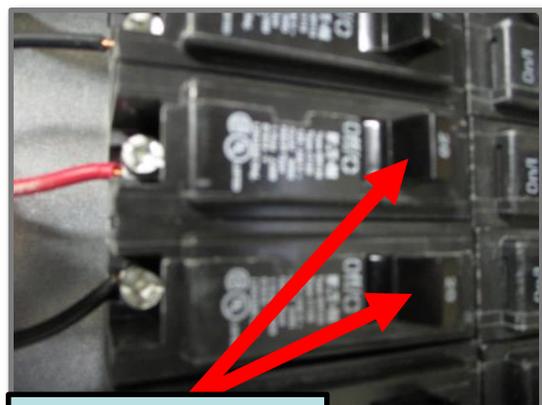
6. There is a multi-wire branch circuit in the main service panel that does not have linked breakers. This is a dangerous situation, since both breakers must be shut off to completely turn off power to the circuit. There is a possibility of someone only shutting off only one breaker and unknowingly being shocked or electrocuted (death) by the remaining live wires on the circuit. I recommend having a qualified electrician link the breaker in this circuit, if possible. If not, I recommend having the electrician replace the breakers with a double pole linked breaker.

These breakers should be linked

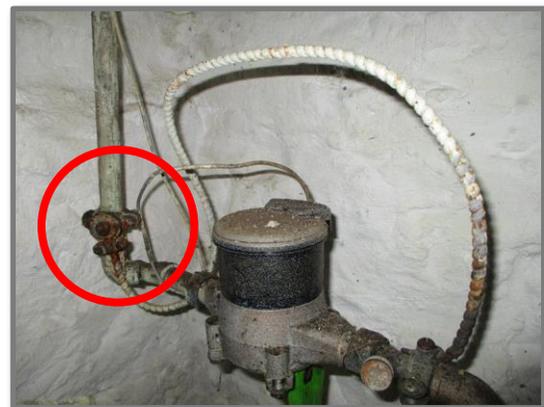
8. There is no bonding jumper at the metal heat ducts and natural gas supply pipes. All interior metal piping systems that have the potential to be energized should be bonded to for a fault current path. If they are bonded and the system is accidentally energized, a circuit will be completed and the breaker or fuse will protect the circuit. If they remain not bonded, the system could remain at elevated voltage potential and be a shock hazard. I recommend having them bonded to the electrical system to reduce this shock hazard.

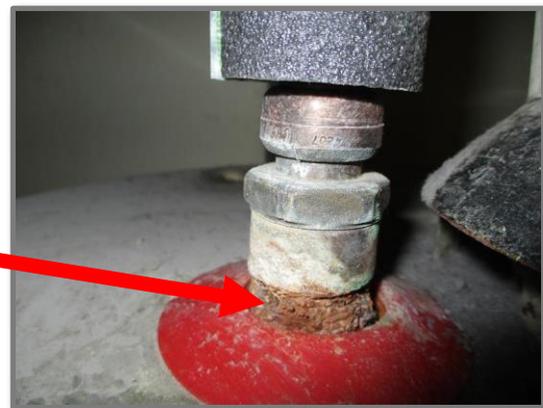
11. The supply and outlet connections at the water heater are rusting. The water heater is 9 years old. These units typically last 12-15 years, so there should be a few more years of service out of this unit, but it's not a guarantee.

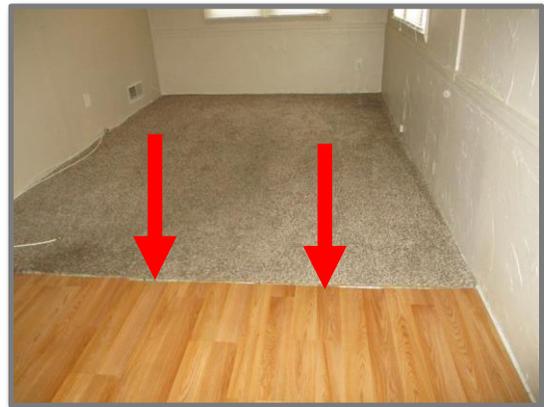
7. On the front porch, there is no transition between the laminate and carpet. I recommend installing one so keep the carpet from being damaged.

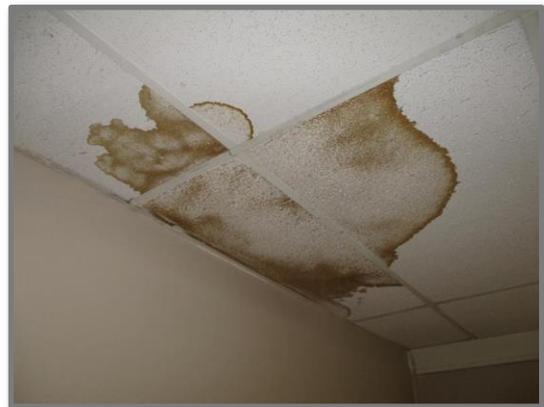
8. This spot on the front porch wasn't leaking during the inspection. I recommend replacing the damaged tiles here.

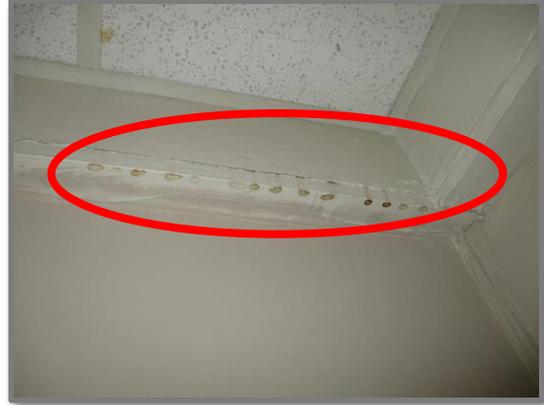
9. This is the south east corner of the front porch. It was dry at the time of inspection, so I think it's from an old leak.

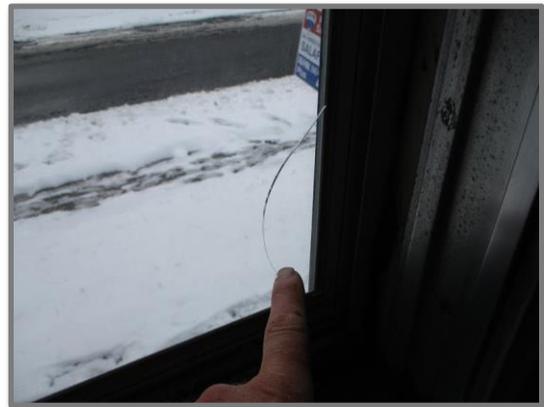
10. Cracked storm window pane located in the south of the porch. Replace it.

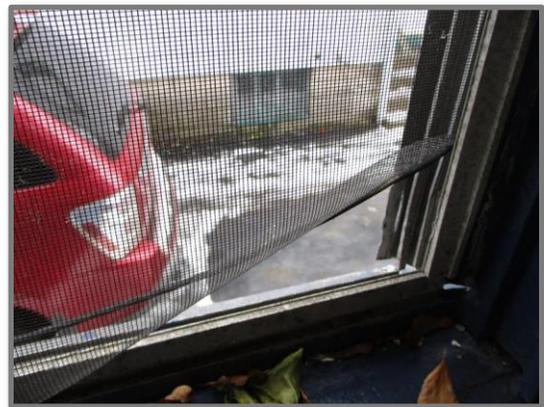
11. This ripped screen is in the bedroom east facing window. Replace it.

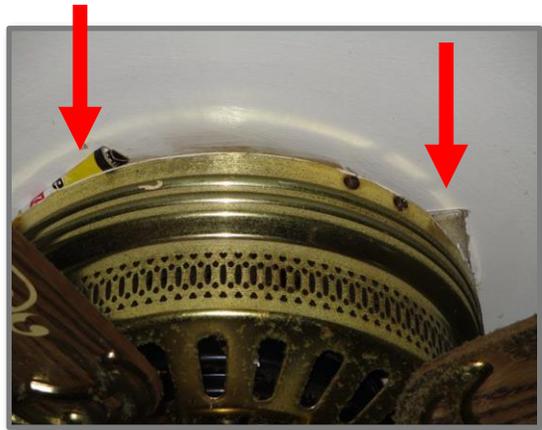
4. The ceiling fan has been shimmed with some folded up papers. It probably vibrated. There was no power so I couldn't test it. I recommend having it properly fixed to the ceiling so that the shims are not necessary.

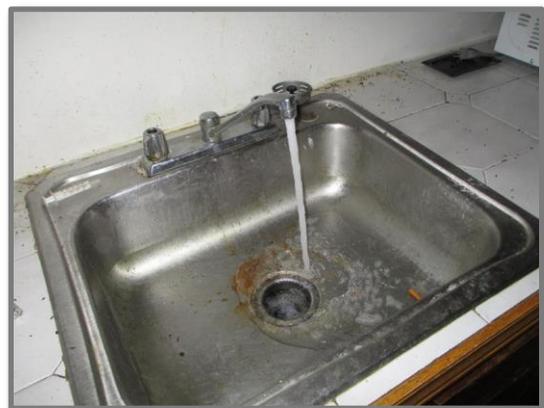
15. The kitchen counter is covered in mouse droppings and so is the floor and appliances. You'll need to either thoroughly clean and disinfect them or replace them. Since the cabinet are so old and worn, I'd replace them. You may be able to pick up some used cabinets at a reasonable price.

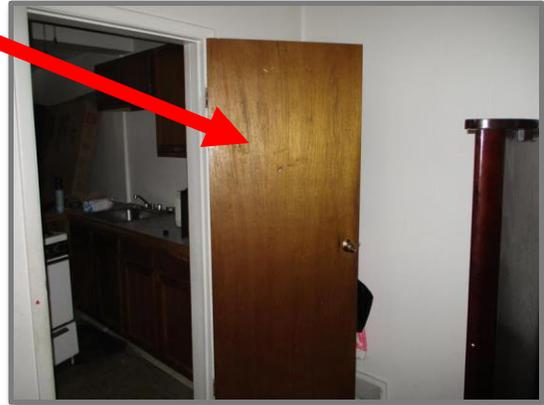
16. This door has a hole in it. Repair or replace it.

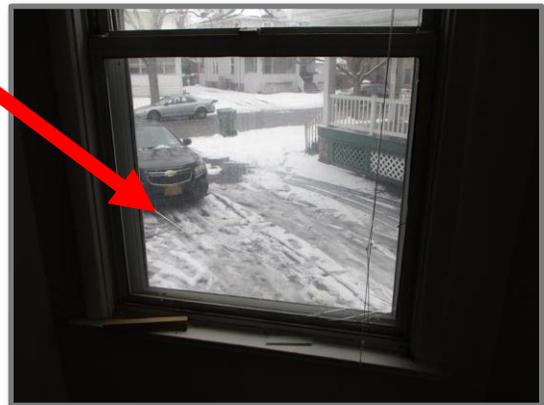
17. This west facing window is broken. Replace it.

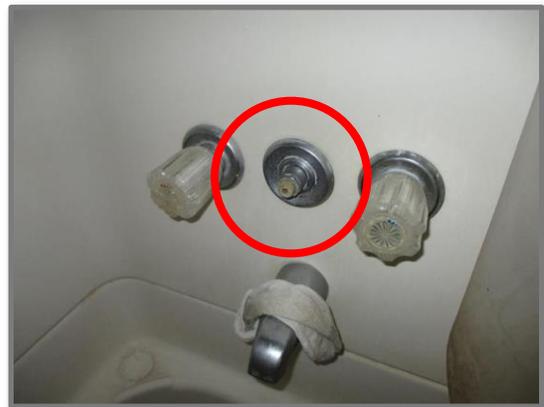
18. The shower diverter handle is broken off. Replace it so that the shower can be turned on.

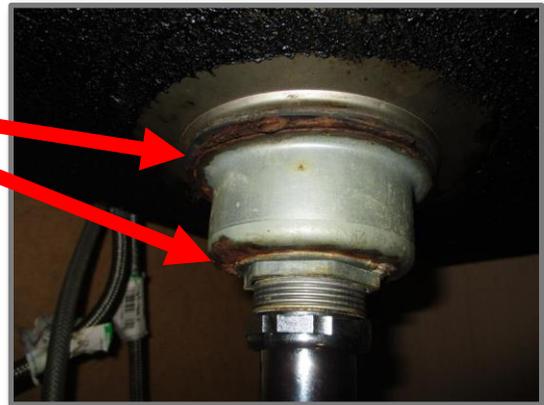
4. The kitchen sink drain is rusting. It's not leaking now, but this is the beginning of the end. Expect it to leak eventually and be ready to replace it.

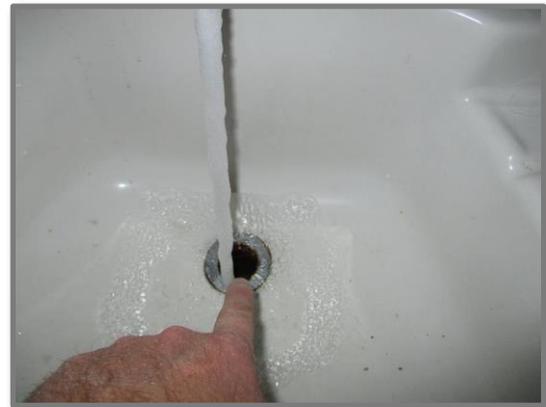
5. There is no drain stopper. You should have one installed.

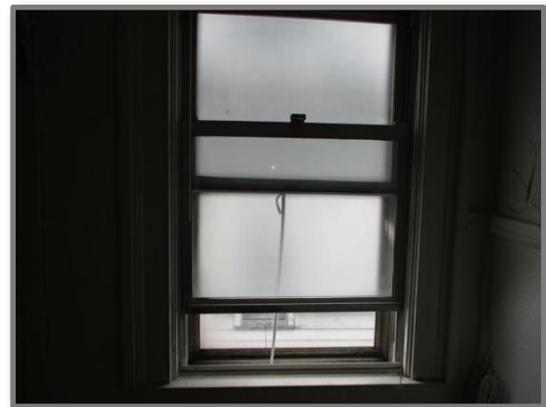
6. The curtain bar holds up the upper sash on this window. The bar could slip out causing the sash to slam down and break or cause injury to someone. I recommend repair or replacement.
