# ***Vesta Home Inspections, LCC*** **Home Inspection Report**

**1234 Fifth Street  
Anytown, NY**

## INTRODUCTION AND OVERVIEW

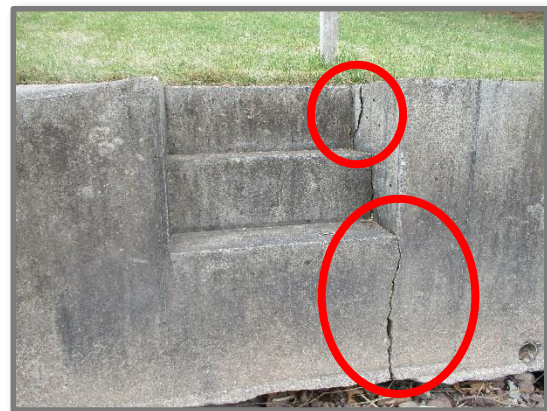
4. The retaining wall/break wall at the lake has a vertical crack running down the length and some other cracks in the steps. I observed no displacement/movement at the crack. I recommend having this assessed by a qualified break wall installer and repaired as necessary.

Breakwall cracks

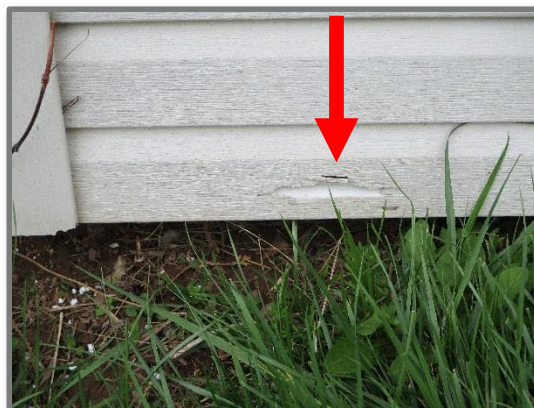
1. The vinyl siding is damaged at several locations, most likely by a string trimmer or lawn mower. Besides being unsightly this can allow unwanted moisture penetration into the exterior envelope and wall cavity. Repair requires removal and replacement of the affected panels by a professional siding installer. I recommend repair as appropriate by a qualified siding contractor.

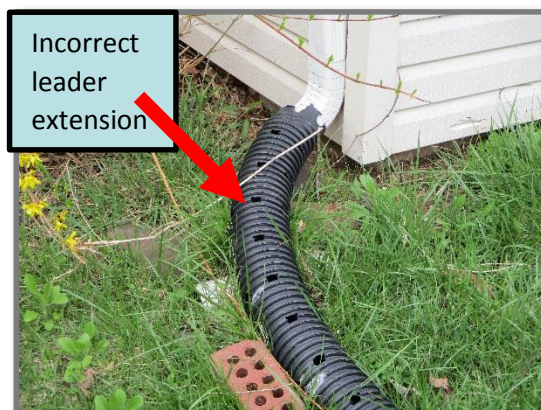
6. The gutters terminate directly next to the foundation in black drainage tile that does not properly remove all water from the foundation. The southeast corner gutter leader runs the entire length of the house and is at a negative slope. This is only going to make the negative grade condition on the east side worse. I recommend installing 6 foot long leader extensions on all downspouts.

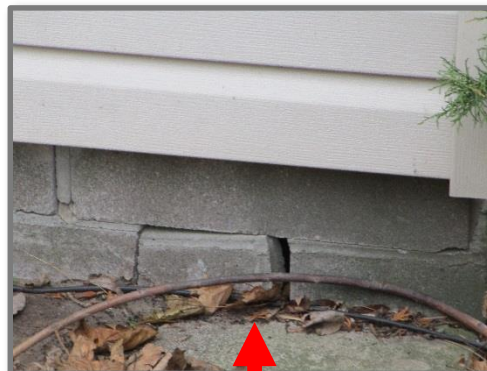
Foundation settlement

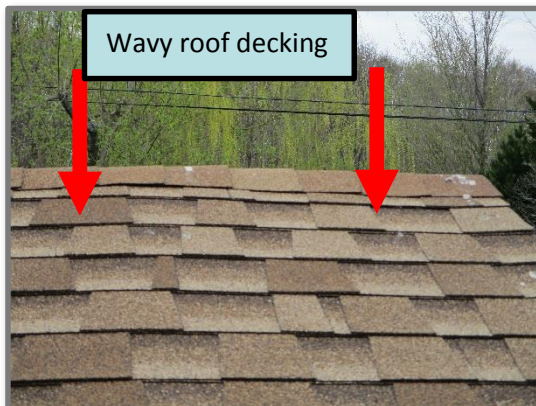
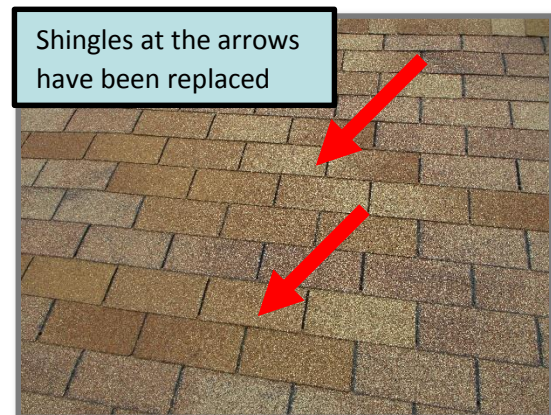
1. The three tab shingle roof cover is aging normally. Some typical indicators of aging (such as granule loss, color change and increased space between tabs) were visible. However, the wear is consistent over the entire surface and typical for a cover this age. There is some wavy areas of decking as well. Some shingles have been replaced already. I found no visible leaks. Roof covers

of this type usually last 15-25 years.

I expect that the 3 tab shingles are in the second half of their useful life. I recommend that you budget for their replacement. Keep in mind, when replacing these shingles it may be necessary to do a tear off to get them to match the architectural shingles on the other side of the home. I

recommend that you use a qualified roofing contractor for all roof work.

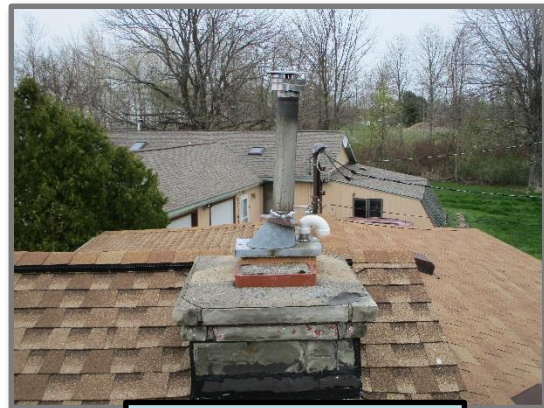
3. I'll talk about the chimney here. It's whipped. There was two masonry stacks, but one has been filled in. The other stack is lined with the metal vent for the wood pellet insert. The masonry portion of the chimney has been repaired many times and is full of cracks. The flashing around it is questionable. It did leak in the past, but I didn't observe any leaks on the day of inspection. It hasn't rained for a while either. The metal portion of the chimney is crooked. There is also a 180 degree PVC elbow that comes up through the chimney. As I said, it's whipped. I recommend a full evaluation of the chimney by a qualified mason.

Chimney damage visible

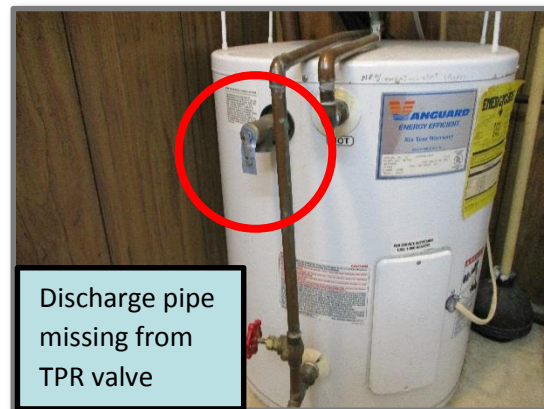
2. There is no discharge pipe installed at the temperature pressure relief valve on the water heater. There is supposed to be a discharge pipe installed and configured in a continuous drainage plane that either terminates outside or within 6- inches of the floor. The reason for the discharge pipe is simple - to prevent injury from scalding, should the TPR valve suddenly vent boiling water or water under extreme pressure. Recommendation: Install proper drainpipe consisting of like material as required.

NOTE: TPR drain lines are prohibited from having threading at the bottom where discharge occurs.

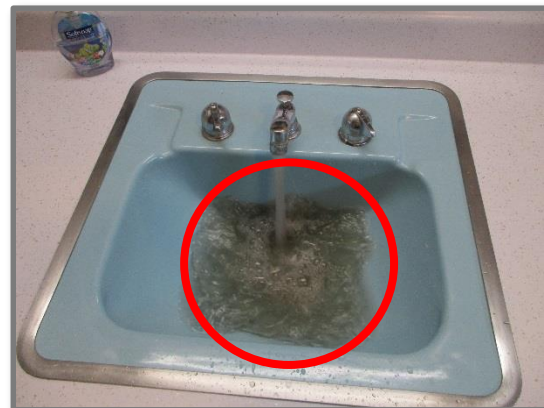
3. When checked, the water coming out of the faucet in the bathroom was black in color indicating impurities in the water. There was also a noticeable smell to the water. I recommend having the well tested prior to closing on the house. I also recommend contacting the Monroe County Water Authority and having the public water supply hooked up. This will provide you with better quality and quantity of water.

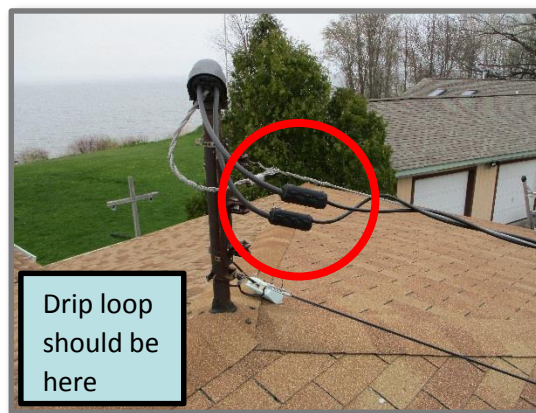
3. There isn't any “drip loop” formed where the service entrance conductors enter the weather head. A drip loop is required by the electrical code (230-54) to prevent water from entering the service conduit or saturating the cable insulation. Recommendation: Repair as appropriate by a licensed electrical contractor or the service provider.

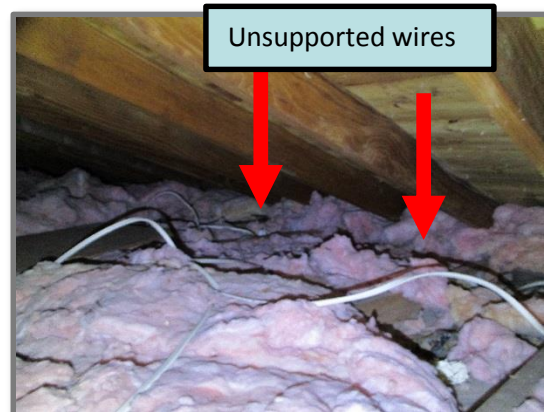
5. There is electrical cable that is inadequately supported in the attic. Metal Clad cable must be supported at intervals not exceeding 6 ft., while Non-metallic Sheathed Cable (NM or NMC) and Armor Cable (AC or BX) must be supported at intervals not exceeding 4½ft. In every case, these cables must be secured within 12 inches of boxes or panels where they terminate. Cables should closely follow building surfaces and need to be secured with proper fasteners. When NM cable is installed perpendicular to and on top of or beneath framing members, it must be secured to running boards. I recommend that an electrician make corrections as needed.

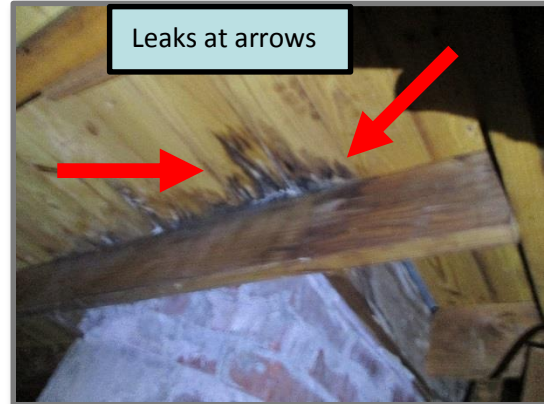
6. There are signs of past water leakages around the chimney in the attic. I don't think that it's leaking now, but it hasn't rained in several days, so I can't be sure. I recommend monitoring the area during a rain storm to see if any water is coming in. A roofing contractor will be able to handle repairs if necessary.

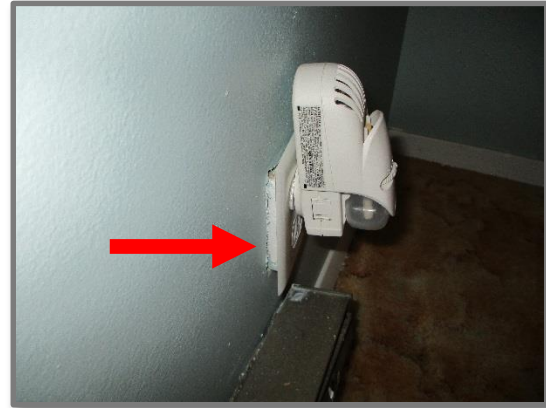
10. The electrical outlet on the west wall of the master bedroom is pulled away from the wall. The phone jack has been pulled away too. If you don't plan on having a landline phone, you can remove the phone jack. I recommend having the electrical outlet fitted correctly into the drywall. A drywall installer or electrician could both handle the job if you are not up to it.

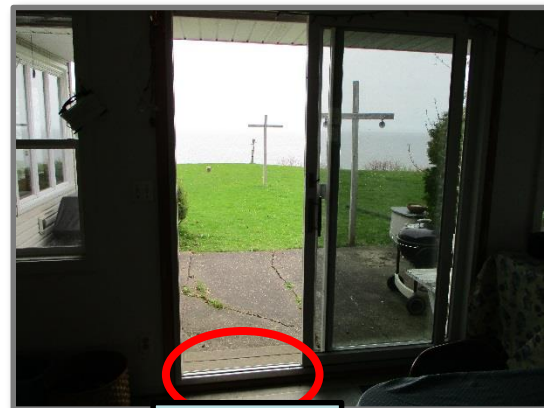
Trip hazard
