Vesta Home Inspections, LLC

Home Inspection Report

123 Fourth Drive

July 9, 2018

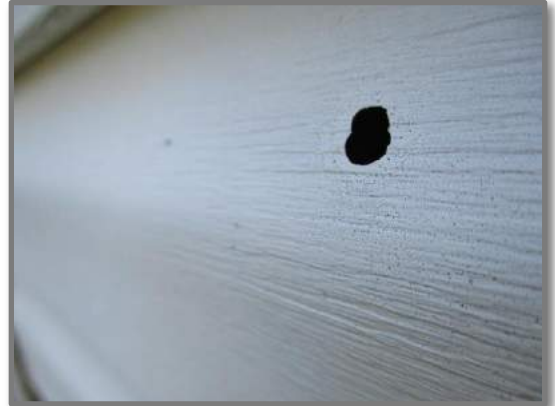
1. There are random small holes in the vinyl siding in front of the unit. I recommend sealing them against pest and water entry either by replacing the panels or using caulk to seal them closed. Keep in mind that it will be difficult to match the existing siding, so replaced panels will be noticeable.

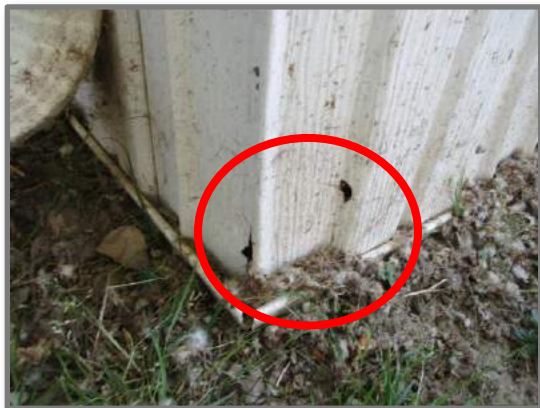
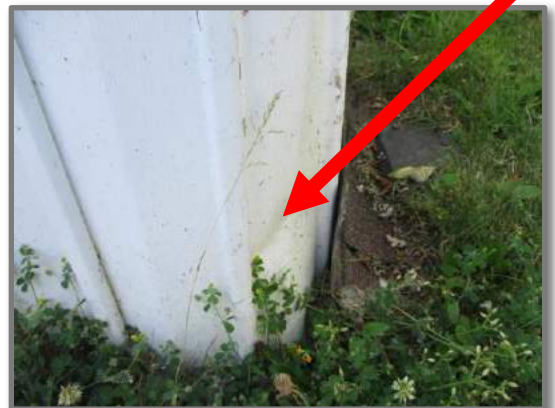
2. There are dents and holes from mowing/trimming in the vinyl skirting. Some of the skirting has pulled away. I recommend spraying within six inches of the unit to kill grass and eliminate the need to trim so close. Re-attach loose panels and seal holes or replace any badly damaged panels (most holes are small).

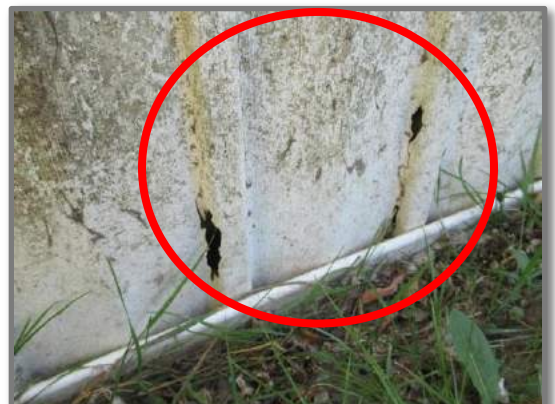
It's easy to push the skirting back into place – you should do this at any area where it has pulled away

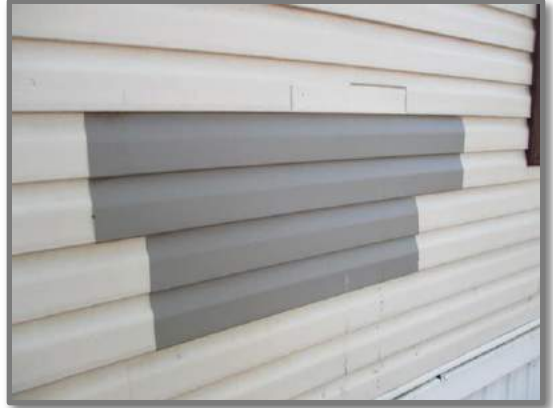
3. You could clean and spray paint this siding on the north side to try and match the surrounding area if you want the repair to be less evident.

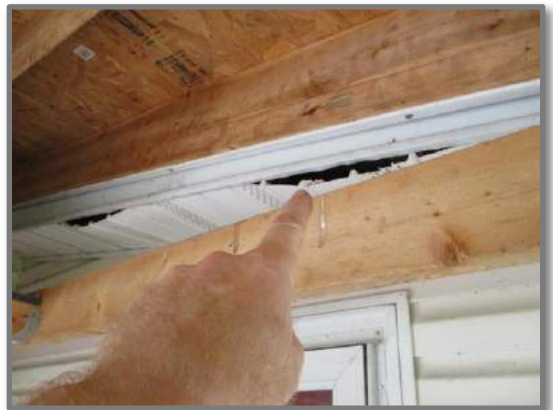
5. Re-attach the soffit material where the deck roof meets the house to reduce the chances of insect (yellow jacket) infestation.

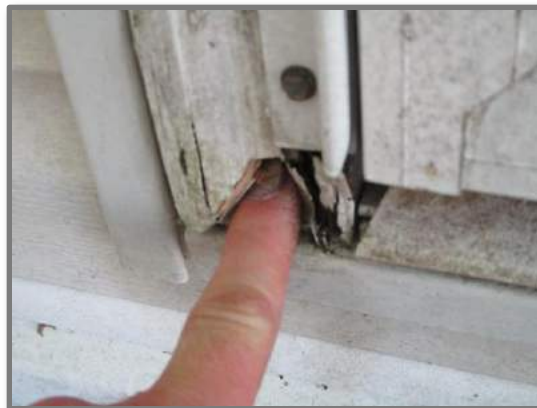
6. The wood frame around the north side entry door has rotted. This is most likely due to exposure to water from the broken gutter above it. I recommend removing the rotted wood and replacing it before it spreads deeper into the structure.

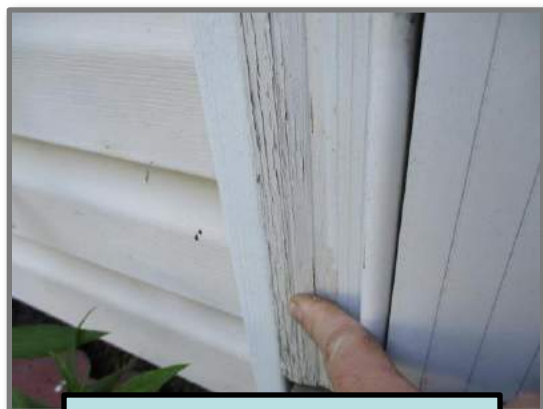
7. The front storm door shock absorber is missing, the seal holding the window glass in place is falling out, the glass is fogged (near the bottom), the wood below the door needs paint, the door frame paint is chipped and door closes on the bush planted next to it. Repair the door, paint the threshold, scrape and re-paint the trim and cut back or remove the bush.

I'm pointing to the chipped paint

Fogged glass

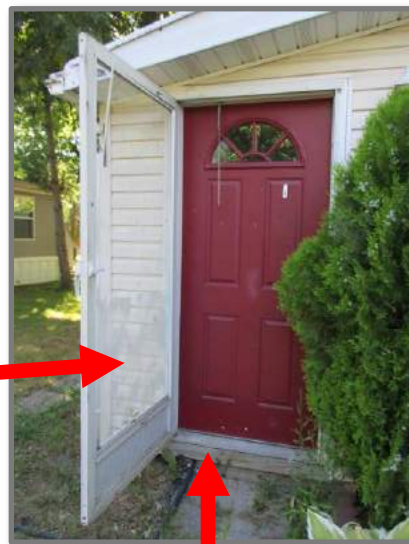
This wood needs paint to protect it from damage

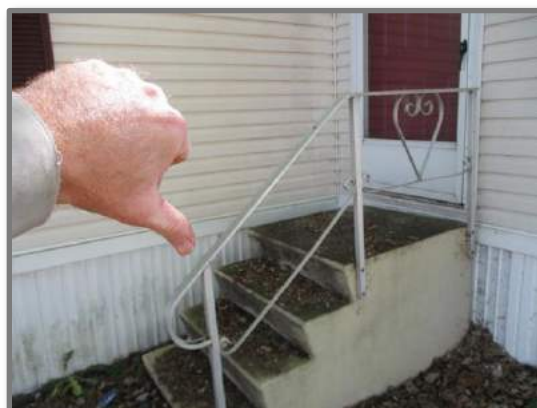
8. This handrail is too weak and doesn't meet modern safety standards. A small child could fall through the large openings or it could fail if an adult grasps it when falling. Have it replaced with a handrail that meets all modern safety standards.

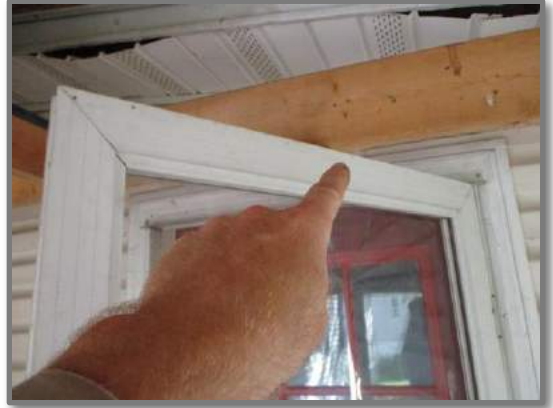
9. The storm door to the deck contacts the deck roof rafter when opening it. The glass is ready to fall out and the shock absorber is missing too. Removing the door would be a simple fix.

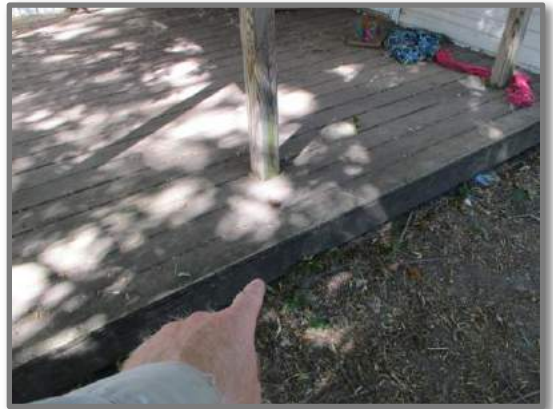
10. The wood deck is in direct contact with soil. This will cause the deck lumber to rot (over time) and need replacement. There's really no way to correct it at this point, so just be prepared to tear off and replace the decking when it fails.

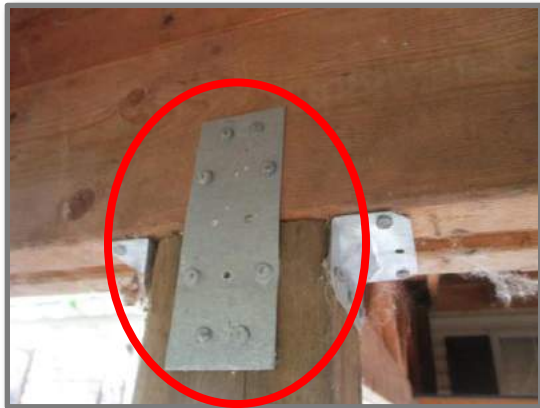
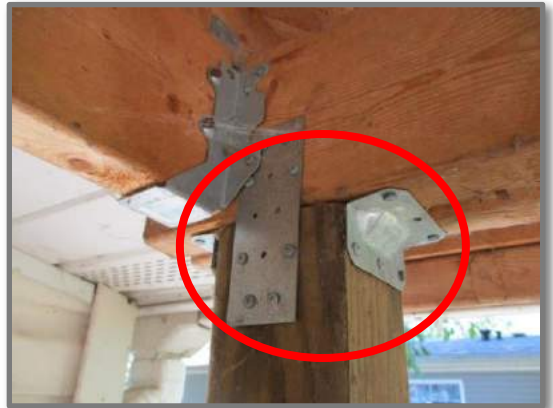
11. Whoever built the deck used the wrong fasteners to connect the columns to the overhang. These fasteners do not resist lateral loads, which means they could bend, causing the roof to collapse. Replace these nailing strips with Simpson Strong Ties or equivalent.

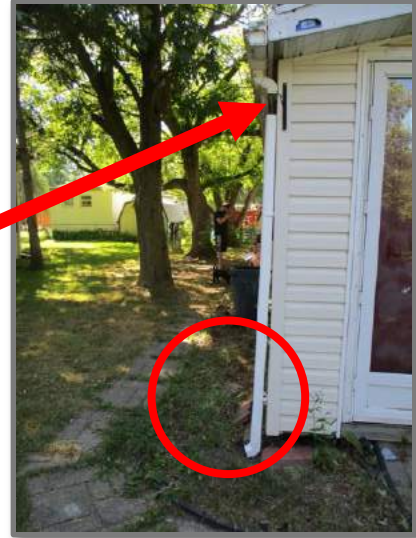
12. The downspout extensions terminate directly next to the foundation. Install a leader extension or bury a PVC extension to direct water at least 6-feet away from the foundation at each location. I recommend correcting this immediately to reduce water intrusion into the crawlspace.

Re-attach this downspout

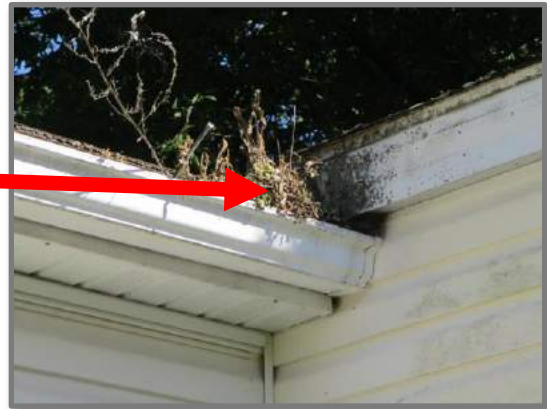
13. The gutters are plugged with organic debris and dirt. They can't drain correctly, and the additional weight could cause them to detach from the fascia. I recommend cleaning all gutters as necessary on a periodic basis.

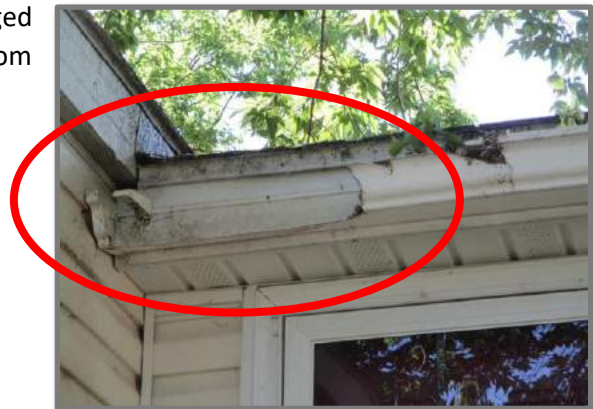
14. The gutter above the north door is badly damaged and needs to be replaced to channel water away from the unit.

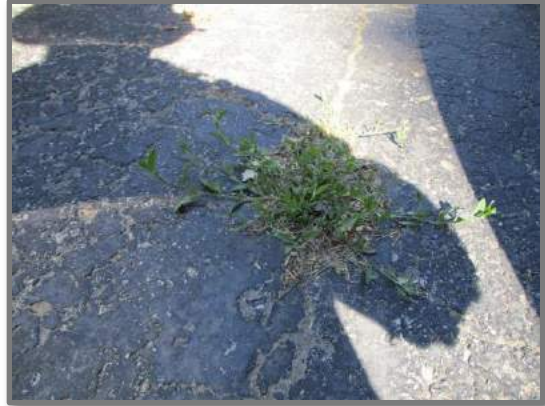
15. The driveway is worn, but it should last quite a bit longer if you kill the weeds and seal it. I recommend doing this as soon as possible. It's a good homeowner project.

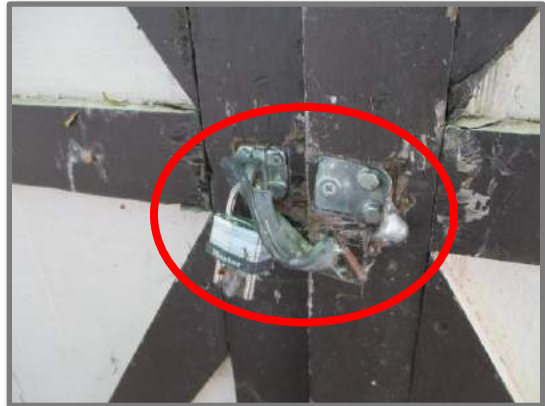
16. The shed latch is badly damaged. Replace it so that you can lock the shed.

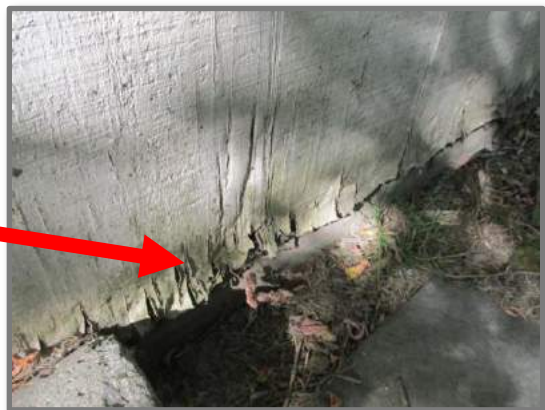
17. The shed is too close to the ground and has begun to absorb water into the walls. Eventually, this will ruin the shed (over time). I recommend elevating the shed to protect it from water by jacking it up and adding stone or concrete below it.

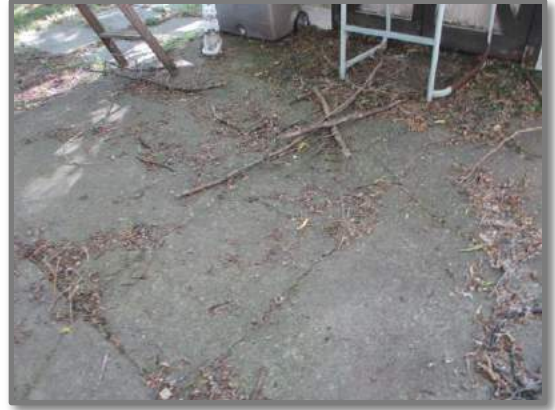
18. The concrete between the deck and patio is old and cracked. You can have it replaced or choose to live with it.

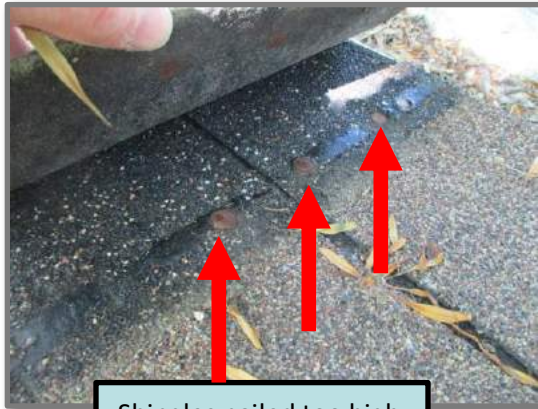
1. The asphalt shingles are poorly installed (nailed incorrectly), several tabs are missing and repairs are evident (this means that shingles are blowing off during wind storms). All flashings at penetrations (chimney, vents, etc.) are badly worn and in need of repair. I didn't have access to the underside of the roof, but I'd bet that it's leaking. Plan on having this repaired right away to preserve the unit. You'll need to work with park management to have the trees significantly trimmed back to reduce the chances of damage to the new roof. Find out who is responsible for the cost of tree trimming.

Shingles nailed too high

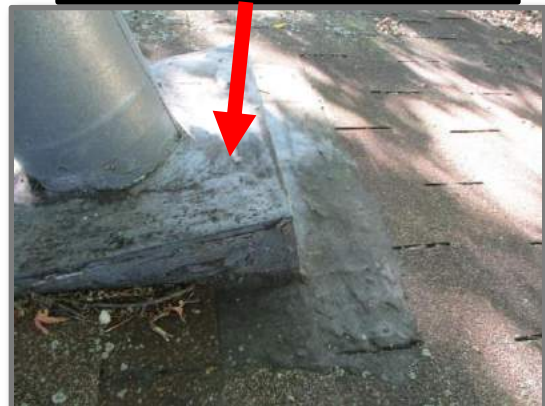
Replacement shingles

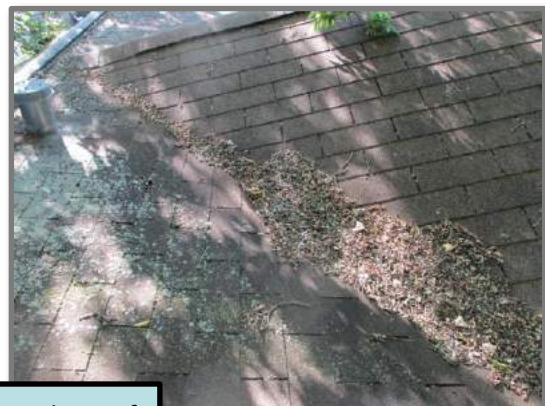
Trees and tree debris on the roof

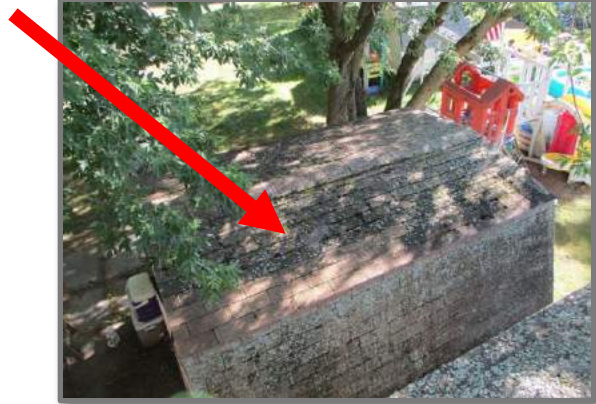
2. The shed roof is just as bad. Have it replaced too.

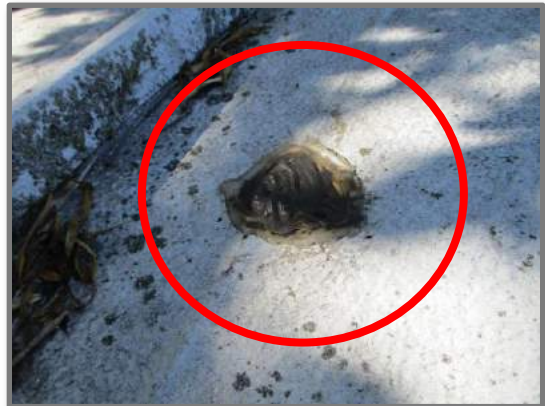
3. The standing seam metal roof is covered in tree debris and has been repaired in several locations (circled). Have the trees cut back and the roof replaced. Plan this into your initial budget because it doesn't have much time left.

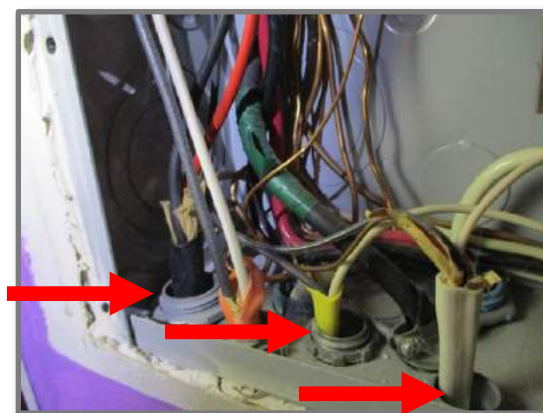
3. There are no protective bushings in several locations in the service panel. I recommend installing bushings to protect the wires from damage.

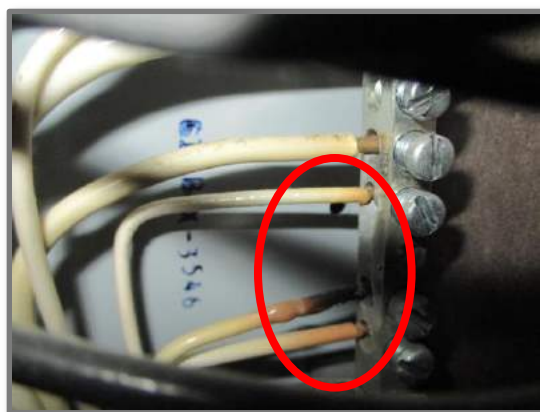
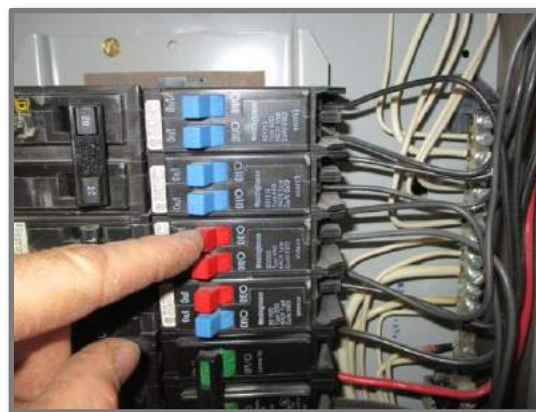
7. There are three neutral wires (circled) that have been overheated and are in danger of starting a fire or burning up/melting. This is a safety hazard. I recommend having them replaced by a qualified electrician who should also diagnose the reason for the problem and repair it.

The darkest white wire at the left belongs to the circuit breaker that I am pointing to – have an electrician correct this before an electrical fire starts

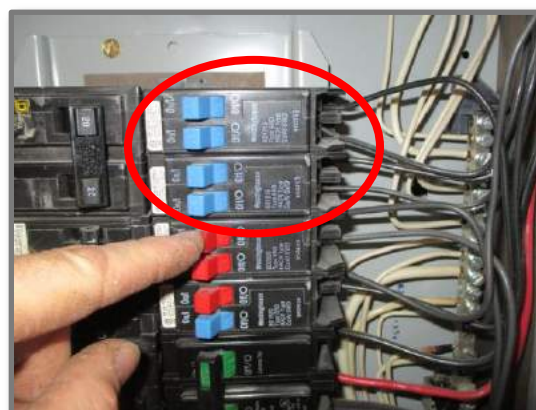
8. There are compact (mini) breakers installed in the top two breaker stabs on the right side of the panel. This type of panel does not allow mini breakers in the top two positions. This is a safety hazard; have it corrected right away.

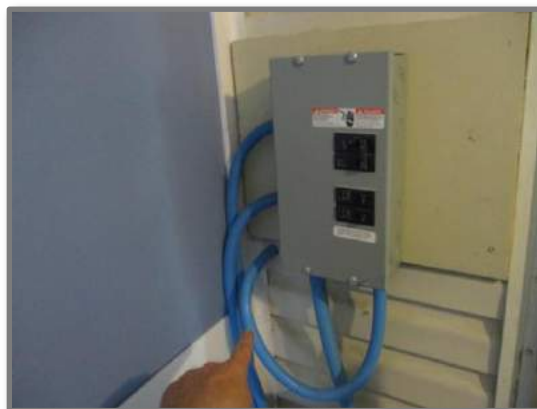
9. This ENT tubing (typically called "Smurf tube" must be protected from damage where installed below 7 feet, similar to NM cable. That means it must be installed behind drywall or another wall covering. It's not suitable for this location. I recommend replacing the ENT (Smurf tube) in the shed and house with thin wall metal conduit to protect the wires from damage and protect people from electric shock.

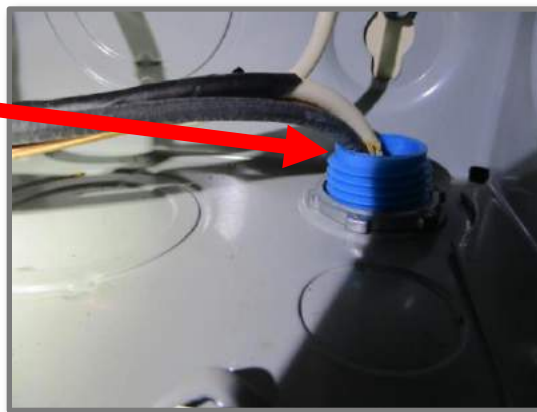
10. There are missing bushings in the Murray sub panel that must be in place to protect these wires from damage. I recommend having them installed.

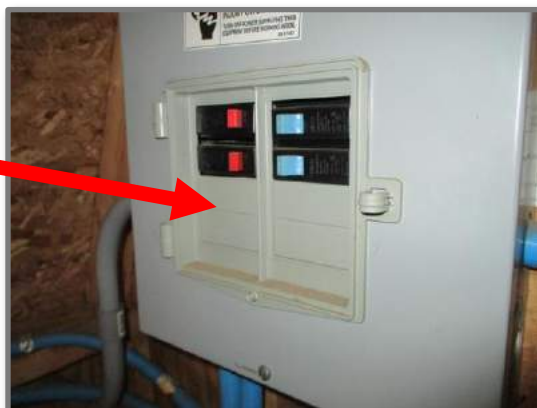
11. The sub panel door in the shed is missing. Install a door here to protect the breakers and to contain a possible electrical fire.

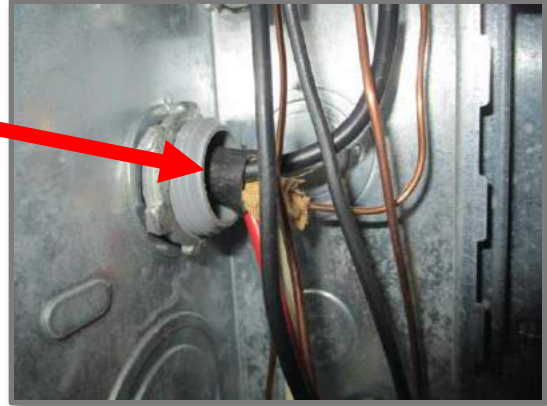
12. Install bushings to protect these wires in the shed sub panel from damage.

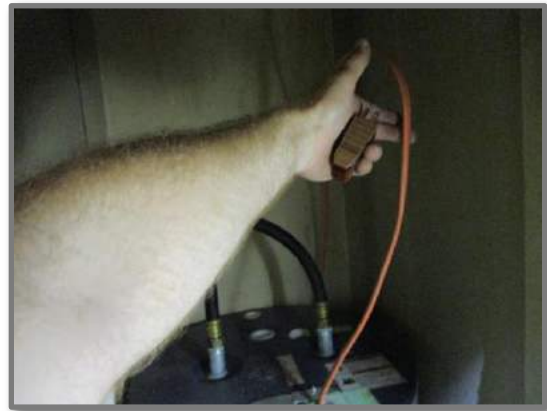
13. The electric supply wire serving the water heater needs to be protected from damage by closely following building surfaces. Have it installed on a drop down running board.

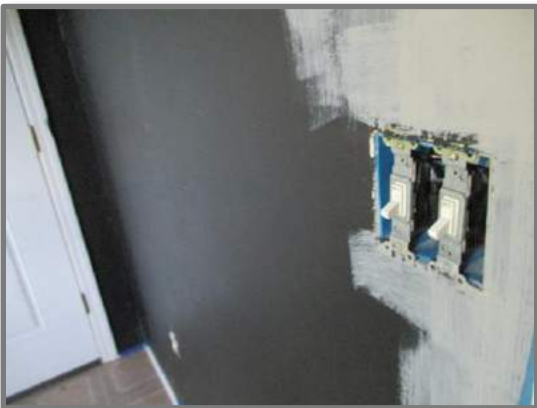
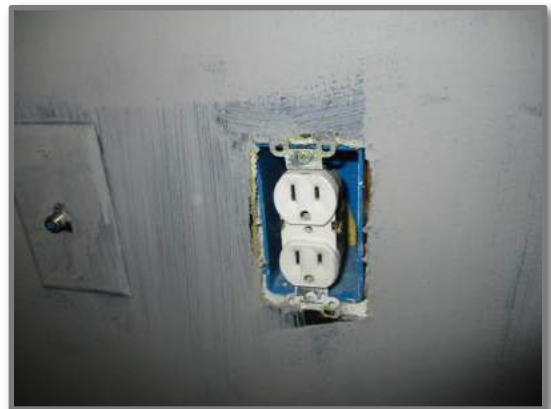
14. There are missing switch and outlet covers throughout the home that need to be installed to protect against exposed wiring.

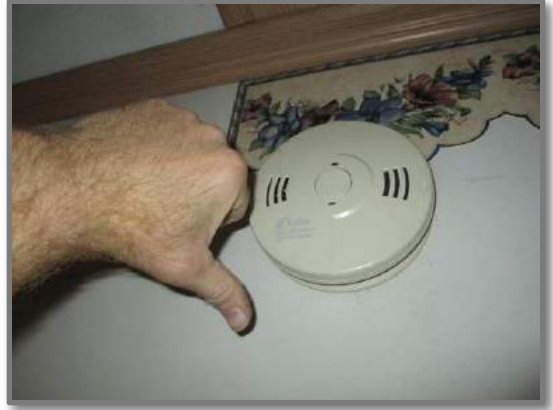
15. None of the smoke alarms worked and there was no carbon monoxide detector. This is a safety hazard and could result in death. Have smoke and carbon monoxide detectors installed as prescribed by the local Fire Marshal.

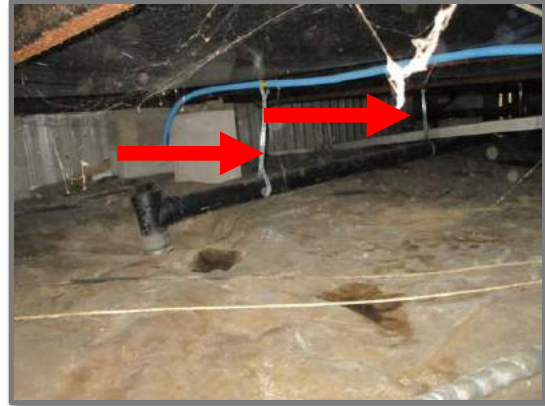
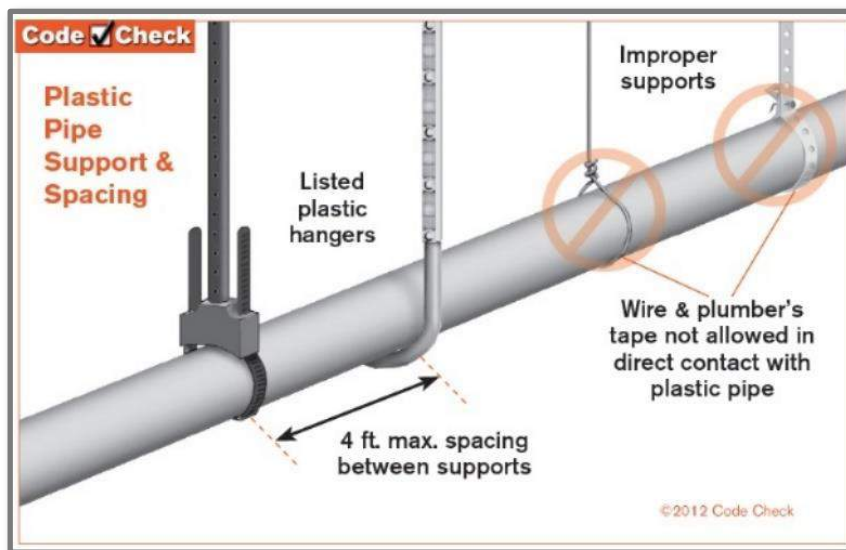
2. The waste drainage pipes visible in the crawlspace are incorrectly supported by metal straps. These type of metal straps do not resist upward and lateral thrust and can cut the pipe, draining water and waste into the crawlspace and requiring costly clean up and repair. I recommend having these replaced with proper pipe hangers.

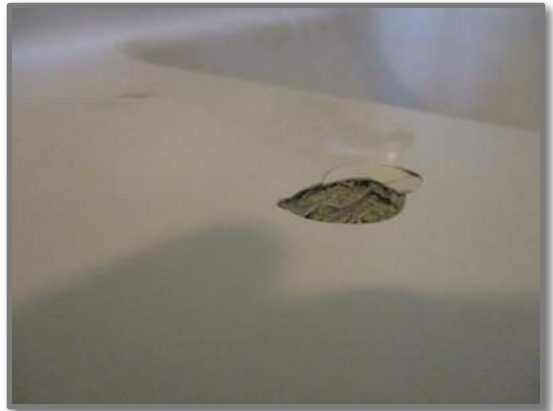
5. The master bathroom tub is chipped in two places. You should have this repaired before the damage gets worse. There may be a resin or sealer that can be used here.

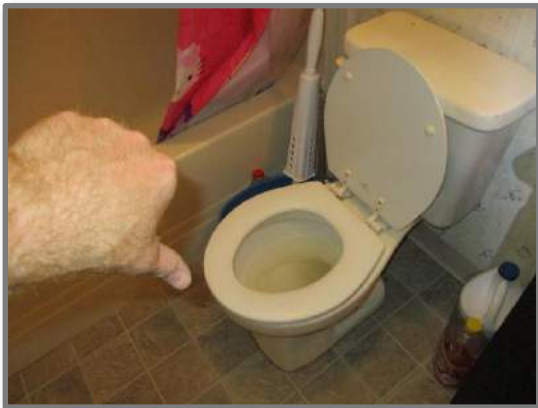
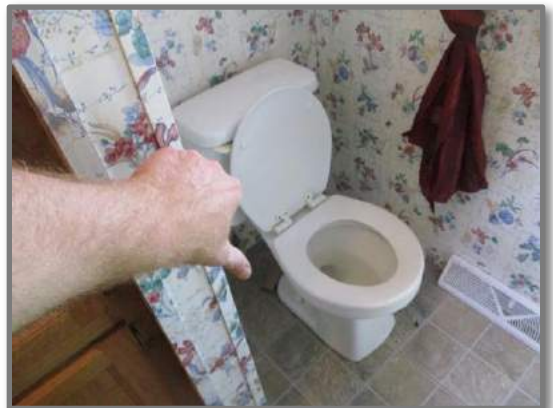
6. The toilets are loose on the floor. Loose toilet pedestals can ruin the wax seal between the pedestal and the soil pipe, resulting in leaks that can ruin floor coverings and rot sub flooring beneath the toilet. I recommend removal of the toilets, inspection and repair if appropriate of the soil pipe collars, replacement of wax seals and re-installing the fixtures.

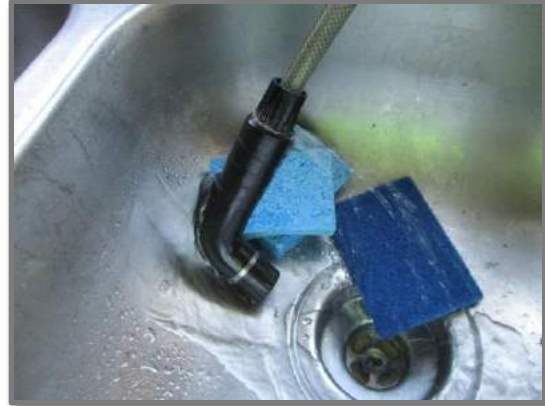
11. The kitchen sink sprayer is broken and stuck in the on position. No water comes from the faucet. I recommend replacing the sprayer. Once the sprayer can be shut off, water should be able to flow from the faucet.

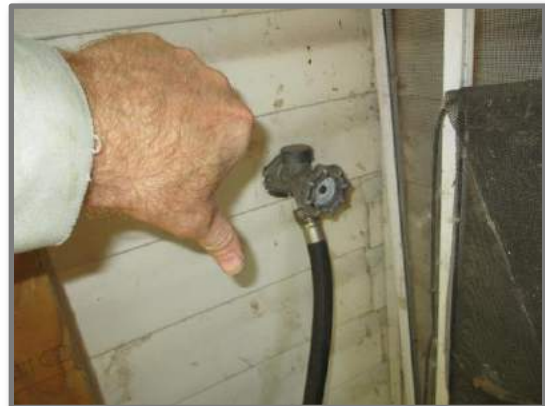
12. The hose bib on the south side didn't work. This could be due to a supply valve being shut off or could be a sign or a bigger problem. As a home inspector, I'm not allowed to operate shut off valves, so I can't check it. I recommend asking the seller about the status of this hose bib and having it fixed if necessary.

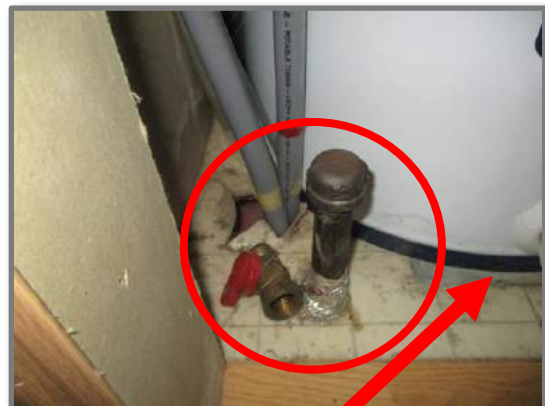
13. This is a capped natural gas line. Never touch it and never remove the cap or natural gas will leak into the house, which is a fire and explosion hazard. It would have been better if the installer left the valve on below the cap so that it could easily be uncapped for future use, but at this point it's fine as long as you leave it alone.

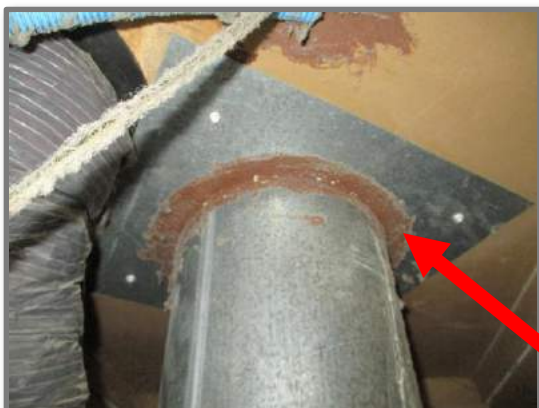
6. The B vent (furnace exhaust) is rusty inside and has had tar applied to it outside. Clearly, it has leaked in the past and it will leak in the future. Applying tar to a metal roof vent is a short-term repair and actually causes the vent to rust quicker. I recommend replacing this B vent.

The B vent is rusted inside (left) and tar covered outside on the roof (right)

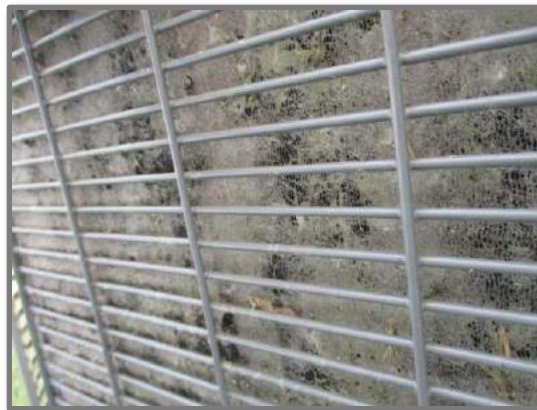
5. The cooling fins on the compressor are dirty/plugged with organic debris. This can cause the compressor to run inefficiently or overheat. I recommend cleaning by a qualified HVAC tech.

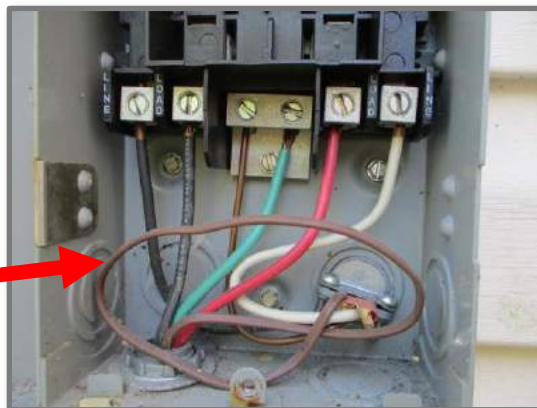
6. There are low voltage wires in the disconnect box that run through the same conduit as high voltage wires. Low voltage wires are not permitted to share a raceway with high voltage wires due to potential interference on the wires. I recommend removing the low voltage wires.

The brown thermostat wire must be run separate from the other conductors

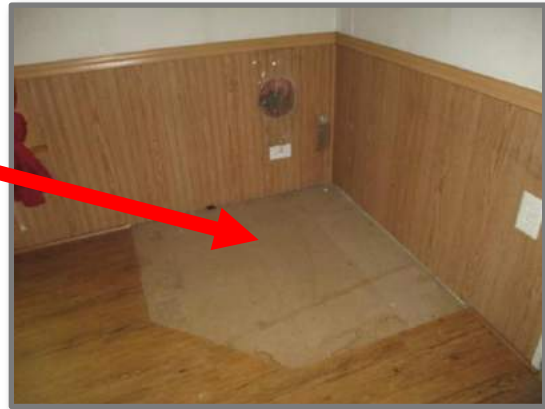
2. Repair the wall and floor in the area where the wood stove used to be.

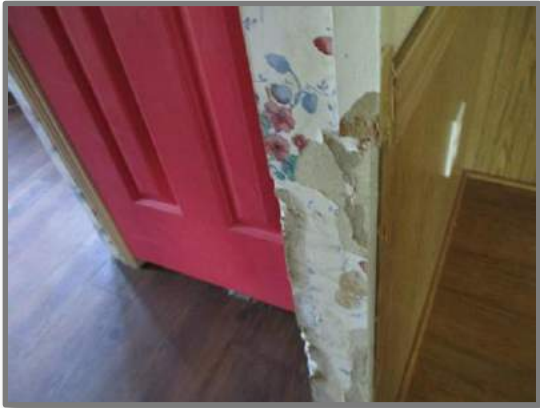
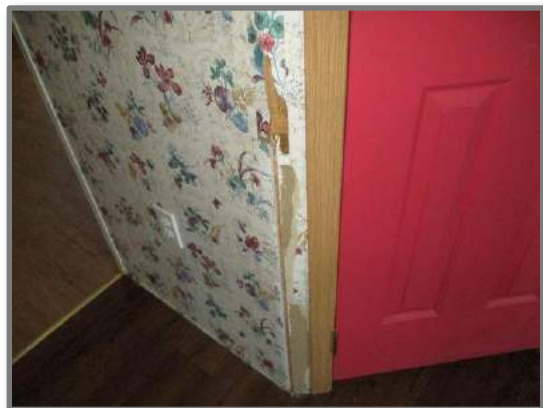
5. The walls are badly damaged in a couple areas (possibly by a dog). You'll need to repair them. It's probably going to be impossible to find matching wallpaper. You could try painting it or try removing it.

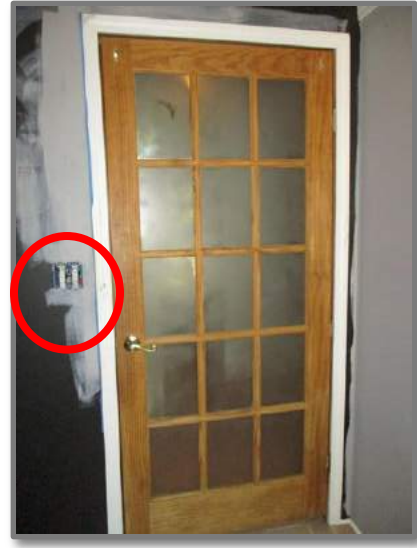
6. There is work in progress in the north entry room. The walls have been repaired and need paint and the switches and outlets need covers to protect the wires. Have this work done.

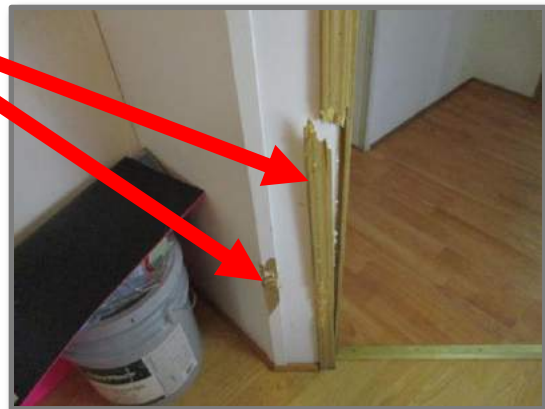
7. Fix this broken trim in the south bedroom.

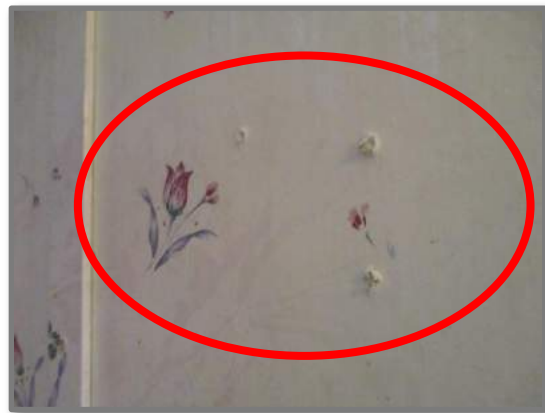
8. There are minor blemishes to the walls and ceilings throughout the home that should be repaired and painted to match the surrounding area.

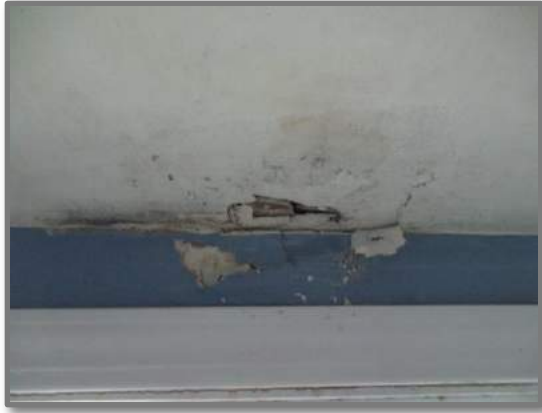
9. Here's the water damaged spot you mentioned to me before you left. I checked it out and traced it to a temporary repair on the metal roof. I can't tell you for certain if the repair worked, but I can tell you that it's not going to work forever. Once caulk is applied to a metal roof, it's only a matter of time until it leaks again. I recommend replacing the roof before you spend the money on fixing the ceiling.

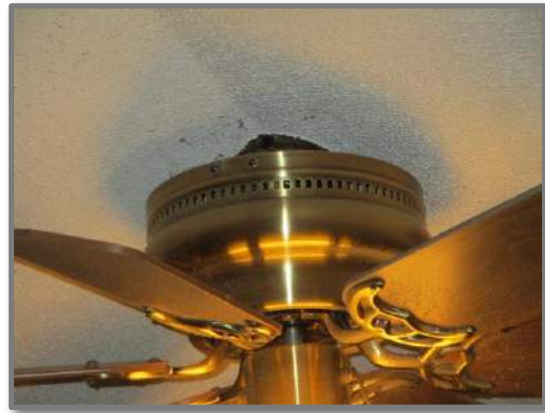
This is the repaired area on the roof – it will leak again at some point so don't spend too much time or money fixing the interior until the roof has been replaced

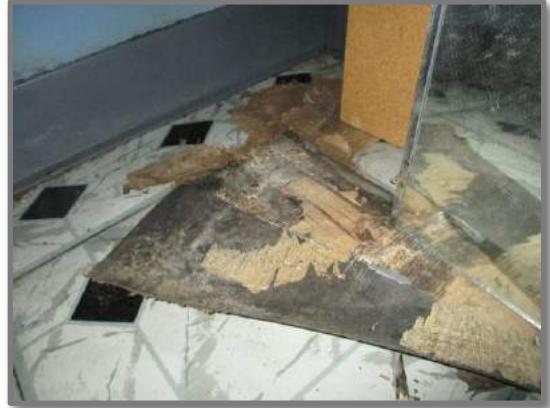
11. The vinyl floor in the entry way is badly damaged in some places. It's worn out. You should replace it. This is a good homeowner project that you could take on. Go find some tiles at a home improvement store, tear out the existing tiles and follow the preparation and installation directions on the new ones. Buy extra tiles anytime you do a flooring project so that you'll have some replacements. Flooring companies change styles from time to time so it's nice to have some extra tiles if they are discontinued.

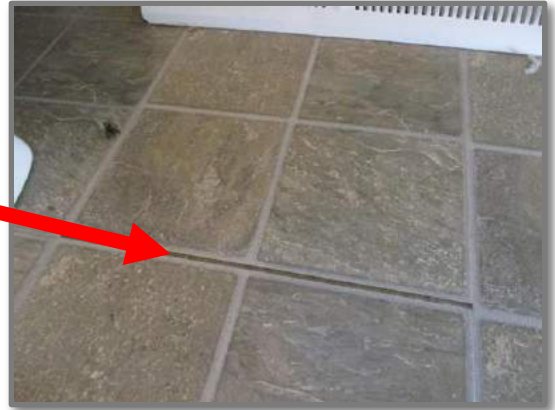
14. This vinyl tile in the master bathroom is loose on the floor. Re-glue it to the floor or replace it if you can get a matching tile.

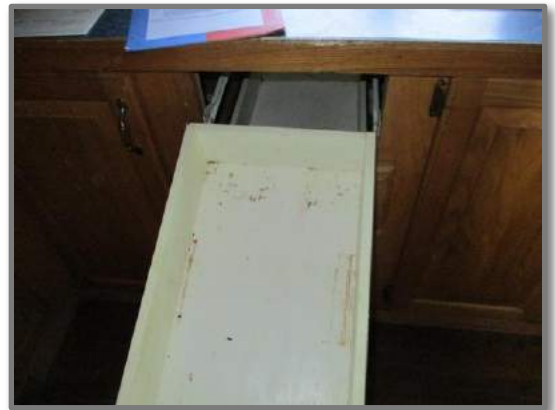
15. The kitchen drawers have no safety stops. They will pull all the way out and fall to the floor. This is a dangerous condition. It could allow the drawer and its contents to fall to the floor, causing damage or personal injury. I recommend installing stops on these drawers to prevent this.

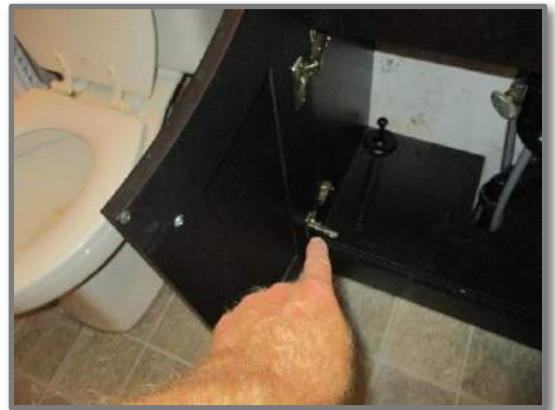
16. The hall bathroom cabinet door hinge needs to be re-attached to the cabinet (see where I'm pointing in the photo).

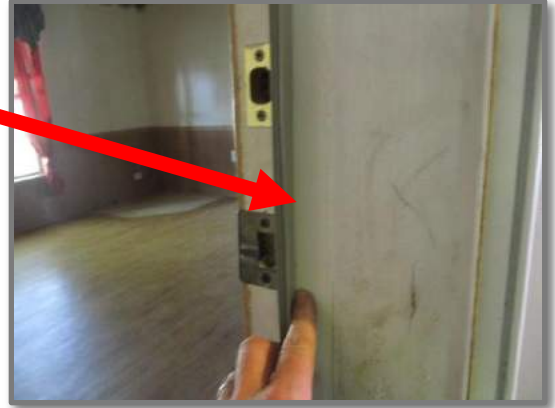
17. The entry door frame into the living room is missing. The door will swing completely through it and can't be properly secured. Have the door frame repaired.

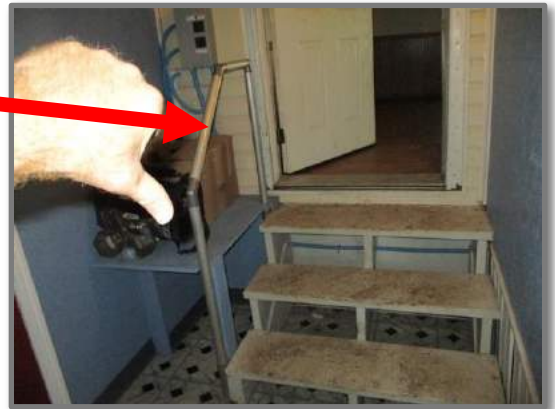
18. The wide-open space under this railing can allow a child (or an adult) to fall through it and get hurt. I recommend installing a railing with balusters here.
