# ***Vesta Home Inspections, LLC*** **Home Inspection Report**

**1234 Fifth Street**

**Report Prepared By:**

Tom Breslawski  
NYS Licensed Home Inspector #1600047670  
(585) 615-8696  
[www.vestainspector.com](http://www.vestainspector.com)

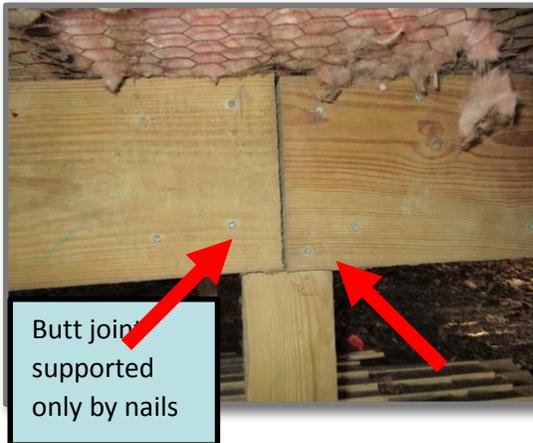
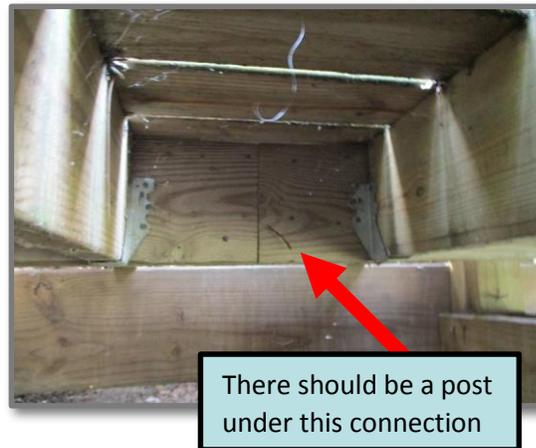
There should be vertical support here

I recommend that you contact at least one qualified carpenter/contractor to discuss repair or replacement options for these deck issues before closing on the home.
