# Vesta Home Inspections, LLC

## Home Inspection Report

**123 4th Avenue**

Any Month, 2016

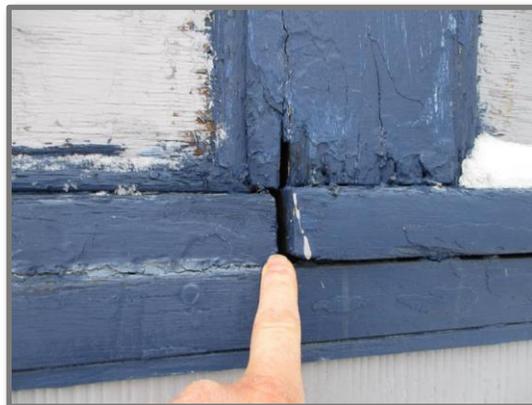
2. There are gaps between trim, windows and siding that should be caulked and painted to help keep moisture and insects from doing damage to the home.

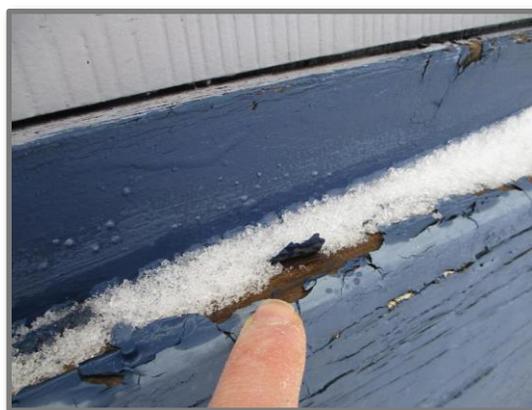
5. The trim paint is flaking off just about every trim and window sill board like this one in front of the house that I'm pointing to. Keeping these painted is essential to preserving the wood; it will rot if it's not protected. This is a big house, there's a lot of trim and most of it needs to be scraped and repainted. You should have it done before it begins to rot.

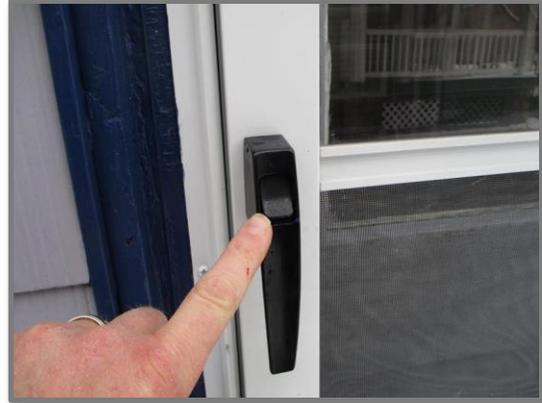
12. The west storm door doesn't latch closed. The button stays pushed in. I recommend having this repaired so that the door is secure and doesn't blow open on a windy day and get damaged or ripped off its hinges.

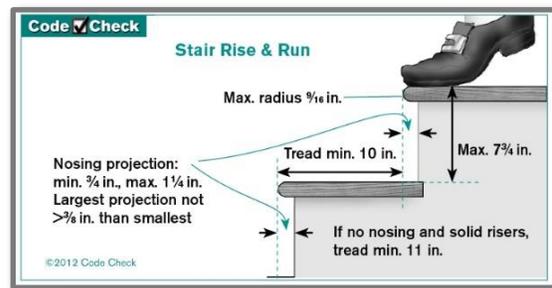
13. The difference in riser (step) height at the porch steps is greater than 3/8 inch from the tallest riser to the shortest. This is a safety concern. Steps with height difference more than 3/8 inch are much more likely to cause someone to trip, fall and be injured. 3/8 inch may not seem like much, but it's enough to cause a real problem.

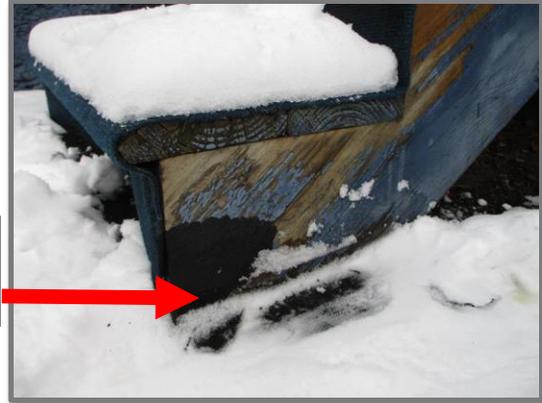
16. The apartment one porch steps are wood and in direct contact with the asphalt driveway. Over time, these wood steps will absorb water and begin to rot. Eventually they'll need to be replaced.

Wood in contact with asphalt

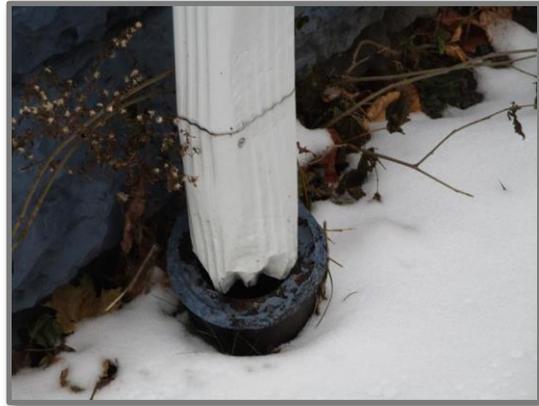
22. The downspouts are draining into old concrete or tile drain connectors, known as 'crocks', visible at the surface around the perimeter of the home. These are supposed to convey roof runoff to a buried perimeter drain that presumably is made of the same type of material. You should be aware that this type of drain system has been rarely used since the 60's and most are prone to frequent clogging and failure caused by settling of the soil close to the foundation or roots that grow into the pipe, allowing it to clog with silt. There is no way to determine whether these are completely intact below grade, but it has been my experience that most are damaged at one or more locations and are a frequent cause of infiltration into basements and crawlspaces. I strongly recommend that you have this obsolete system replaced.

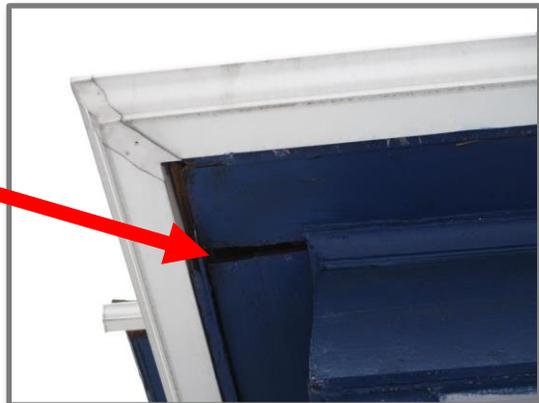
23. Here's a gap in the eave at the front of the house. This is a great place for squirrels, bees or birds to take up residence. Have it covered.

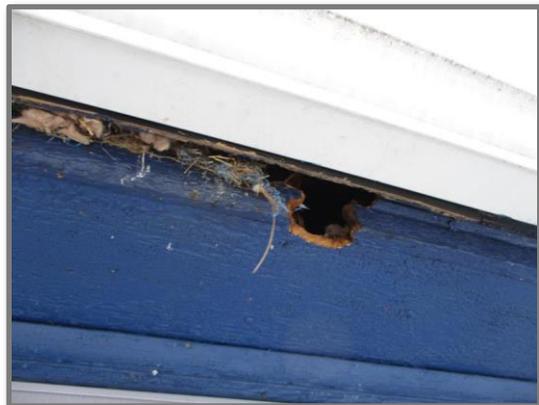
24. This hole in the upper eave, above the front porch roof, is a classic example of squirrel damage. You'll need to have the squirrels removed from the house and the holes sealed up. Squirrels love walnuts and there is an abundant supply in this neighborhood, so plan on a constant battle to keep them out of the house.

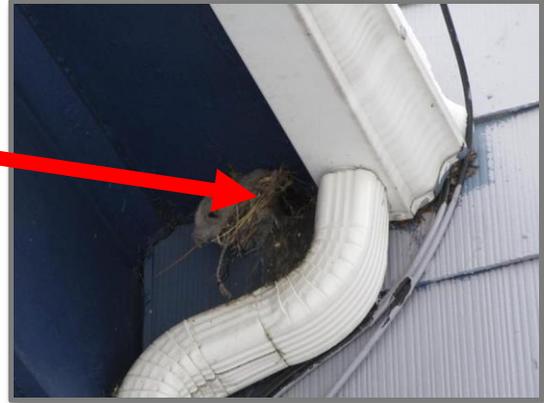
25. Here's another entry hole for critters that needs to be repaired. This one is located at the east side of the front porch roof.

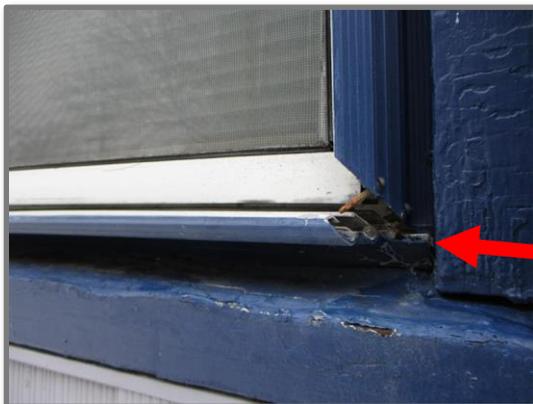
30. The storm window frame on the center window (pictured) is damaged and should be repaired or replaced.

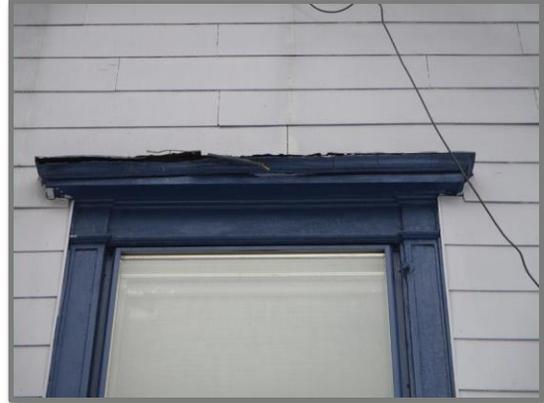
31. The roofing above this window on the west side of the house is damaged. It's probably allowing water to enter the wall cavity and cause damage. I recommend having the roof over this window replaced. There are several other windows around the home that need the same attention.

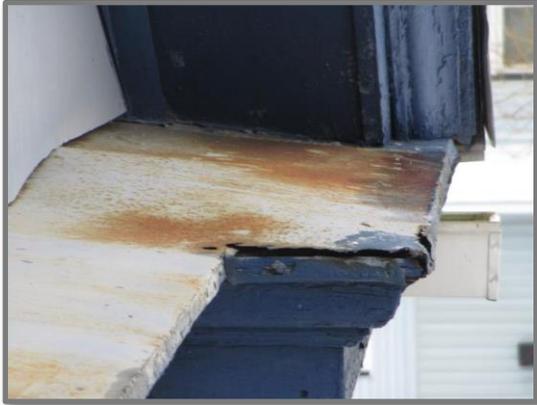
34. The flashing over the windows and ledges on the house is rusted and failing. This will allow water to enter the wall cavity of the house and can cause the sheathing and framing to rot. I recommend having this flashing replaced as soon as possible.

These pictures are from the west side of the house, but I expect all the window flashing to be in similar condition

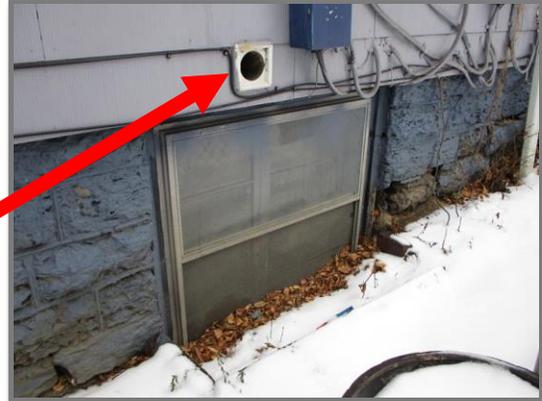
Add a new cover  
for the dryer duct

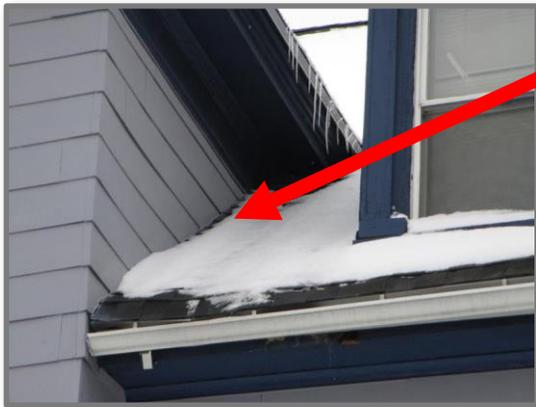
2. At the roof to wall intersections, there is siding in contact with the roof covering. This is a common problem on homes that have either been re-roofed or re-sided. It allows moisture to wick up into the siding and cause damage. There should be at least a 1 1/2 inch gap between the siding and roof covering. I recommend having this adjustment made to prevent damage to the siding.

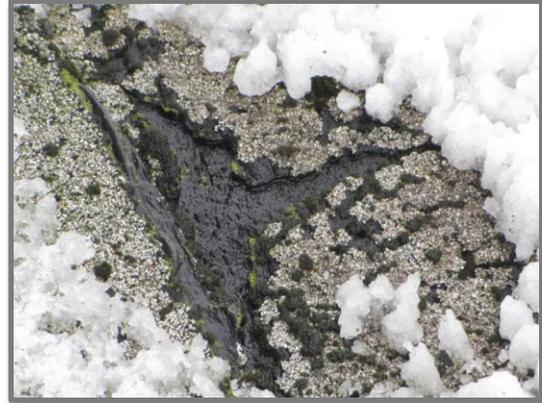
4. The spot on the back lower roof (over the apartment two bathroom) is damaged. Although the roof covering is mostly covered in snow, I'm pretty sure that it's near the end of its life. You should plan on replacing it.

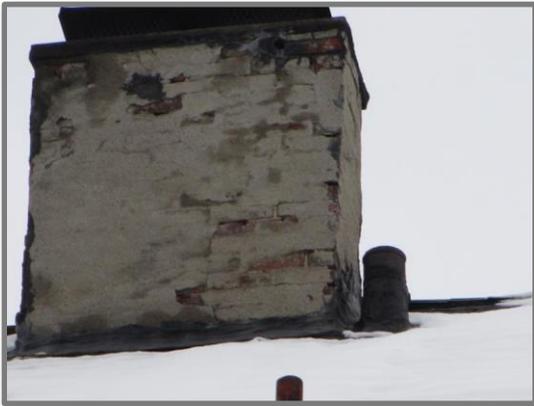
5. Here's a couple pictures of the chimney. It's obviously been repaired in the past. I didn't notice any cracks, but it's a long way up there so I couldn't see the whole thing. The roof was snow covered so I couldn't get up there.

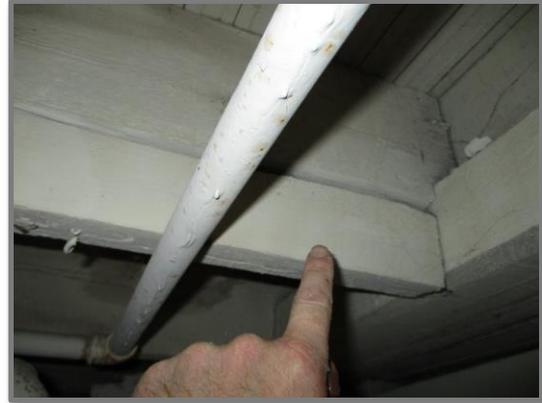
4. There are several broken joists in the basement. I'm not sure what caused them to break, but they are all next to each other. I didn't notice any problems resulting from them. These can be repaired fairly easily by sistering another joist to each of them if they ever become a problem.

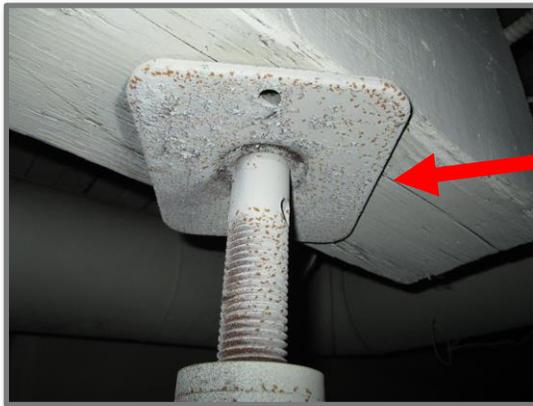
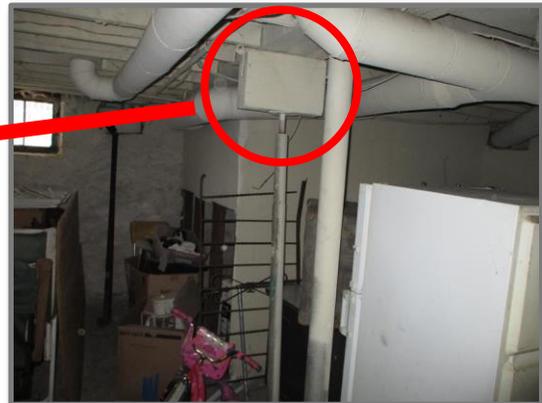
5. There are two jack posts in the basement that are designed to be temporary and are not attached to the beam above. I often see homeowners put these in place to try and stop a squeaky or spongy floor. It's hard to say how long they've been there. I recommend having them lag bolted in place.

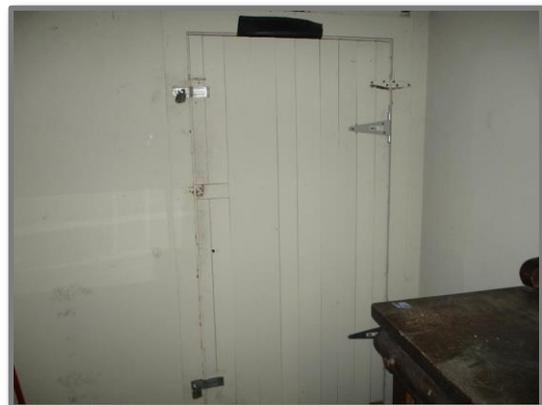
6. This door was locked. I peeked through a gap on the side and it looked like there was more storage items in there.

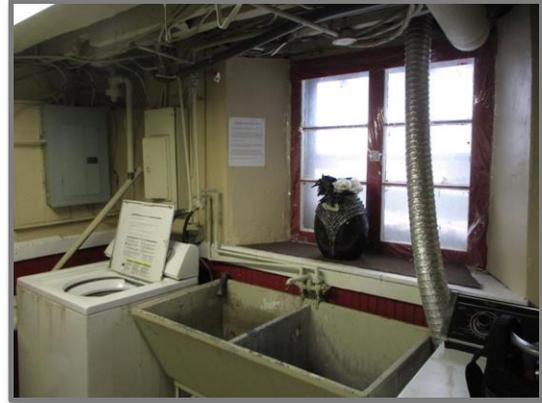
7. The cement laundry basin in the basement is not attached to the wall. It's possible that a child (or an adult) could pull on, or lean against this basin and cause it to fall and injure them. The plumbing pipes would also be damaged if this happened. I recommend securing the laundry basin to the basement wall.

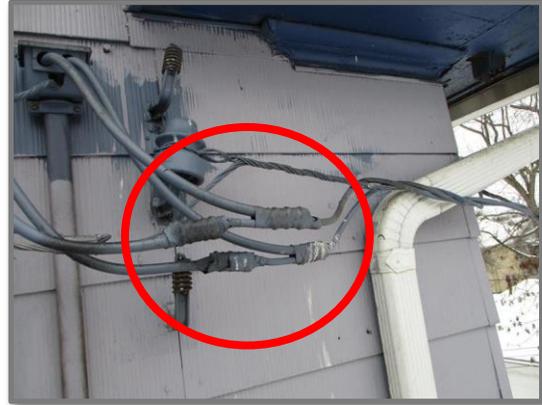
3. The splices between the overhead service conductors and the service entrance conductors have been made at the bottom of the drip loop where they are subjected to moisture running down the conductors. I recommend contacting the electric utility company and requesting repair.

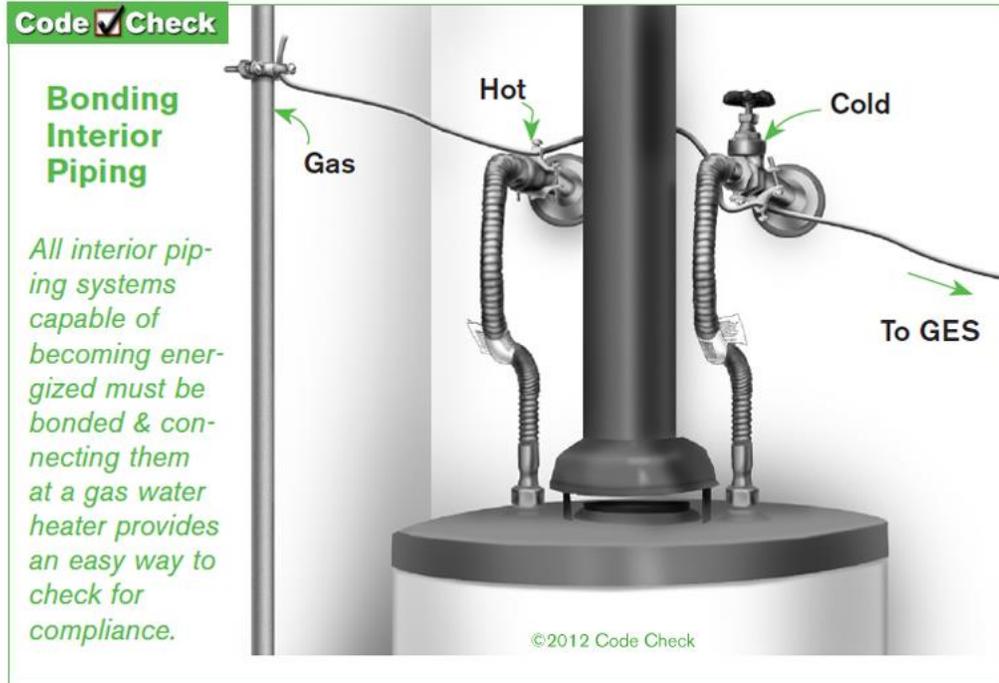
7. There is no bonding jumper at the water heater. Bonding jumpers must be installed around items which could disrupt the continuity of the metal underground water pipe system. This includes the water heater, pressure reducing regulators, water filters, softener or other water treatment equipment. I recommend installation of a bonding jumper at this location.

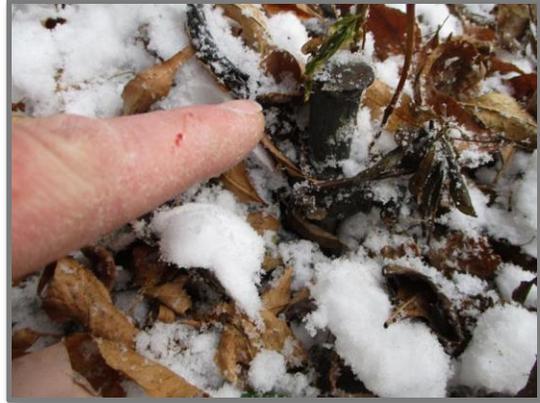
10. The two grounding rods on the east side of the house are both loose in the ground (I'm pointing to one of them). These rods are supposed to be ten feet long, but it's pretty common for installers to drive them until they hit something, then cut them off. This can result in an insufficient ground for the electrical system, which is a safety hazard. I recommend installing new grounding rods outside the house.

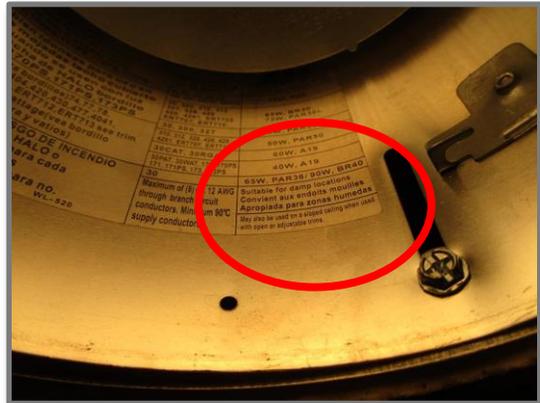
11. The can lights in the downstairs bathroom above the shower are only rated for "damp location." Any area above the shower stall should be considered a "wet location." These lights should be either moved, or replaced with light fixtures rated for a wet location. This is an electrocution hazard.

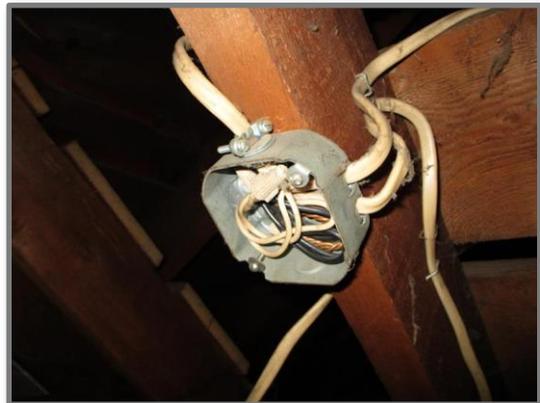
12. I found uncovered electrical junction boxes in the home in the attic. These boxes must be covered in order to contain any electrical fire within the box and to keep debris, insects and vermin out. Note that the covers may be missing because of too many conductors in the boxes. If this is the case, any overfull boxes will need one or more extension rings added. I recommend having this issue corrected by a qualified electrician.

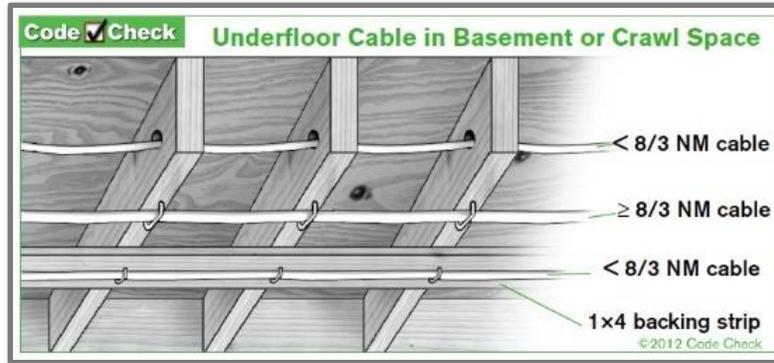
13. In the basement, there are NM electrical cables that are improperly supported. It's possible that someone could hang clothing or other objects from this cable and damage it, causing a shock or fire hazard. I've attached a schematic of the correct cable routing procedures and recommend that you have them corrected.

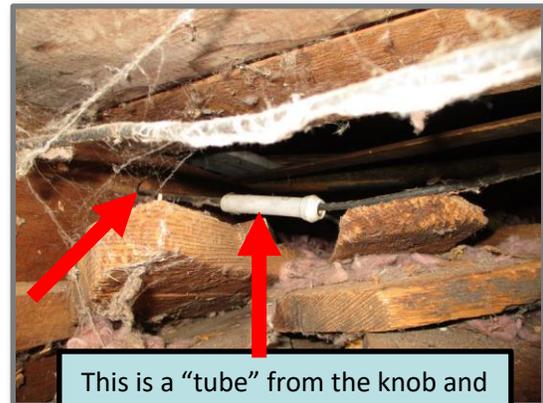
14. Portions of this home are still wired with knob-and-tube wiring. This type of wiring has no ground conductor and is installed with separated hot and neutral conductors secured to porcelain knobs, or threaded through porcelain tubes, to insulate them from framing members. K & T wiring is considered obsolete and the cloth and rubber insulation is frequently deteriorated and fragile. Even though I may not have found any obvious deficiencies with this wiring, I still strongly recommend you consider having it replaced or at least thoroughly inspected by a qualified electrician who can discuss options and cost for eventual replacement.

This is a "tube" from the knob and tube wiring; it should be inserted into the hole that the other arrow is pointing to so that it insulates the wire from the

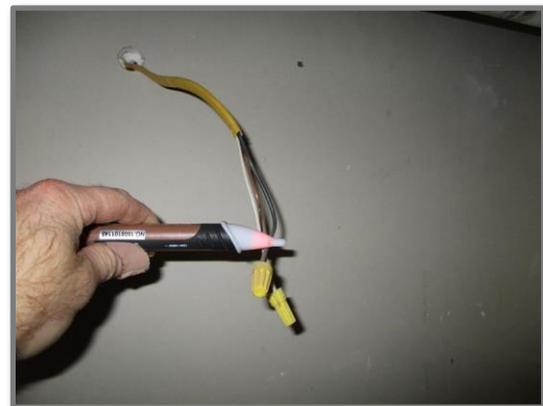
15. There are electrical wires in the basement bathroom that have been spliced and not contained in an approved junction box. They are energized, so they are a safety hazard. I recommend having all splices installed inside required junction boxes by a qualified electrician.

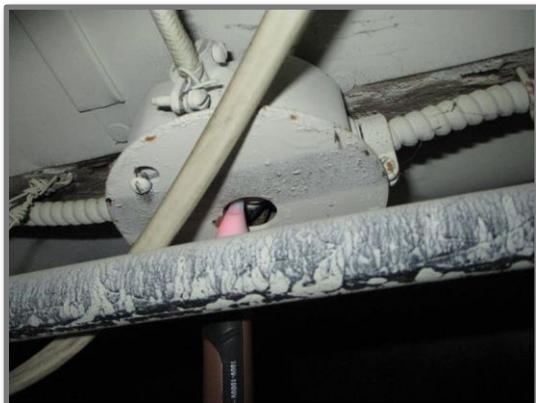
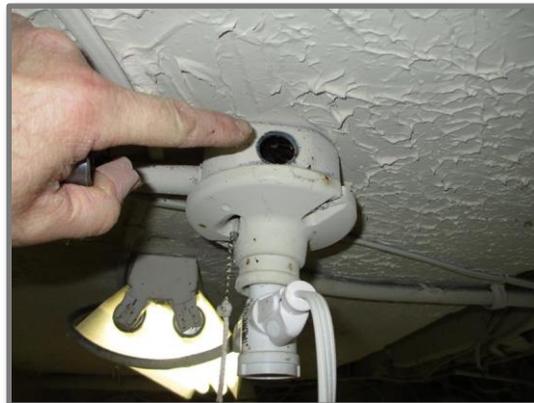
16. There are several junction boxes in the basement that have an open knock out (see pictures below). This means that the box will not contain a fire. It's a safety hazard. I recommend either plugging or replacing these junction boxes.

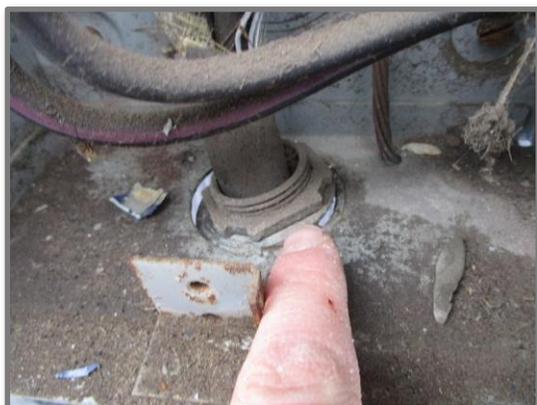
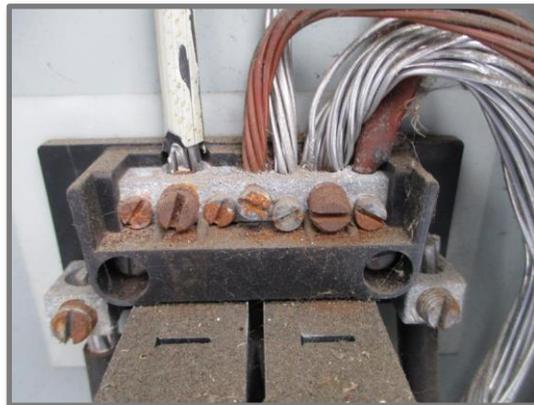
21. At the outdoor Crouse-Hinds panel, there is an open gap in the panel box (left photo) and inside, there is rust on the bus bar (right photo). This rust may require the panel to be replaced. I recommend having it looked at by a qualified electrician and replaced if necessary. At a minimum, the rusted and corroded parts will need to be replaced. You should put a lock on this box to make it more difficult for someone to tamper with it.

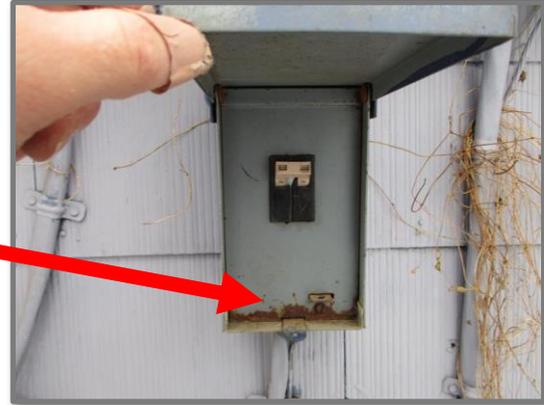
22. The smaller Cutler-Hammer outdoor panel has some rust on its dead front but looks alright inside. Have the rust cleaned off and the area painted. I recommend locking this box to reduce the chance of it being tampered with.

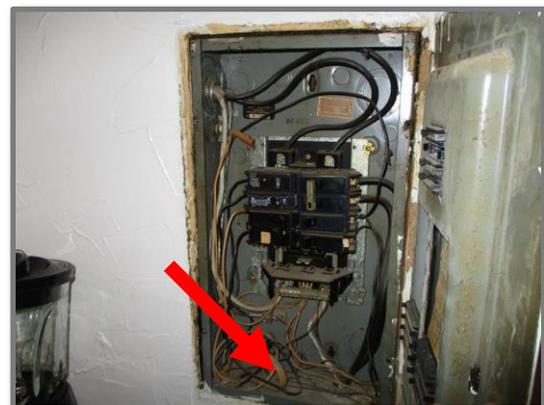
25. The service panel in apartment four doesn't have the proper working space around it that is required. I believe that this is a sub panel (see comment #24, I am not certain of this), which means it's wired incorrectly with grounds and neutrals on the same bus bar. This is an electric shock hazard.

The interior of the panel is dirty and there is a wire that is unprotected and passes through an open hole in the sharp metal box. This could cause the wires insulation to be damaged and electrify the box. The open hole

The arrow points to the wire passing through the open hole

also means that the box cannot properly contain an electrical fire. There's some work to be done here. I recommend having it done by a qualified electrician.

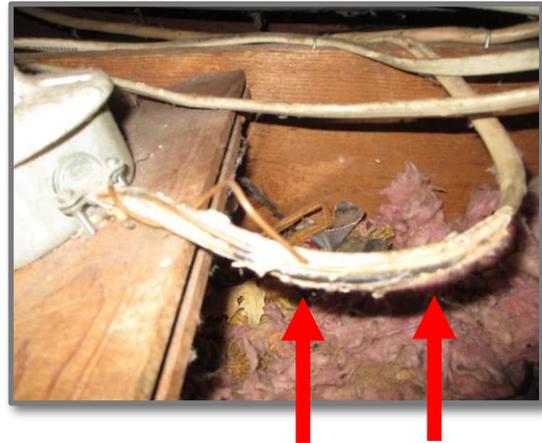
26. I found this squirrel chewed wire in the attic. There are probably more like it that aren't so easy to find.

This isn't a surprise, it's what squirrels do. For some reason, they seek out wires and chew on them, which can result in electrical fires inside the house. This is another reason to get the squirrels out of the house. You should have these and any other damaged wires repaired by a qualified electrician.

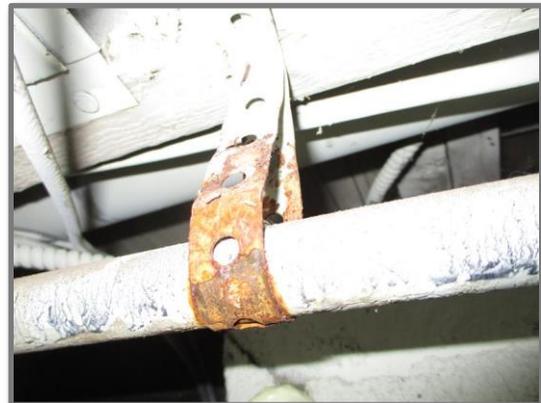
3. There are improper hangers used on the copper supply pipes. In this case, they are steel straps used to suspend copper pipes. Steel in contact with copper will sometimes cause a chemical response known as 'galvanic reaction' that accelerates deterioration of the components involved and results in leaks. I recommend replacing these metal straps with proper pipe hangers.

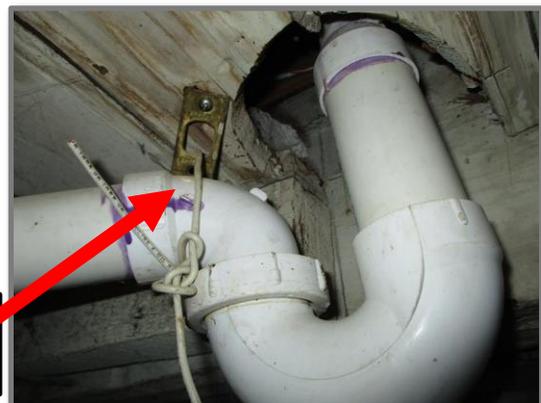
4. The plumbing hangers are installed at improper intervals or are poorly attached. This can result in water hammer in supply lines or low-spots in drain lines that will interfere with proper drainage. I recommend having a qualified plumber install additional brackets or reinforcement to improve the way the system is suspended and attached.

This is an interesting plumbing hanger; have it replaced

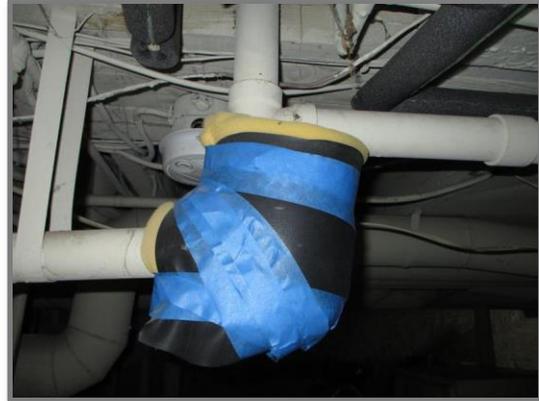
5. This plumbing connection in the basement is covered by padding. I'm not sure why. I recommend asking the current maintenance person why.

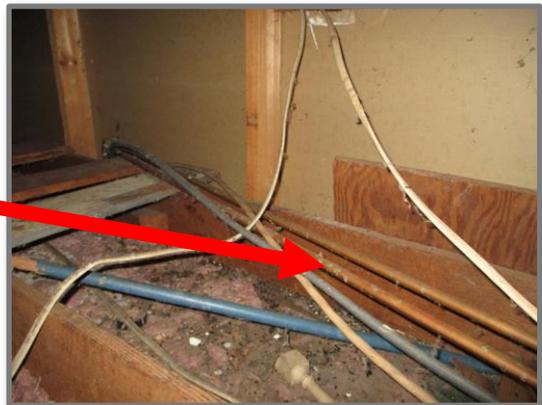
6. There are uninsulated copper pipes in the attic. I recommend insulating these pipes or having them removed from the attic to reduce the chance of them freezing and bursting.

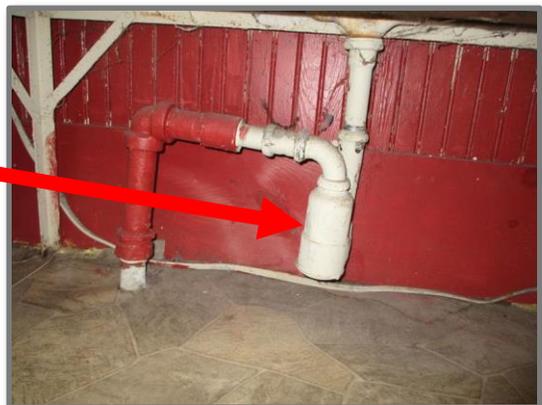
8. The sink drain at laundry basin is plumbed with a drum trap. Drum traps are now obsolete since they are unreliable and tend to clog easily. I recommend having the drum trap replaced with a P-trap.

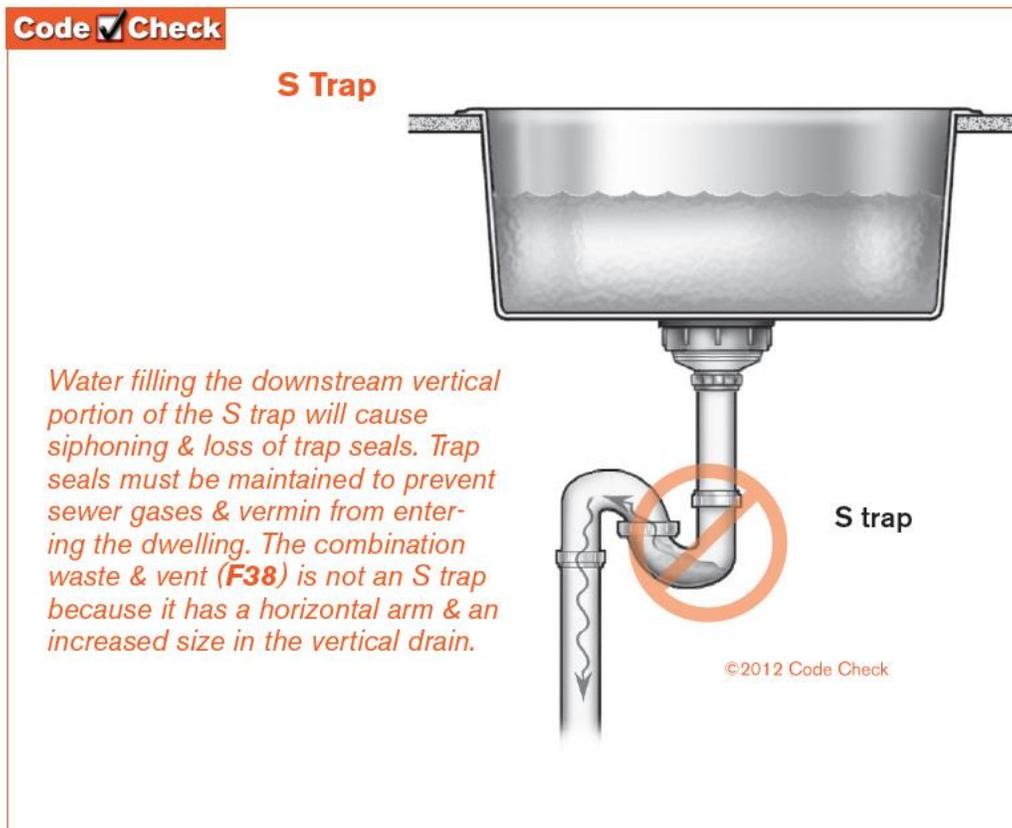
10. The sink drains at the kitchen (apartment 1 & 2), bathroom (apartment 1, 2 & common bath) are plumbed with an S trap. S traps are now obsolete since they can sometimes syphon themselves dry, which then allows sewer gasses to pass through into the living space. The proper trap to have in place is a P trap, which does not syphon. Practically speaking, it's sometimes difficult or impossible to install a P trap into existing plumbing without completely removing and re-plumbing the entire drain pipe. In that case, you can simply run a little water to refill the trap if you smell sewer gasses from it. If this happens frequently, you should consider having the sink drain re-plumbed and a P trap installed. A qualified plumber should be used for the work.

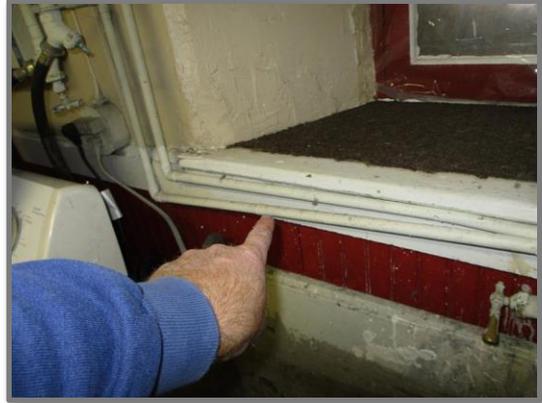
13. These pipes that serve the wash basin are poorly supported. If someone tips the basin over, they'll be damaged. I recommend securing them properly to the wall.

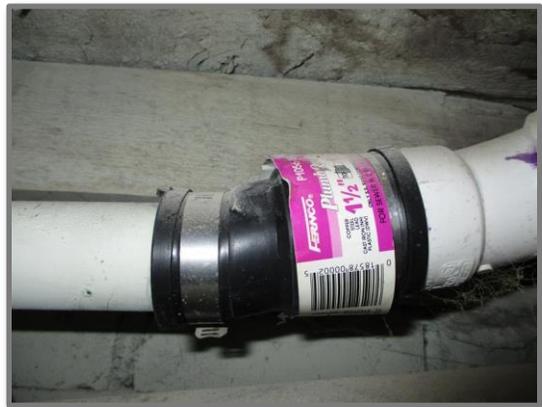
14. This rubber fitting is located in the basement behind the furnaces. Fittings such as this, that contain an internal ledge, are not permitted in the drain system. They are prone to clogging. I recommend replacing this with a proper connector.

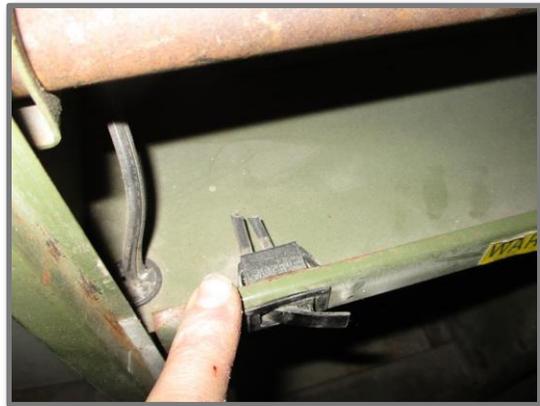
1. All rooms were checked for a heat source (delivery register) with no defects noted.
2. There was no service sticker on the furnace. I have no way of knowing the last time it was serviced, but it's probably been a while. I recommend having the furnace cleaned and serviced by a qualified HVAC technician right away and establishing a regular schedule of service afterwards.
3. The fan cut off switch wires have been cut, which means that the furnace fan will not shut off when the access door is opened. This is an unsafe condition, since someone working on the unit could be exposed to the moving fan. I recommend having it repaired.

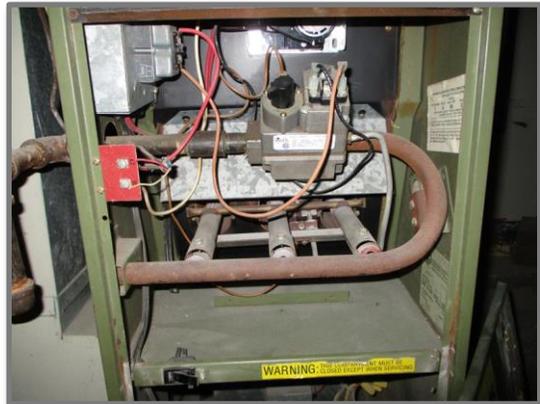
4. This unit had "#2" written on it, but I couldn't get it to fire. The thermostat in apartment two was shut off. I recommend verifying with the property maintenance manager that this unit is working properly.

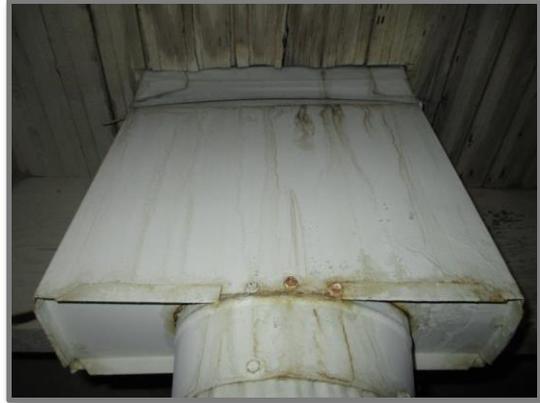
5. The ducting has been painted white. Generally, when I see something painted white it's because the seller is trying to hide something. There are some signs of rust in the ducting, but I couldn't find any holes or areas that were rusted completely through. This was about as bad as it looked.

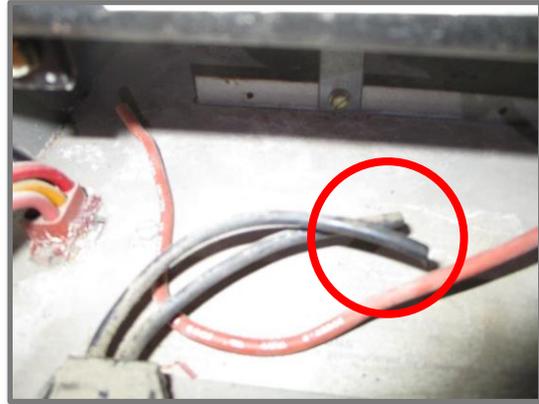
2. The wires to the fan cut off switch have been cut on this furnace too. I recommend having them fixed.

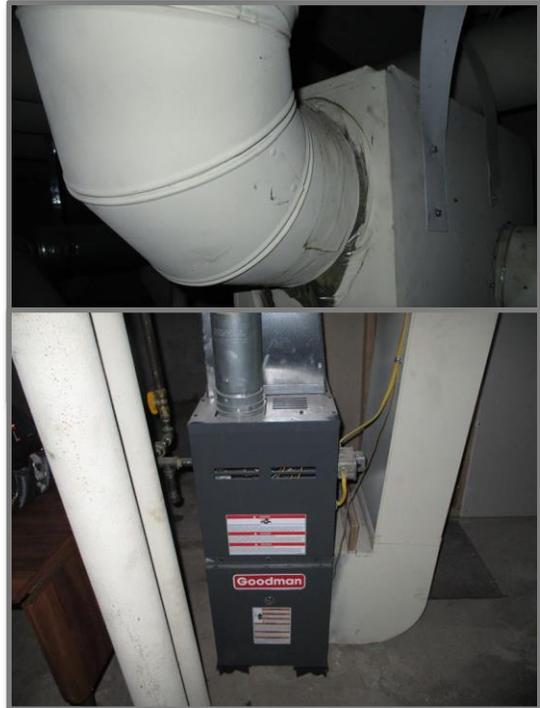
4. This furnace is not mounted level. It's much higher on the left side than on the right. I'm not sure why, but it's actually been shimmed on the left side to raise it up. Taking the covers off was difficult and so was re-installing them. I recommend having the furnace leveled by an HVAC tech.

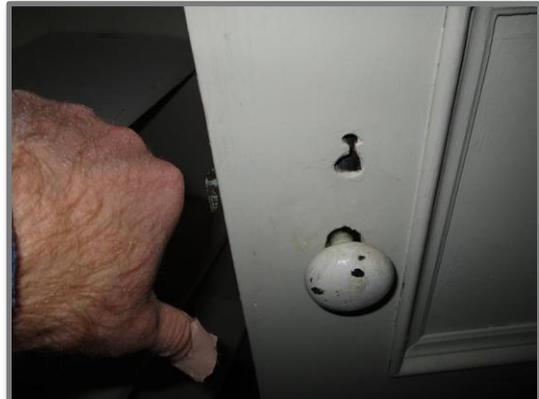
1. There are minor wall blemishes throughout the home that are of no real significance other than cosmetic.
2. One of the metal kitchen cabinets doesn't latch. I recommend installing a new latch here.
3. There is a loose cabinet door hinge on the kitchen cabinets under the sink.
4. This door handle to the front porch does not turn. I recommend having it repaired.

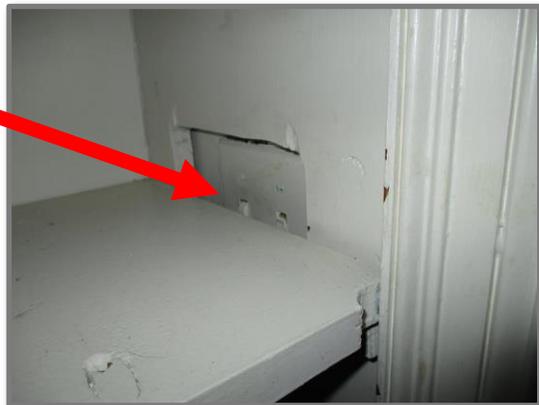
5. One of these light switches turns on the porch lights, the other didn't turn anything on. I recommend moving the shelf so that the switches are more accessible.

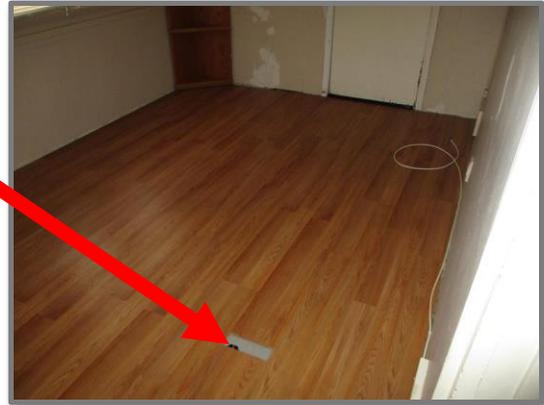
6. There is a missing piece of laminate flooring in the porch. I recommend having it replaced.

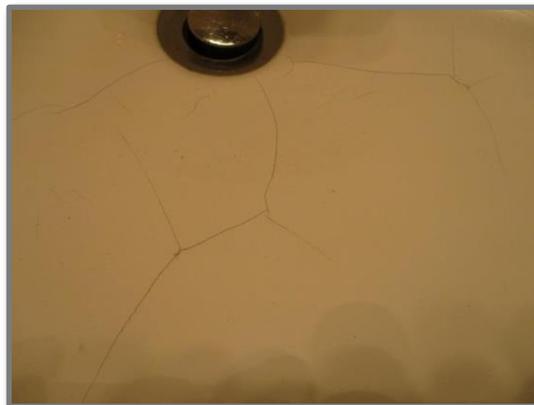
12. There are surface cracks in the bathroom sink. They're cosmetic only at this point.

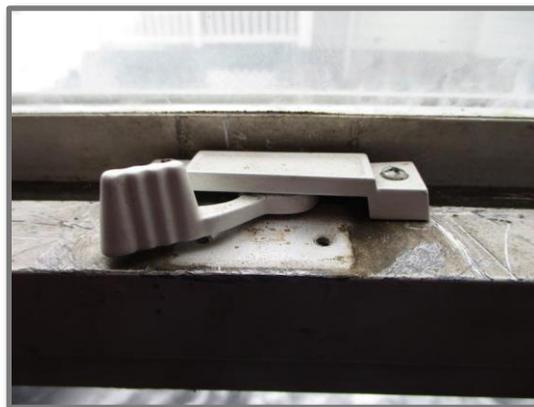
13. There are several broken window locks in the home. These locks should be repaired or replaced so that all windows can be securely locked. You should be able to find replacement locks at just about any home improvement store.

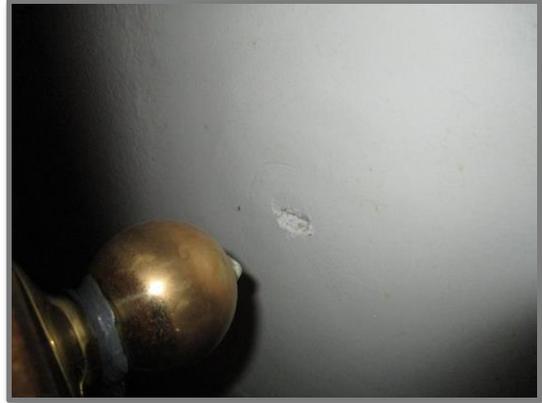
2. There is a hole in the bathroom wall caused by a door handle because no door stop is in place. I recommend repairing and painting as appropriate. I also recommend installing a door stop to prevent this from happening again in the future.

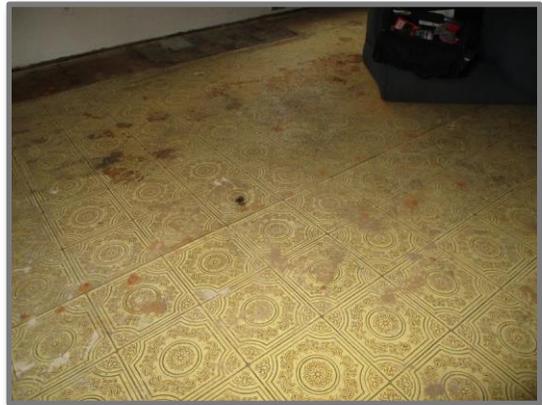
3. You need to install new flooring in nearly the entire apartment. The kitchen and bathroom sheet vinyl is poor fitting and worn and the carpet was ripped out of the living room. The bedroom wood floors are decent, so you can probably get away with just cleaning them up.

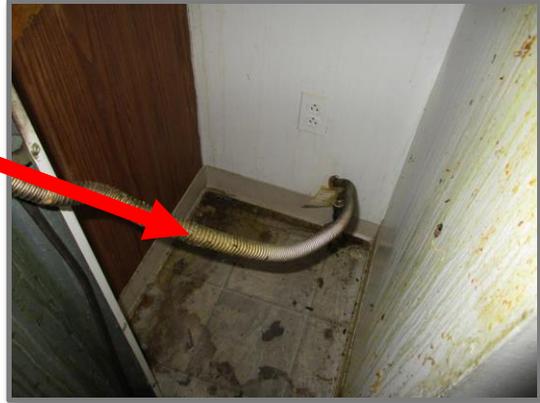
5. Replace this metal natural gas connection with a modern yellow plastic connector. The metal ones have a history of failing and causing gas leaks.

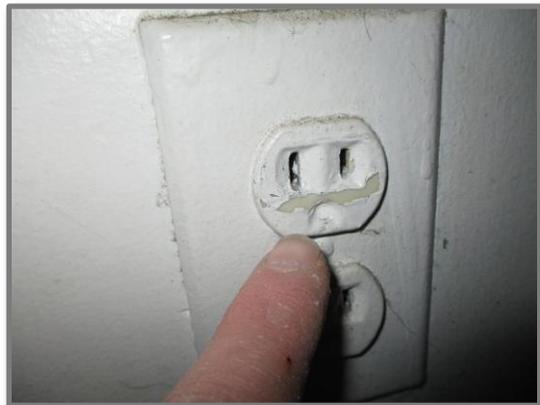
6. Several electrical outlets in the home are painted shut. They are not useable. Removal of the paint could expose you to electric shock risk and some solvents could damage the plastic of the outlet. I recommend having a qualified licensed electrician clean or replace these outlets.

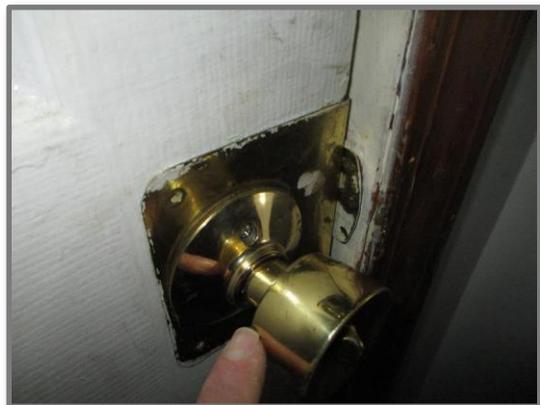
7. The entry door handle is loose/damaged. It worked, but it's on borrowed time. I recommend replacing it.

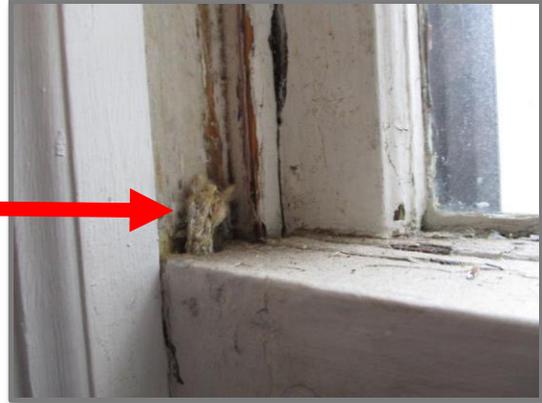
8. The wood windows in this apartment are on their last legs. They open, but one in the living room won't stay open due to a broken sash cord. The paint is chipped and the windows are very loose in their frames, so they are certain to leak air. I recommend having them replaced.

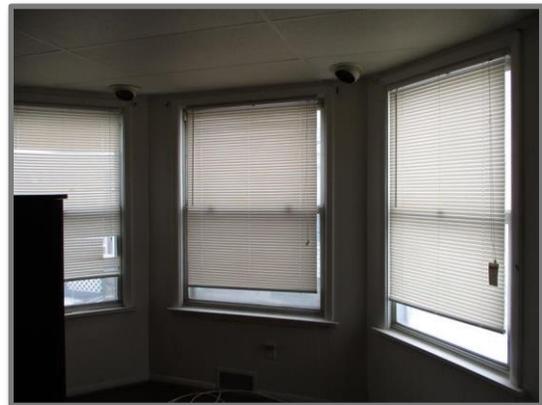
9. The right window has a bad seal, so it's foggy between the glass panes. The window in the middle has a broken lock. I recommend replacing them.

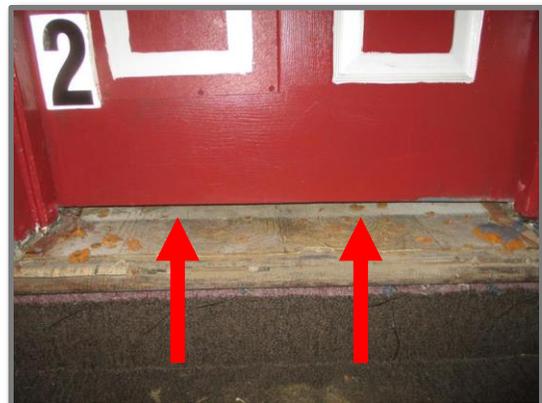
11. There is a large gap underneath the entry door. I recommend installing a threshold here or re-installing carpet to fill this gap.

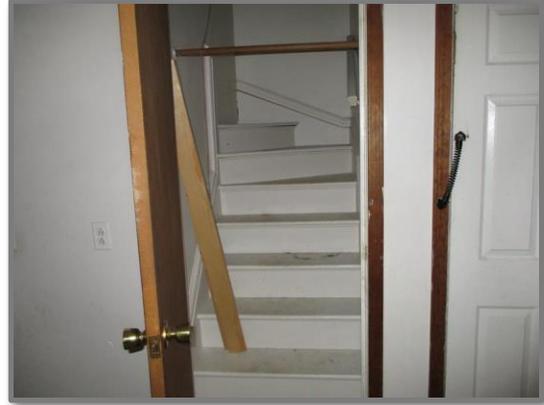
12. You're probably not going to be able to do anything with this stairway to nowhere in the closet, since it's above the basement steps.

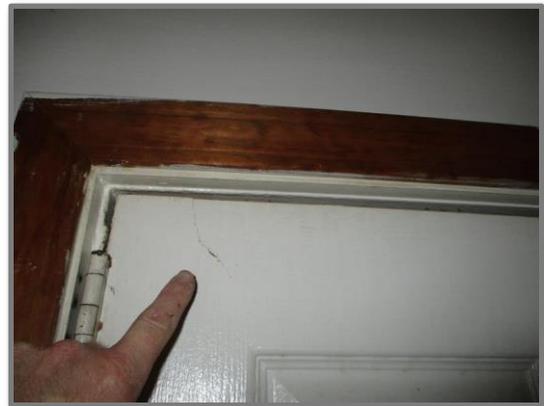
14. The entry door is damaged, I'm pointing to one of the areas but there are a couple others too. This is a hollow core door, so it's not the best choice for an entry door since it's not as strong as a solid wood or metal door. I recommend replacing it with a solid wood door.

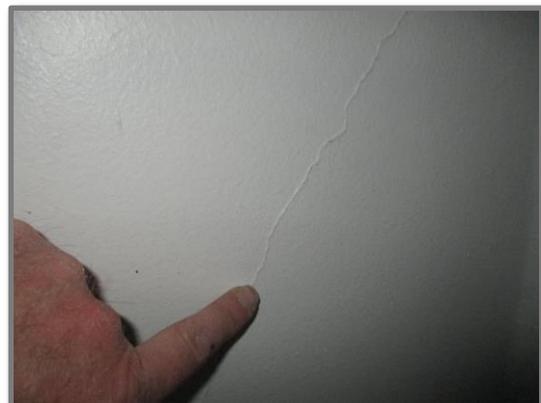
1. There are wall cracks were noted in several areas of the home. None of the cracks were serious in nature. The one I'm pointing to is in the kitchen. I recommend repairing and repainting these cracked areas.

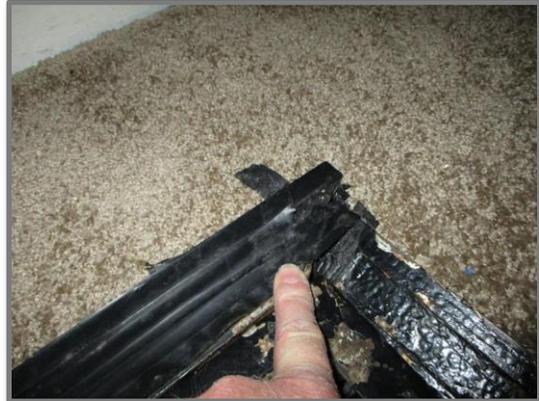
3. This heat register in the bedroom is broken. I recommend replacing it to reduce the chance of someone putting their foot through it and being injured.

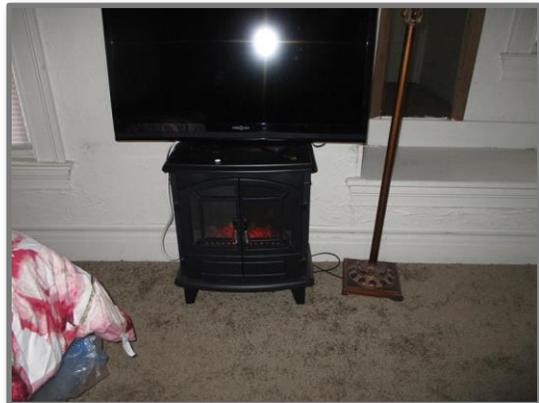
4. It was cooler in this apartment, so I asked the tenant if the heat was working. She responded that she couldn't tell but it doesn't seem like much heat blows through the register. The landlord gave her this stove, which was running to keep the place warm when I was there. I recommend making sure that the heat works to this apartment, which will mean gaining access to the locked thermostat in the hall.

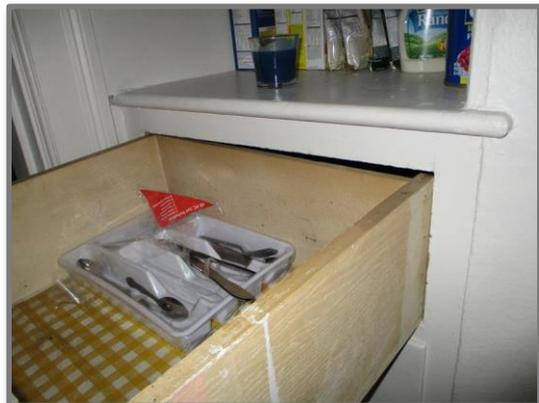
5. The kitchen drawers have no safety stops. They will pull all the way out and fall to the floor. This is a dangerous condition. It could allow the drawer and its contents to fall to the floor, causing damage or personal injury. I recommend installing stops on these drawers to prevent this.

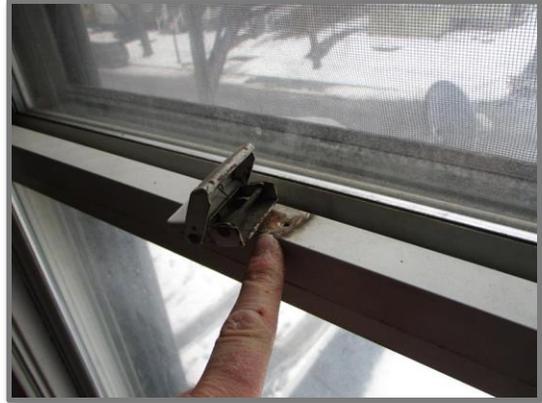
6. The window lock in the bedroom does not work. I recommend having it fixed or replaced so that the window can be properly secured.

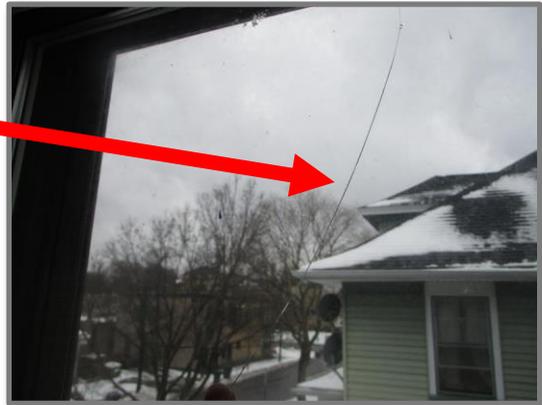
7. The storm window glass is cracked and the window screen is taped in place in the west facing kitchen window. I recommend replacing them.

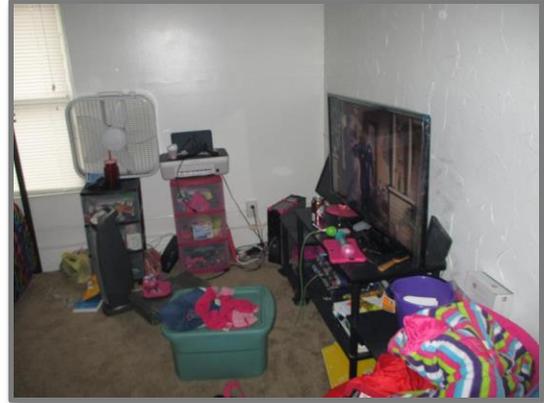
2. Since the house is still furnished, I wasn't able to see some things, such as the condition of floor covering under furnishings and appliances. These areas are excluded from the inspection. Rooms or garages where floors or walls cannot be observed because of furnishings or stored items are similarly excluded from the scope of the inspection. If you have any concerns about these areas, I recommend arranging with the seller to move the furniture/storage items so that you can see them.

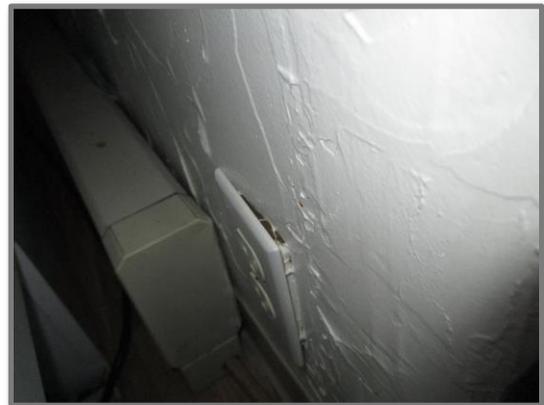
3. The outlet in the kitchen is pulled away from the wall. It should be remounted so that it sits flush with the wall surface.

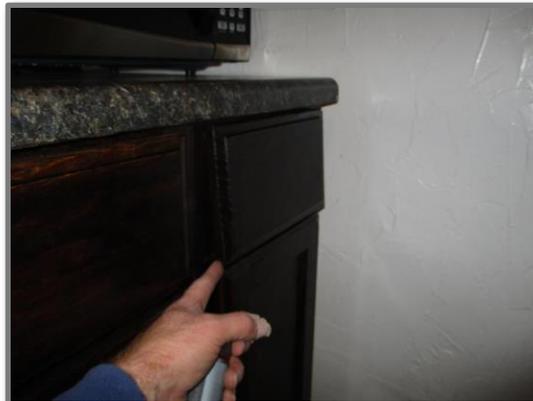
5. This kitchen drawer wouldn't close properly. It may be off the track but I couldn't get it far enough out to see because there is a chest freezer in the way. It should be a simple fix.
