# Vesta Home Inspections, LLC

## Home Inspection Report

**123 4th Avenue**

Any Month, 2016

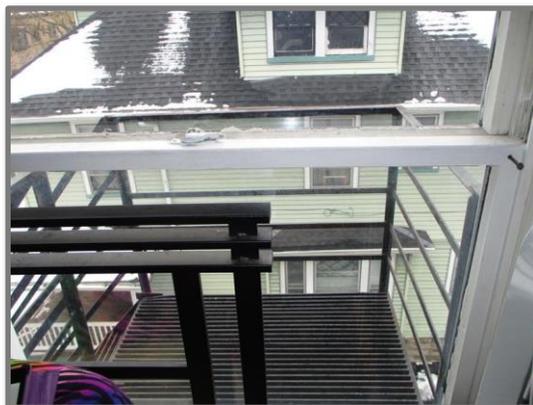
6. This window has been nailed shut. As you can see, the fire escape is directly out the window. This is a life safety issue. If people can't get out the fire escape, they die. I recommend fixing this window or replacing it so that it works all the time.

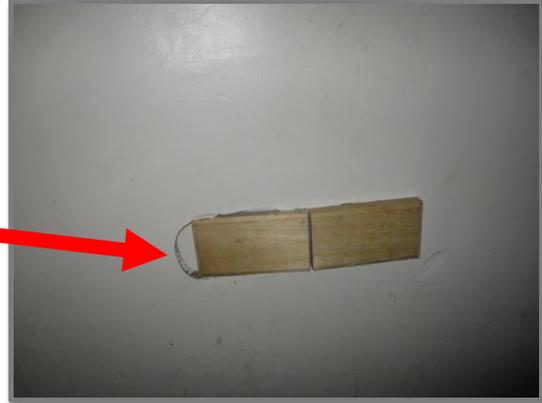
2. There is a hole in the wall caused by a door handle because no door stop is in place. I recommend repairing and painting as appropriate. I also recommend installing a door stop to prevent this from happening again in the future.

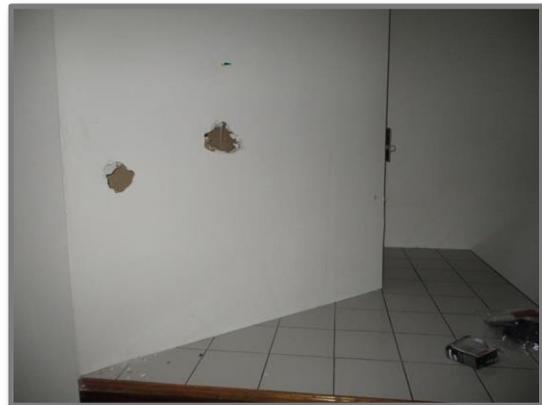
3. The walls are full of holes. Thankfully this is drywall instead of plaster, but you're looking at a lot of drywall repair in this unit.

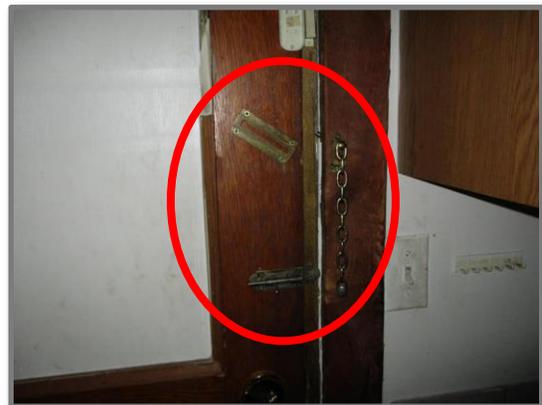
4. The front door bolt and chain locks are damaged. They should be replaced.

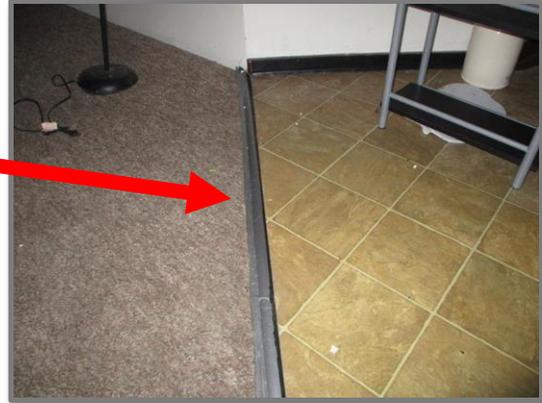
6. You should install a proper transition between the sheet vinyl and carpet so that they are both protected from damage.

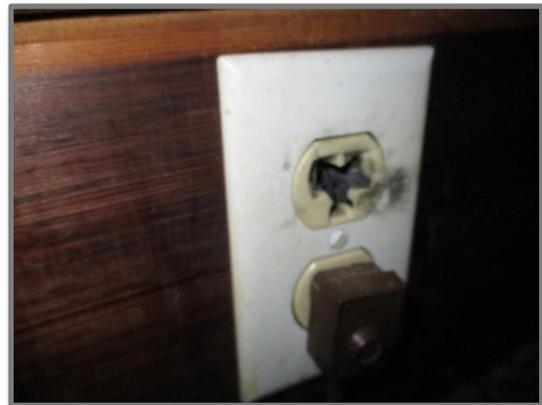
7. This outlet behind the refrigerator has been damaged by an electrical fire. Have it replaced by a qualified electrician.

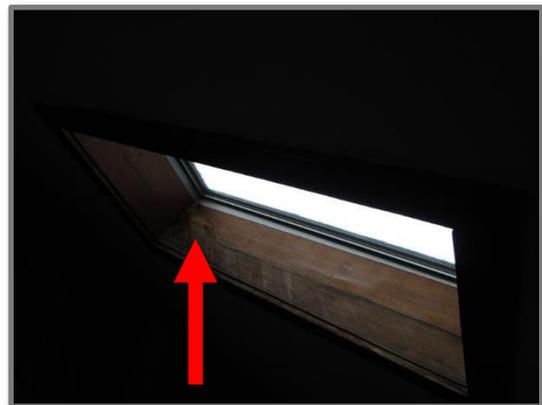
8. As you can see, the skylight has leaked in the past. It was dry at the time of inspection, which is good news, since there was snow and ice up there. I recommend removing it when you have the work done to the north side of the roof so that you don't have to worry about it leaking in the future.

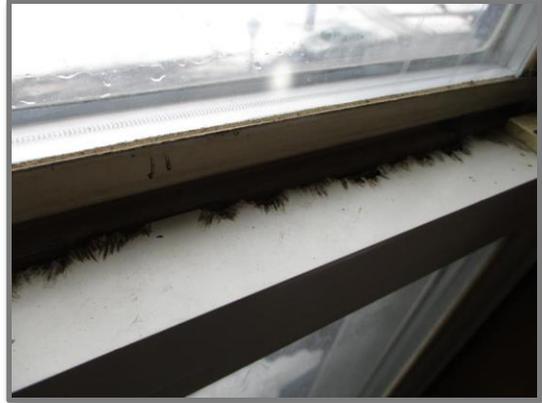
9. This window facing south is pretty chewed up. I recommend replacing it. There's one facing east that's at least this bad, maybe worse. Replace that one too.

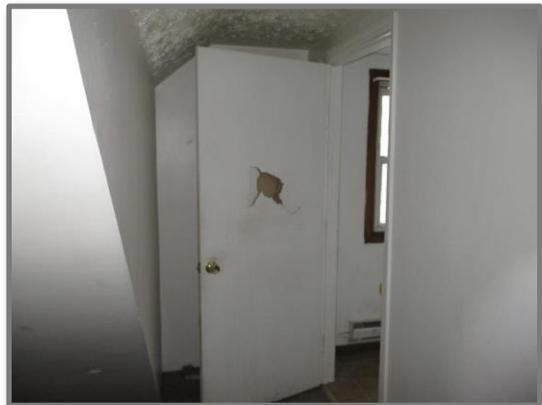
10. It looks like somebody put their fist through the bathroom door. Replace it.

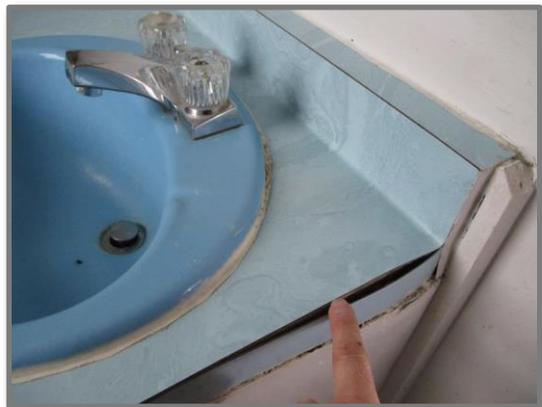
11. The bathroom counter is delaminating. It may be possible to glue it back together and get some more time out of it. If not, you'll have to replace it.

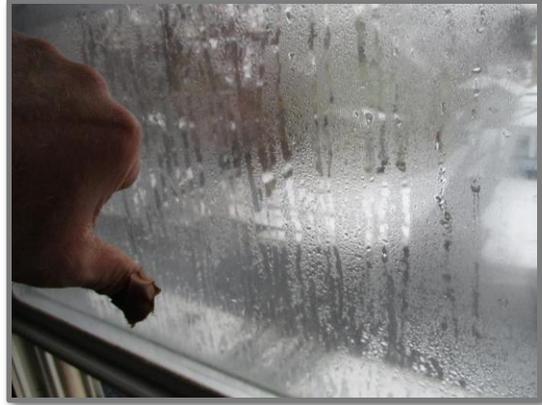
12. The double-glazed window in the bathroom has a failed seal. This means that the insulating properties of the window have reduced and it will almost always have a fogged appearance. I recommend replacing this window.

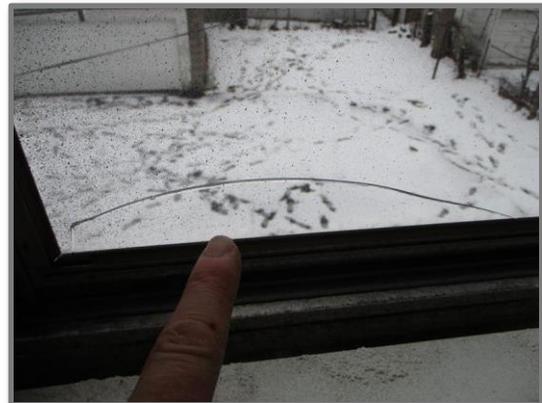
1. The hot water handle turns backwards on the sink. It's a real minor thing, but you can have it easily corrected.
2. This cracked storm window faces north. Replace it.

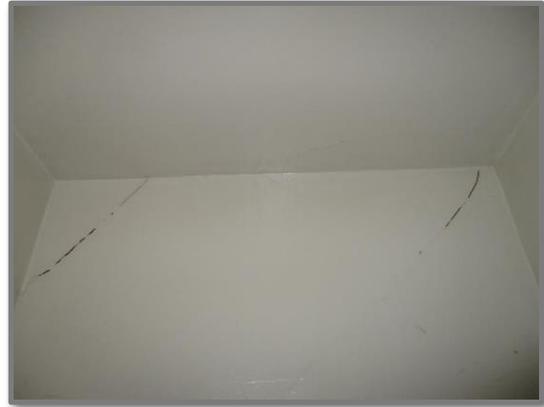
3. There are some cracks in the wall surface inside the closet. They look like old cracks from settlement. I recommend caulking and painting them.

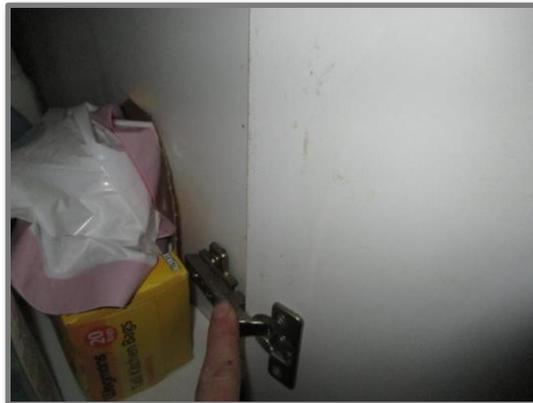
2. This lower cabinet hinge is loose. It took me longer to type this than it will take you to tighten it up.

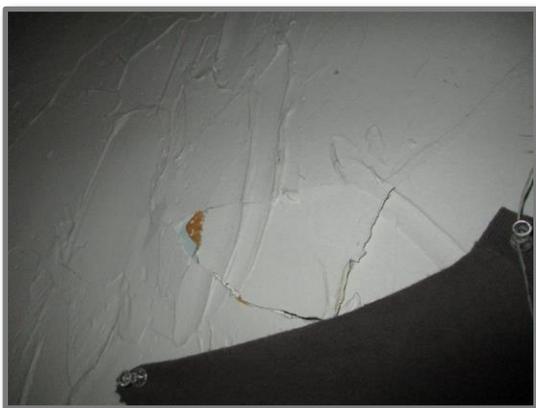
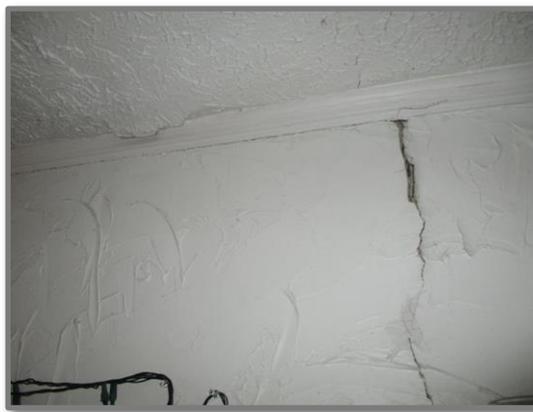
3. There are wall cracks in the plaster that should be repaired. I'm not sure what the cause of the cracks are, but didn't notice any other signs of structural movement in the building. I recommend having the cracks repaired.

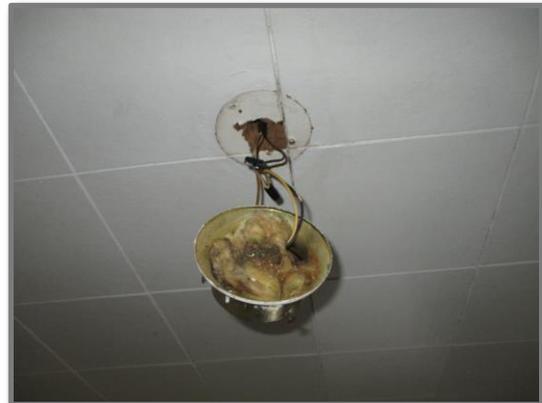
1. Due to the age of the home (built before 1978), I recommend that you follow the EPS's Lead Safe Guidelines anytime you remodel or attempt to remove paint. You can find out more about the dangers of lead paint at <http://www2.epa.gov/lead>.
2. The light fixture needs to be repaired/replaced. The wires were not hot at the time of inspection.

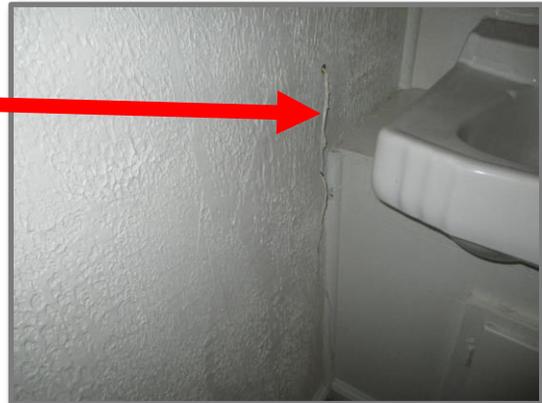
3. This wire from the locked hall thermostat should be protected in conduit so that it will be more resistant to tampering.

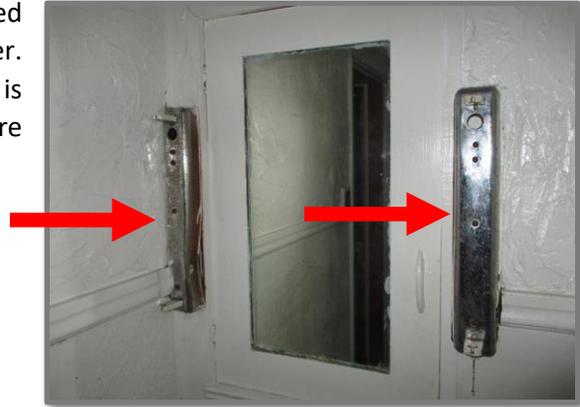
4. The light fixtures on either side of the mirror tested hot for electricity when I touched them with my tester. I'm not sure if the metal is actually hot or the tester is just sensitive. I recommend replacing these, since there is a chance of electric shock here.

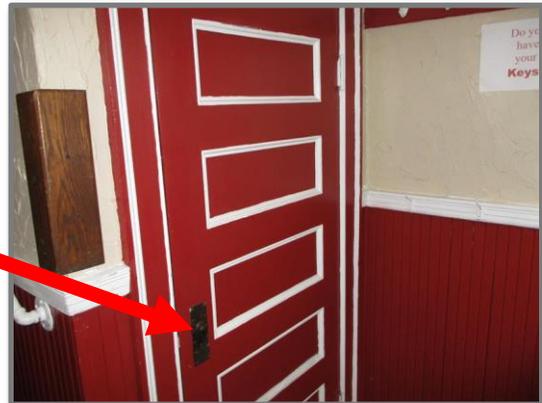
1. The basement door has a lock on the outside. That means that someone could lock themselves in the basement. I recommend changing the door handle so that there is no lock, or so that it's a keyed lock that all tenants have a copy of.
2. The west entry closet door is missing a handle. I recommend installing a pull handle here so that it's easier to open.

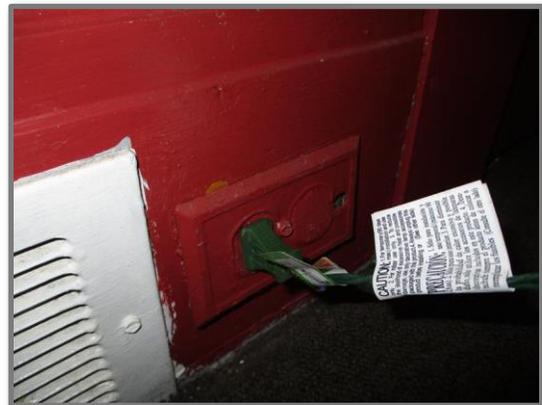
3. One side of this outlet on the first floor has been taped and painted red. I recommend repairing it if necessary so that both plugs are available.

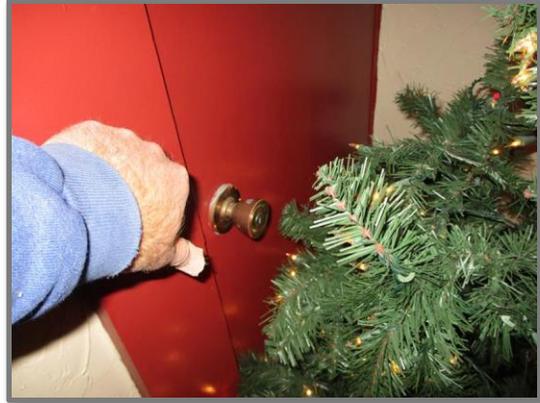
4. The door behind the Christmas tree was locked. I don't know where it goes.

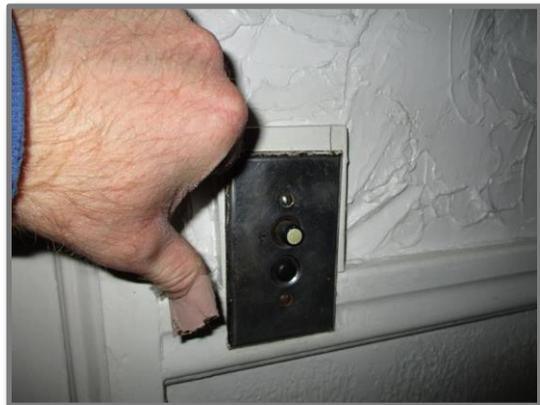
5. This push button switch on the second floor doesn't work. I recommend having it removed and replaced with a modern switch.

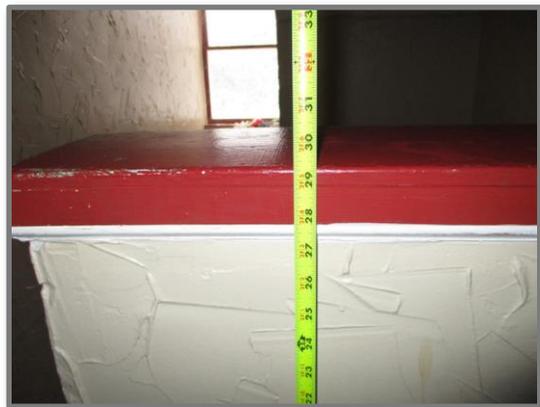
6. The wall at the third-floor stairwell landing is 29 inches tall. It should be a minimum of 36 inches tall to help reduce the chance of someone falling over into the stairwell. This is a life safety issue. I recommend installing a guard rail here that is at least 36 inches above grade.

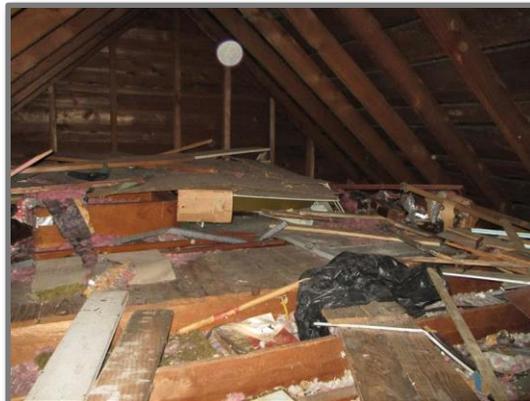
2. I found vermin-trails through/over the insulation, droppings, urine spots and nesting materials in the attic.

This may be an older condition that's already been resolved, or it may be ongoing. I recommend that further inspection be done by a qualified pest control operator/exterminator and remediation performed if necessary.

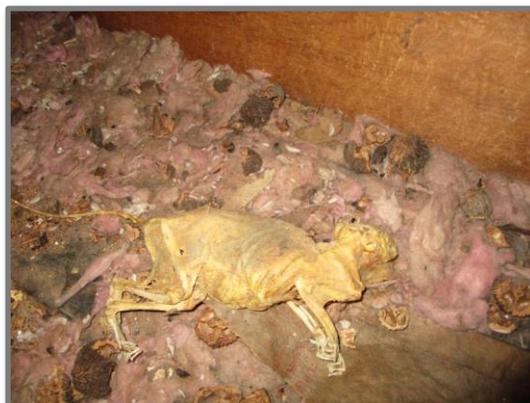
3. I debated over adding this picture, but wanted to get across the importance of sealing the squirrels out of this house. This squirrel didn't survive (I assume it was a squirrel instead of a rat because of all the walnut shells present in the attic). Sealing the house off from these guys is going to be a constant battle.

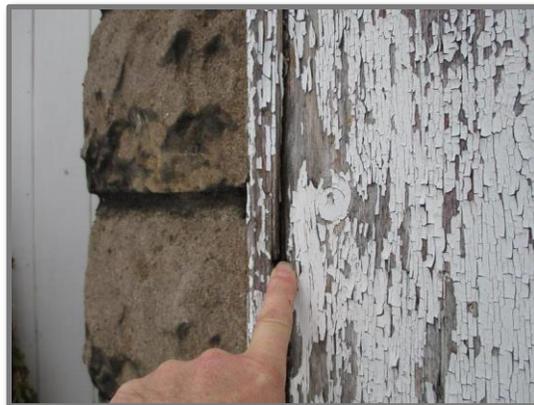
1. The garage has the same paint trim issues that the house has. I recommend scraping and painting.

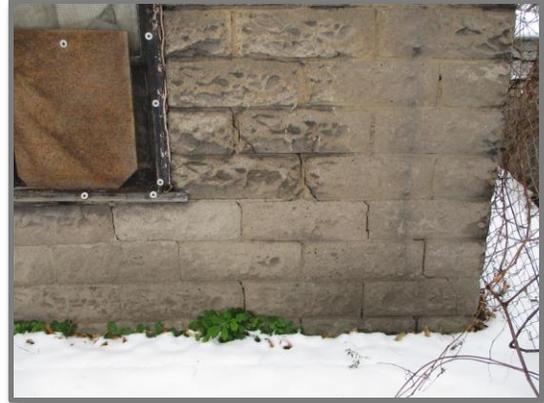
2. There is step cracking on the garage walls. This picture is of the east side, but the cracking exists on the west side too. I see this fairly often in garages like this, usually because they are built on soil that hasn't been compacted well enough. The soil settles over time and the building begins to move. In this case, the garage is located in a low spot, which makes it even worse.

I recommend having the garage foundation evaluated by a structural engineer to see what, if anything, can be done to save the building.

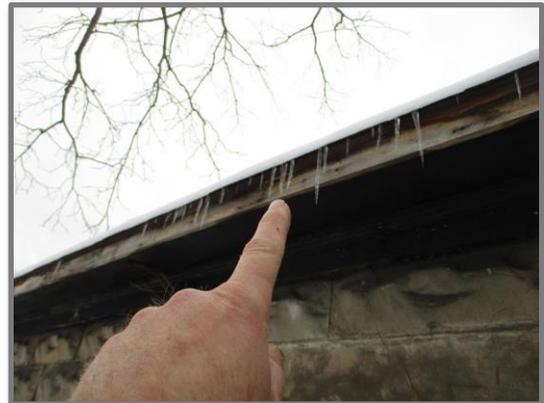
3. I couldn't get into the garage because the door was locked, so my inspection was limited to outside. The roof was completely covered in snow, so I could not look at that either. If you'd like, I would be willing to return to inspect the inside of the garage and roof if you can coordinate a time with the seller to open it up.

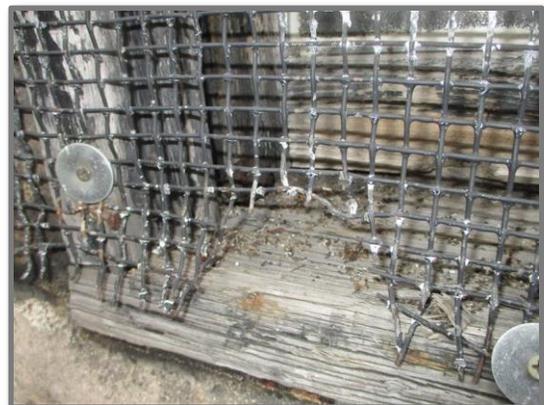
5. The squirrel problem extends to the garage as well. They've actually chewed through this hardwire cloth window screen. You'll want to have them removed from the garage too and have it regularly checked for their return.

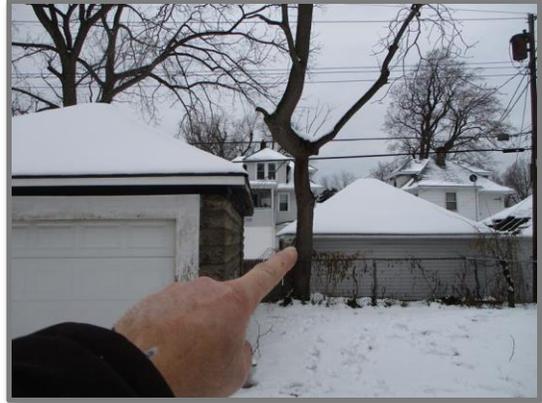
6. This tree leans way out over the garage. It's not on the property, but it may be within your rights to cut it back. I recommend doing so to reduce the chances of damage to the garage from falling branches.
