Vesta Home Inspections, LLC

Home Inspection Report

123 Fourth Drive

July 9, 2018

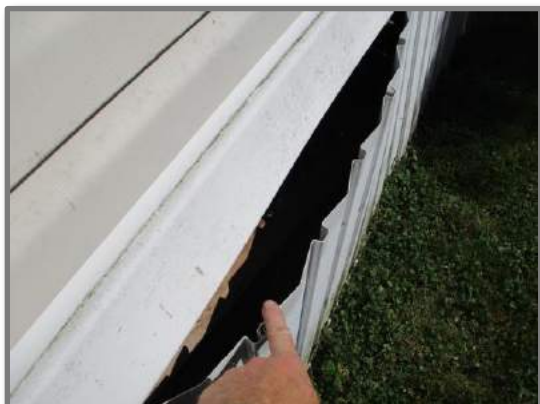
2. There are dents and holes from mowing/trimming in the vinyl skirting. Some of the skirting has pulled away. I recommend spraying within six inches of the unit to kill grass and eliminate the need to trim so close. Re-attach loose panels and seal holes or replace any badly damaged panels (most holes are small).

It's easy to push the skirting back into place – you should do this at any area where it has pulled away

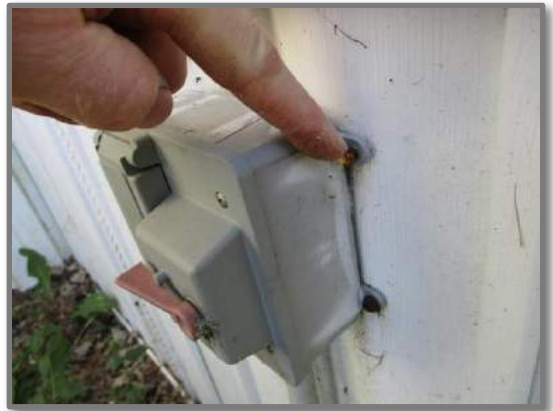
4. Tighten this screw to hold the outlet/switch combo onto the unit.

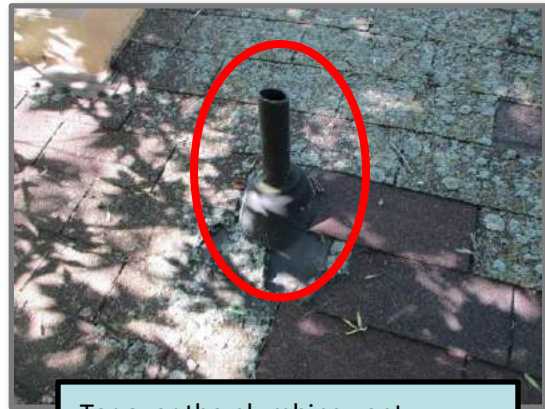
1. The asphalt shingles are poorly installed (nailed incorrectly), several tabs are missing and repairs are evident (this means that shingles are blowing off during wind storms). All flashings at penetrations (chimney, vents, etc.) are badly worn and in need of repair. I didn't have access to the underside of the roof, but I'd bet that it's leaking. Plan on having this repaired right away to preserve the unit. You'll need to work with park management to have the trees significantly trimmed back to reduce the chances of damage to the new roof. Find out who is responsible for the cost of tree trimming.

Tar over the plumbing vent (above) and furnace vent (below)

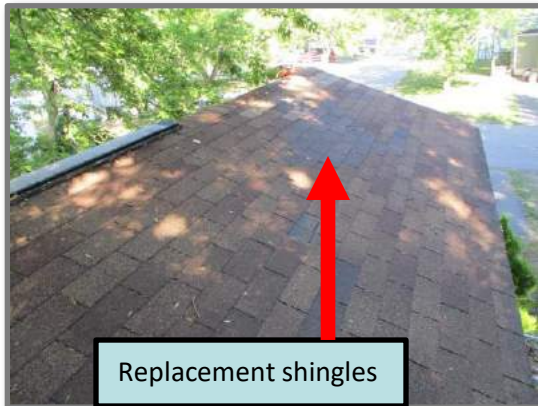
Replacement shingles

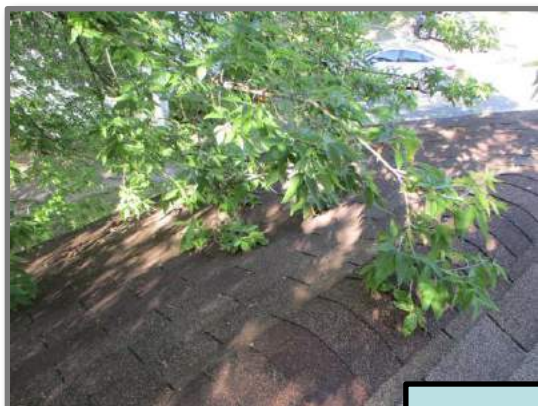
Trees and tree debris on the roof

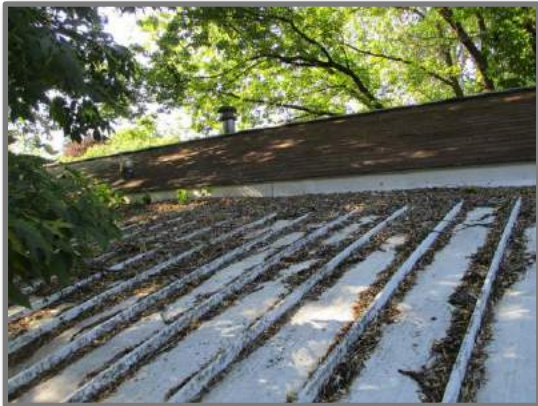
3. The standing seam metal roof is covered in tree debris and has been repaired in several locations (circled). Have the trees cut back and the roof replaced. Plan this into your initial budget because it doesn't have much time left.

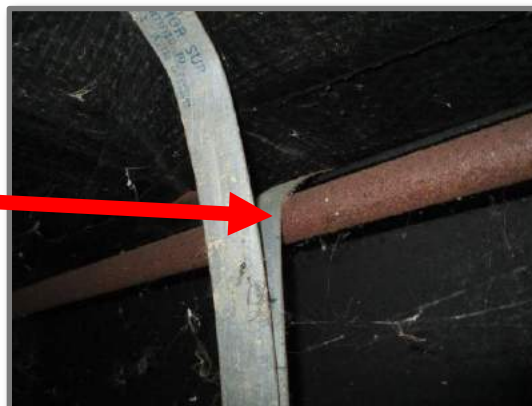
1. The wind anchor strap is over the natural gas supply pipe on the north side of the unit. This could cause the pipe to be damaged if the strap was tested by high winds, resulting in a gas leak. I recommend re-routing the pipe.

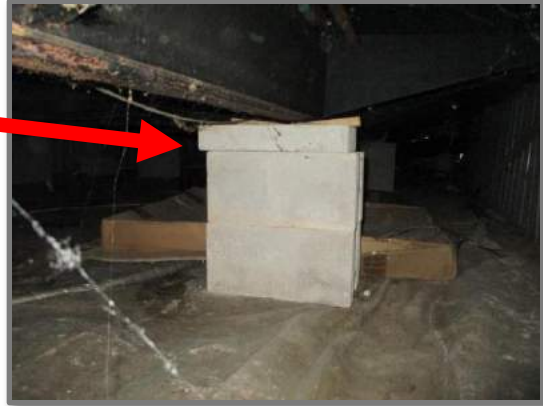
2. These concrete blocks on the north side have shifted. The unit should be jacked up and the blocks should be re-positioned to support the load.

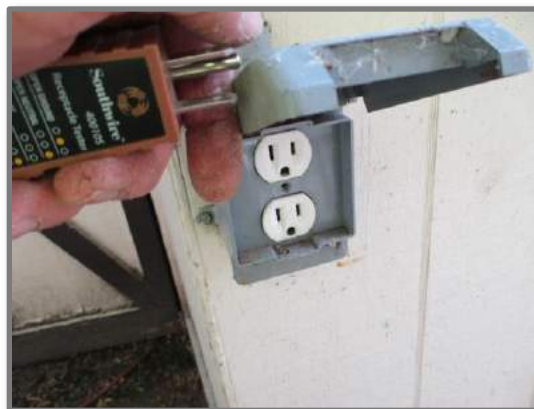
2. There are no GFCI outlets in the outdoor shed outlet (pictured) or the laundry area. GFCI's are required on all outlets within 6 feet of a sink (kitchen, bathroom, etc.), or where moisture is typically present (basement & garage). This is an electric shock hazard. I recommend having a qualified electrician install GFCI outlets at these locations.

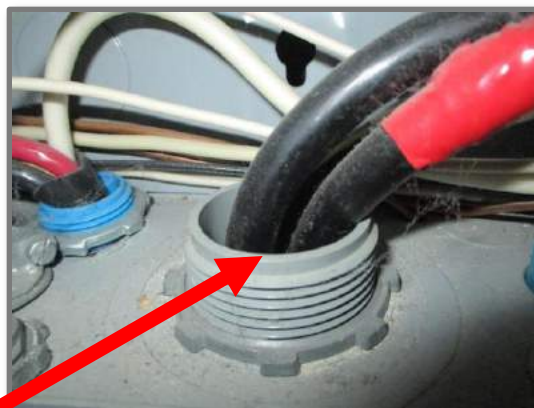
4. There is no protective bushing where the service entrance cable passes through the electric panel. Bushings are required here to protect the wires from damage. Keep in mind, just because the wires may not have been damaged yet, there is still a real chance that they could be damaged and cause a short, fire or electrify the panel. Bushings for this hole in the panel probably cost less than \$2, but unfortunately installing them at this point requires a service disconnect, so expect to pay several hundred dollars for an electrician to do the job. I recommend installing bushings to protect the service entrance cable from damage.

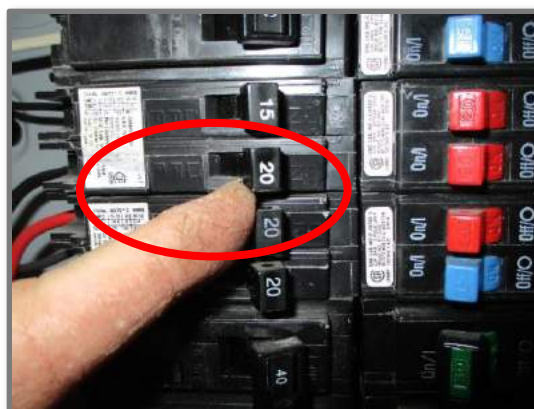
5. There is a multi-wire branch circuit that is incorrectly wired from a mini breaker. Both throws of a mini breaker are on the same electrical phase, which means that a multi-wire branch circuit wired from one mini breaker, such as this, will allow 240 volts of electric to return on the neutral wire as opposed to a correct configuration, which will limit the voltage on the neutral to 120 volts at a given time. This will overload the neutral wire and can cause an electrical fire. I recommend immediate correction by a qualified electrician.

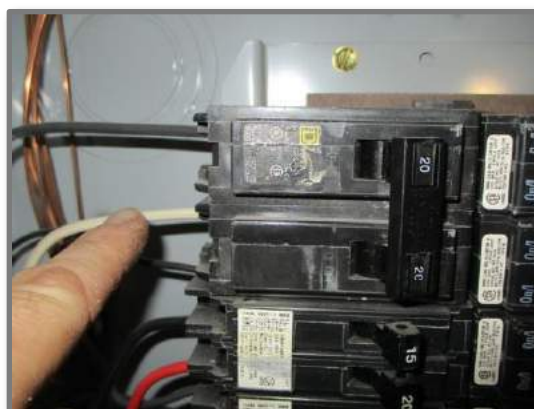
6. In the panel, there is a white wire that needs to be re-identified. Sometimes an electrician must utilize black wires for neutral conductors or white for hot conductors or some other color for equipment grounding conductors. When this happens, the electrician is supposed to mark the conductor with the appropriate wire color using tape or paint (white=neutral/black=hot) but this hasn't been done. Another person working in the panel could accidentally be electrocuted because of this problem. I recommend having this corrected by a qualified electrician.

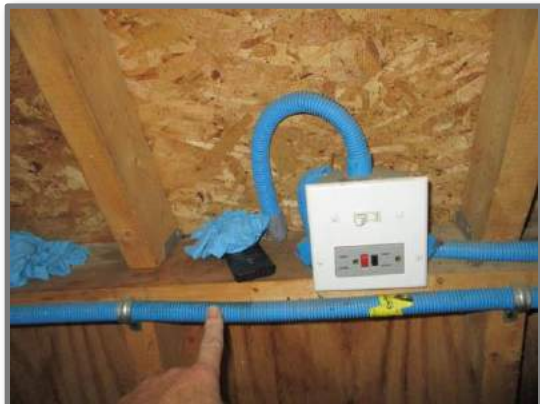
9. This ENT tubing (typically called "Smurf tube" must be protected from damage where installed below 7 feet, similar to NM cable. That means it must be installed behind drywall or another wall covering. It's not suitable for this location. I recommend replacing the ENT (Smurf tube) in the shed and house with thin wall metal conduit to protect the wires from damage and protect people from electric shock.

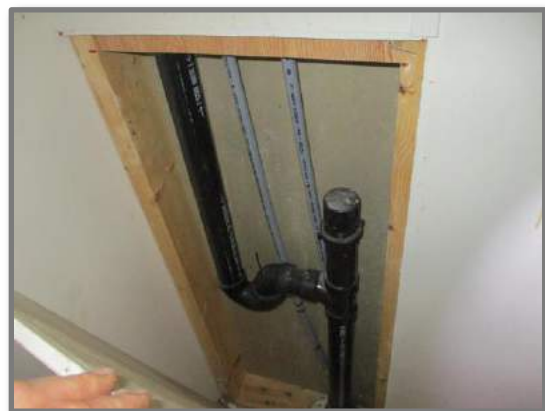
3. The laundry waste piping is located behind this wall panel. Re-install the panel with screws so that they can be easily backed out if the plumbing ever needs to be accessed.

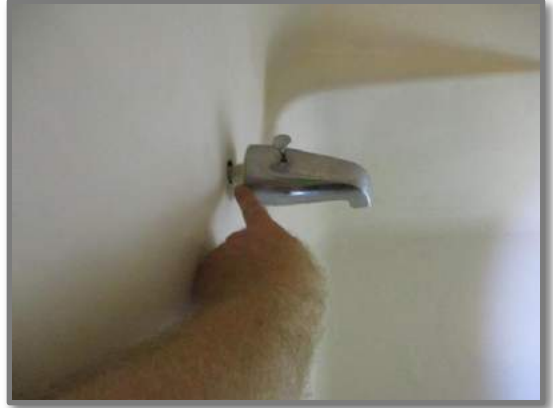
4. The tub faucet in the master bathroom has pulled away from the shower. Have it re-secured (behind the wall using the access panel in the bedroom).

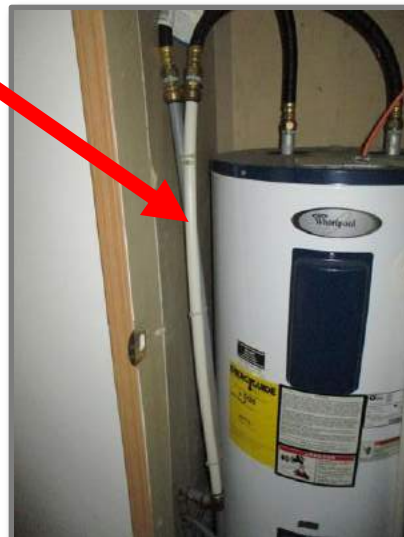
7. The supply and return lines at the water heater should be properly supported to the wall to reduce the chances of future damage.

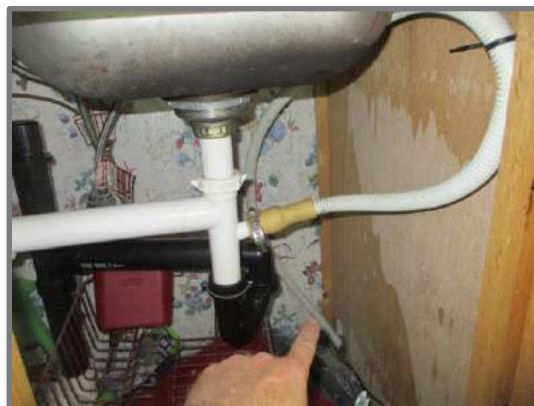
9. The dishwasher drain is not connected correctly. The "high loop" method should be used to create a slug of water, or trap, keeping sewer gasses from entering the dishwasher much like how a typical plumbing trap blocks sewer gasses from entering living space. Sewer gasses in the dishwasher can cause the dishwasher to become permanently unsanitary. I recommend having a qualified plumber correct this.

I'm pointing to the drain hose – see the diagram on the next page for the correct installation

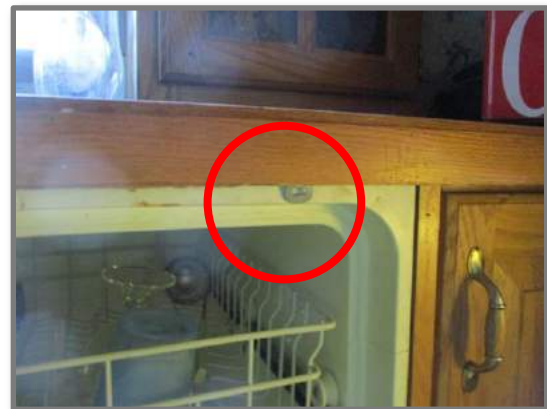
10. The dishwasher has not been properly attached to the counter. It tips forward when pulled. Have it secured to the countertop.

No screws in the mounting holes

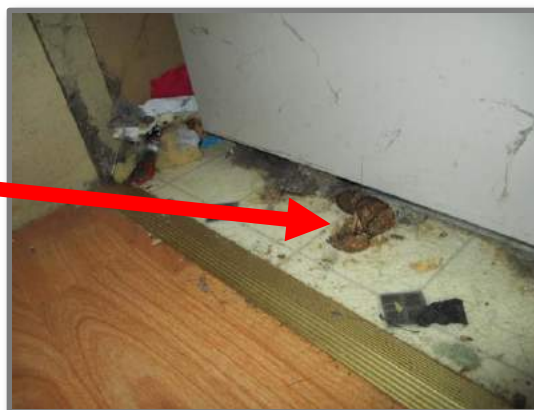
1. All rooms were checked for a heat source (delivery register) with no defects noted.
2. I couldn't test the forced air gas furnace for function due to the outside temperature being too high and the furnace being shut down.
3. The furnace utility closet is really dirty. Clean it out and keep it clean.

That's dog poop

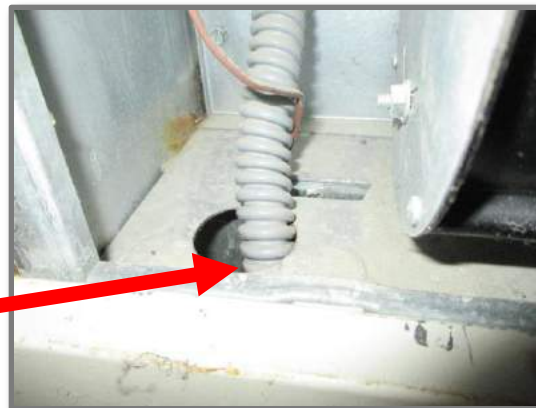
5. No furnace manufacturers allow natural gas connectors like this one to pass through the furnace cabinet because it can be cut or damaged if/when the furnace fan becomes out of balance or if the cabinet is bumped or shifts. This is a safety hazard because damage to the connector would cause a natural gas leak inside the home. I recommend having rigid metal pipe installed to extend through the furnace cabinet; at that point, the connector can be installed safely.

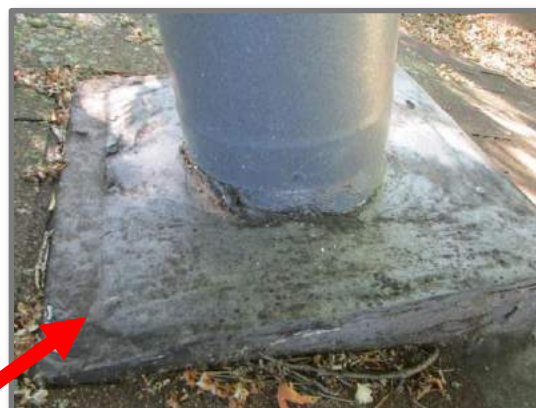
6. The B vent (furnace exhaust) is rusty inside and has had tar applied to it outside. Clearly, it has leaked in the past and it will leak in the future. Applying tar to a metal roof vent is a short-term repair and actually causes the vent to rust quicker. I recommend replacing this B vent.

The B vent is rusted inside (left) and tar covered outside on the roof (right)

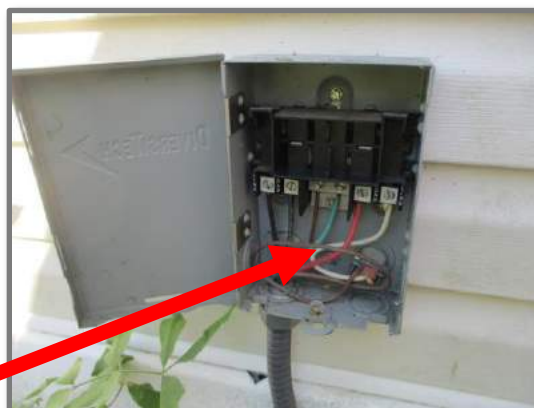
3. In the air conditioner disconnect, there is a white wire that needs to be re-identified. Sometimes an electrician must utilize black wires for neutral conductors or white for hot conductors or some other color for equipment grounding conductors. When this happens, the electrician is supposed to mark the conductor with the appropriate wire color using tape or paint (white=neutral/black=hot) but this hasn't been done. Another person working in the panel could accidentally be electrocuted because of this problem. I recommend having this corrected by a qualified electrician.

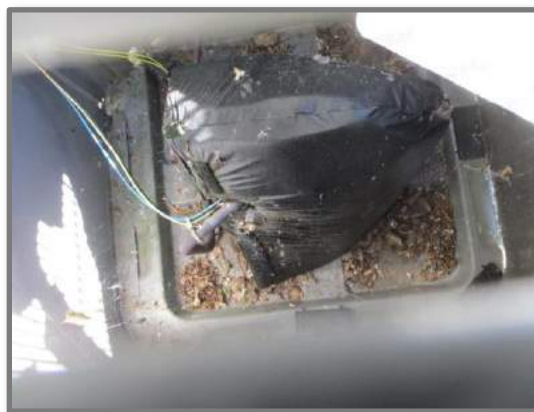
4. There is debris in the outdoor compressor unit. Have it cleaned out now and as needed in the future. Install a cover during the off season to reduce the amount of debris that enters the cabinet.

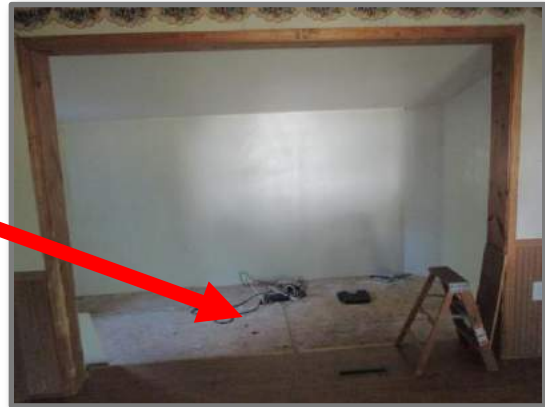
3. This room on the south side is a work in progress. Have it finished.

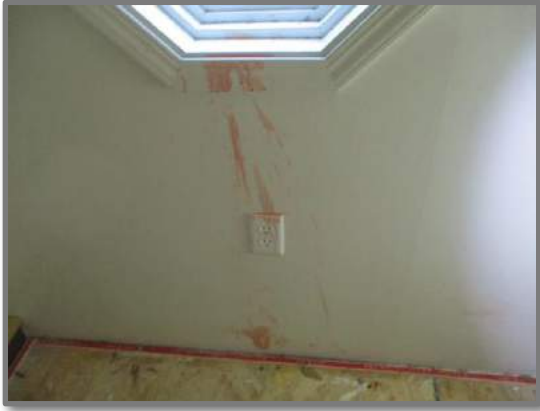
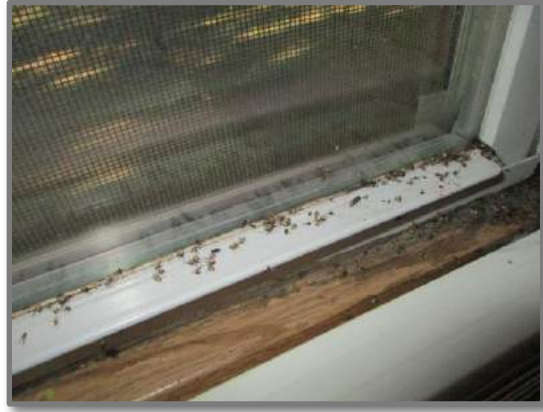
4. Plan on cleaning every surface in the home, opening up the windows to air the place out and throwing away the refrigerator/freezer full of rotted meat. I don't think there's any way to make it sanitary for food storage again. Plan on buying a new refrigerator when you move in.

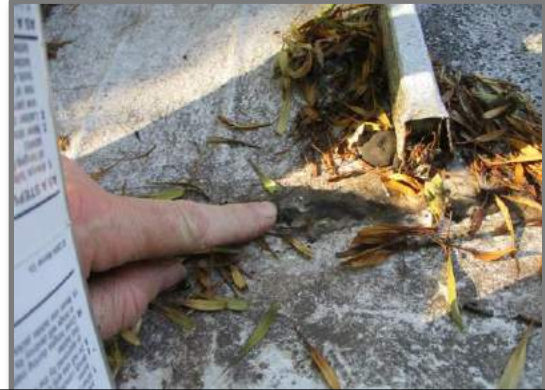
9. Here's the water damaged spot you mentioned to me before you left. I checked it out and traced it to a temporary repair on the metal roof. I can't tell you for certain if the repair worked, but I can tell you that it's not going to work forever. Once caulk is applied to a metal roof, it's only a matter of time until it leaks again. I recommend replacing the roof before you spend the money on fixing the ceiling.

This is the repaired area on the roof – it will leak again at some point so don't spend too much time or money fixing the interior until the roof has been replaced

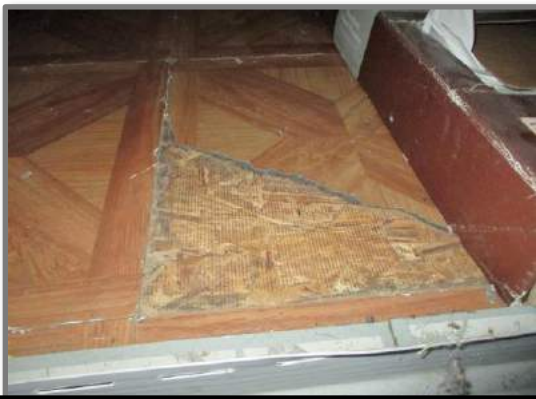
12. You could probably install some sliding doors here and use this area for additional storage.

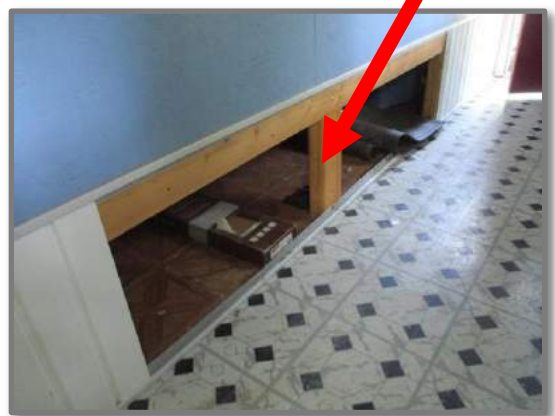
The flooring inside the storage area is whipped

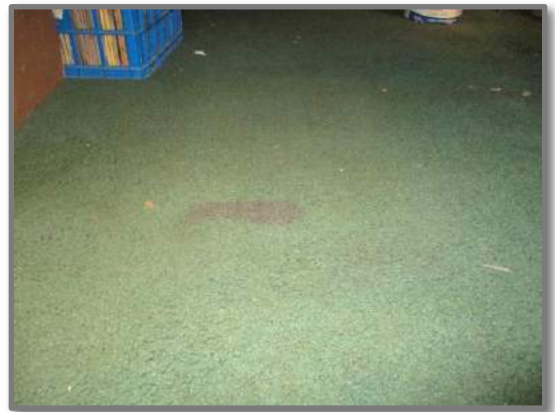
13. Plan on replacing the master bedroom carpet. It's dirty and it smells. There's a chance that you can clean it, but new carpet is fairly cheap so you should at least get a price on it before making the decision.
